LEVEL 3

Your survey report...

Inspection Date

20/02/2026

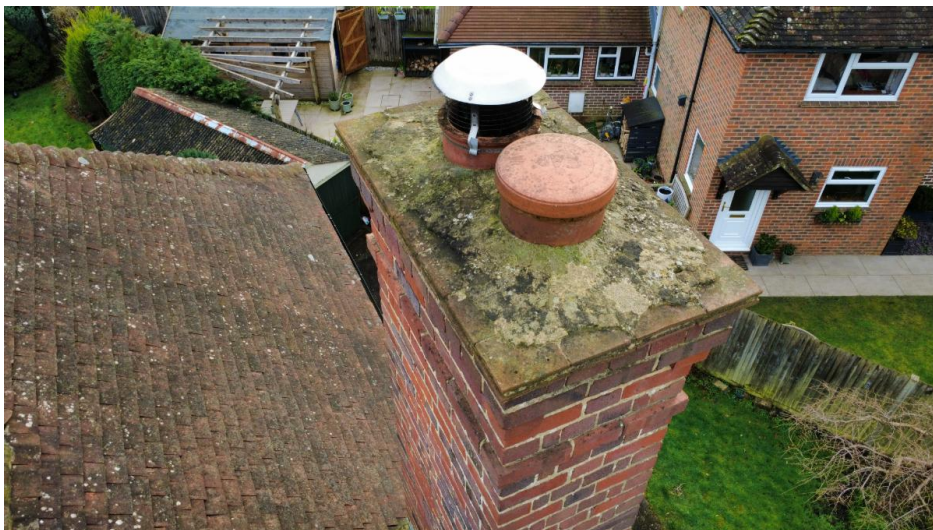
Flaunching replacement required

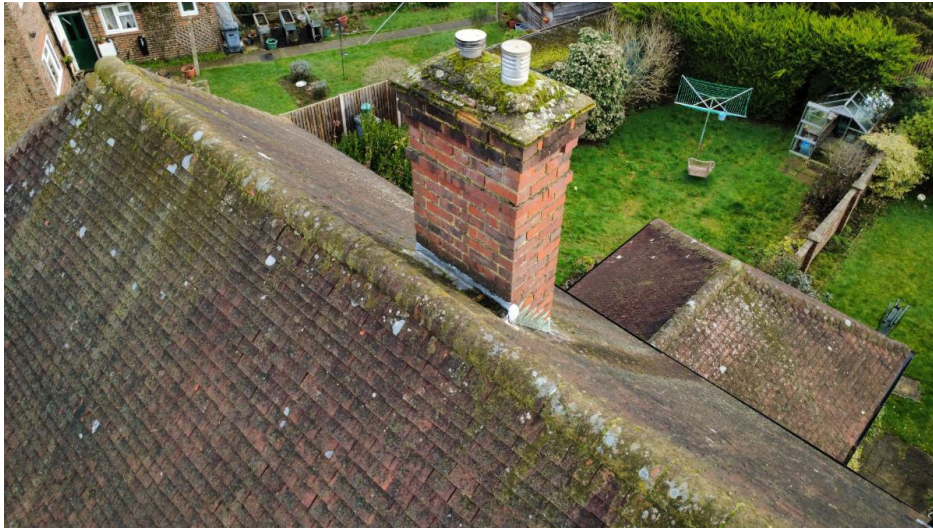
Flaunching replacement required

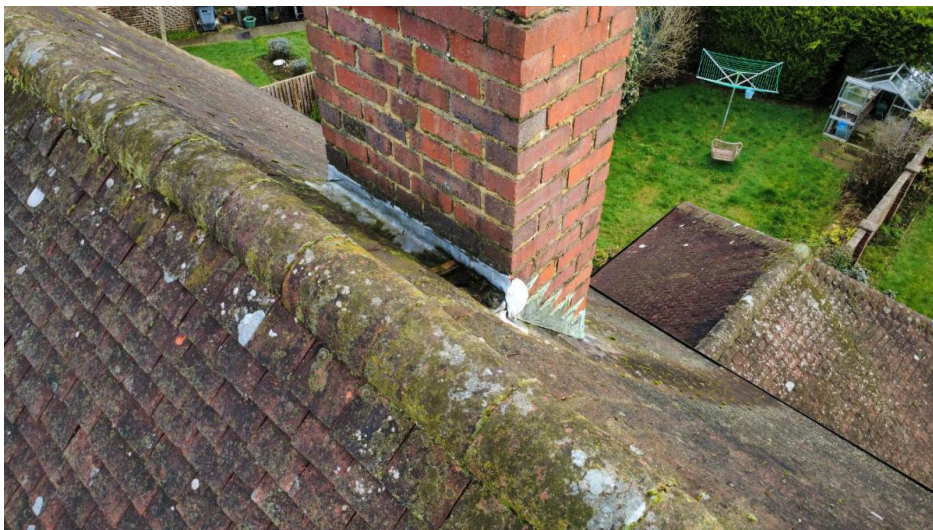
Debris and poor detailing to back gutter

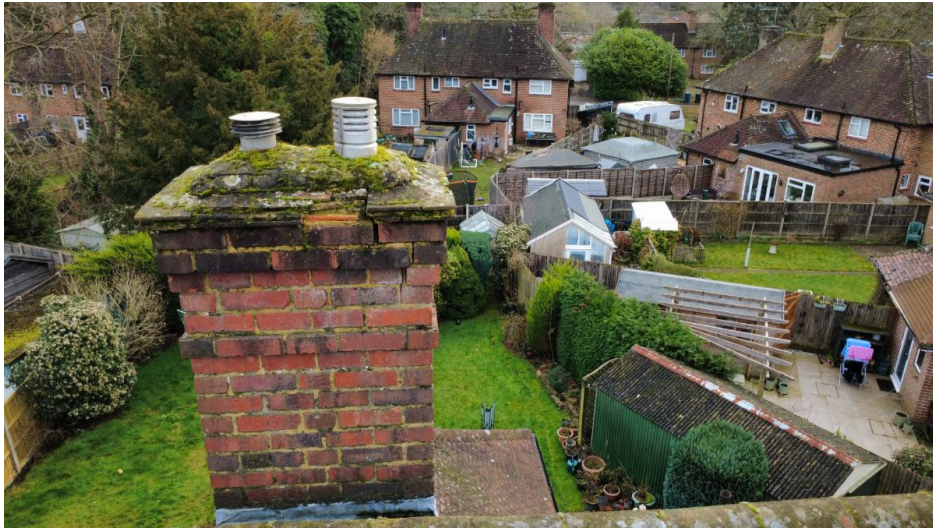
The chimney stack(s) display signs of notable disrepair. The chimney(s) require repair to the brickwork and pointing to ensure structural integrity. You should instruct a contractor to provide costs to make good. This should include all flashings and any flaunchings (the mortar that holds the pots in place) and undertake repairs as needed. There was a significant crack noted to the shared chimney stack and urgent inspection is required.

Crack to side of chimney requiring urgent investigation

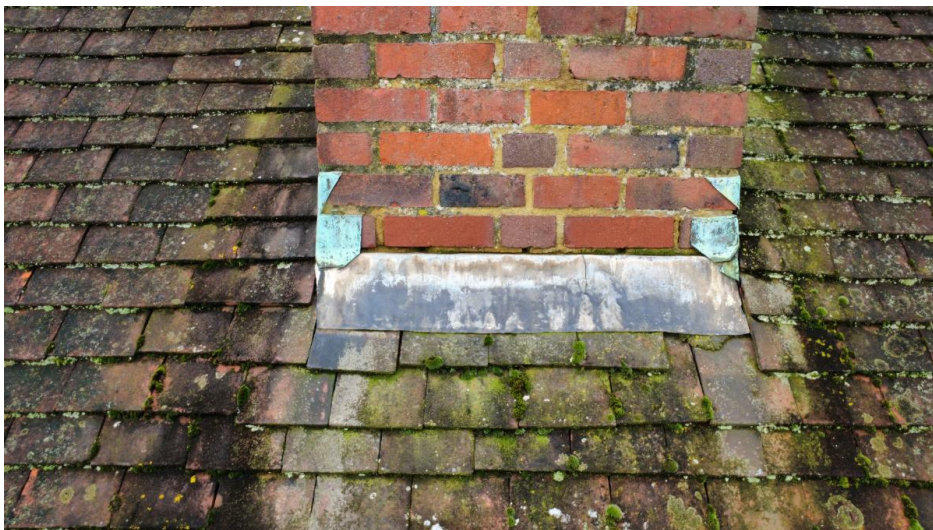
Split lead front apron and missing pointing

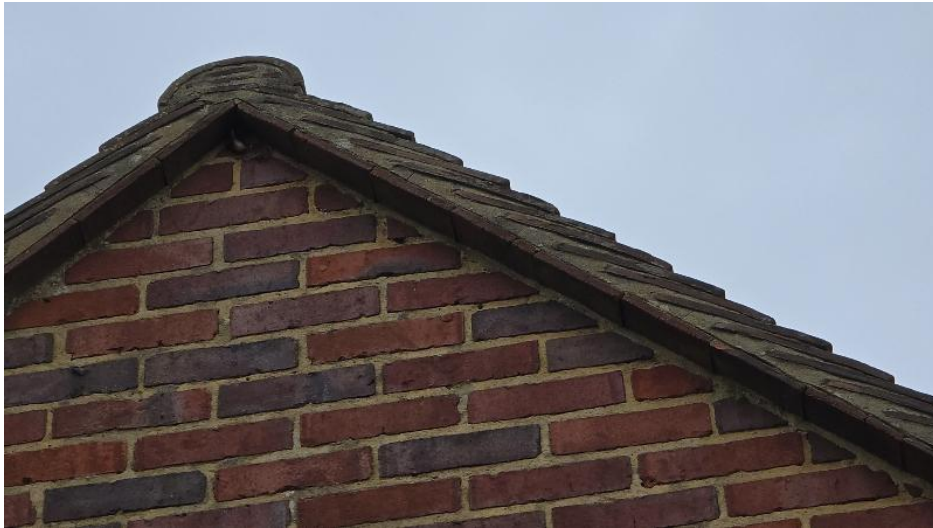
Cracking to mortar on verge

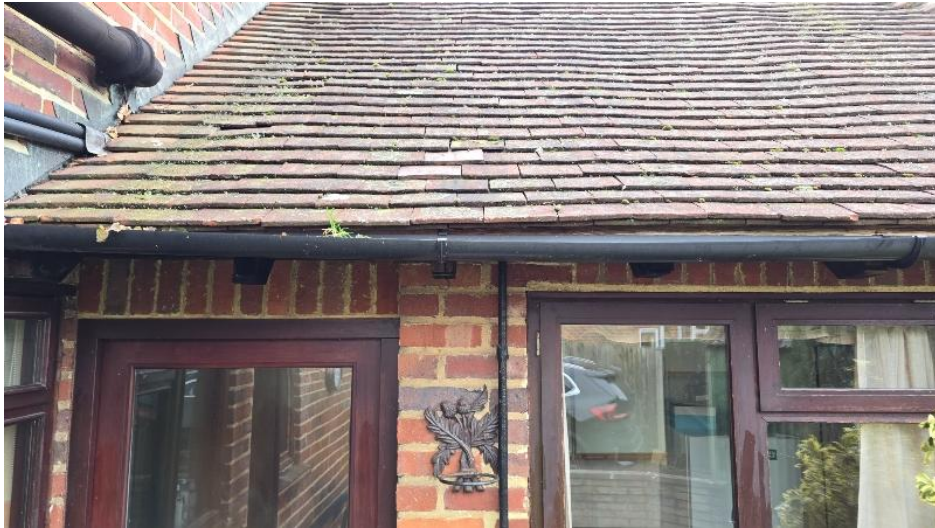
Defective timber to eaves

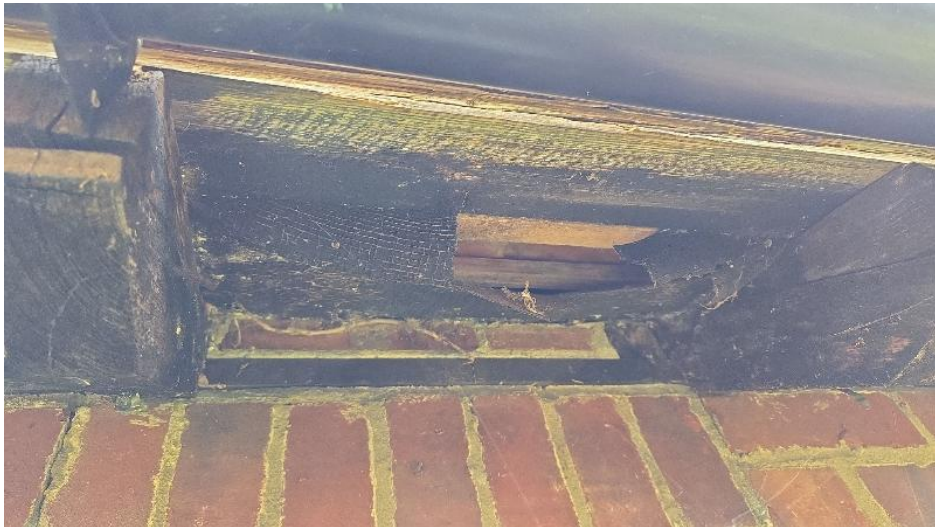
Defective timber to eaves

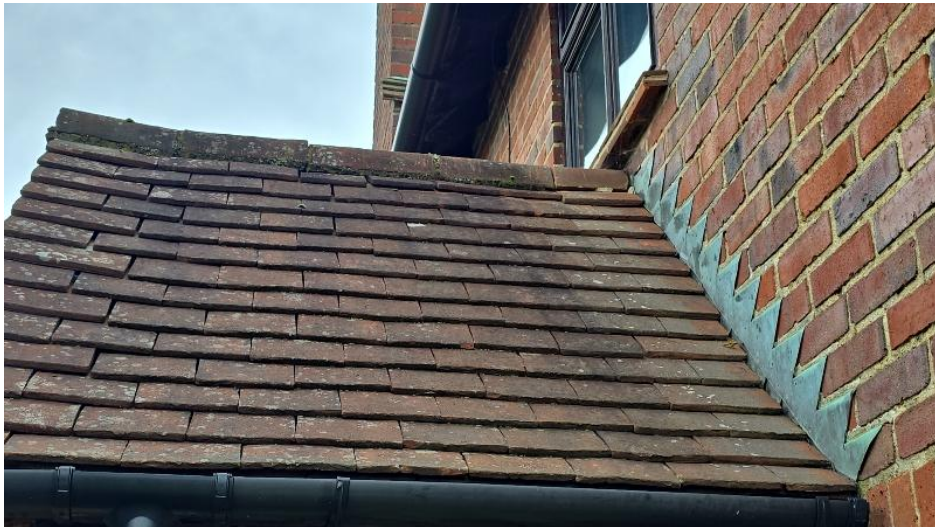
Loose ridge tiles to porch

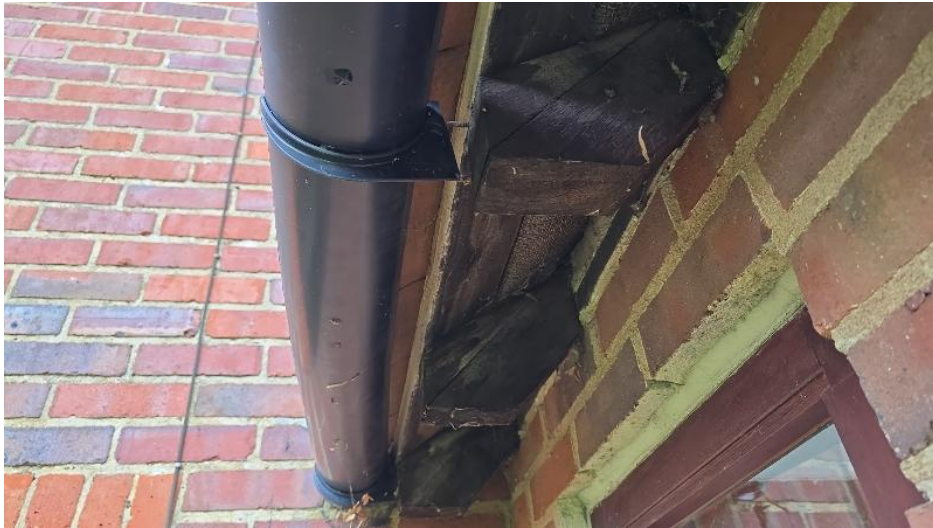
The roof cover is lined with underfelt, which is in poor condition, including torn and damaged sections most notably at eaves level, and should be replaced or repaired. Complete replacement of the felt requires the roof to be stripped and replaced.

Torn underlay to eaves, defective timber

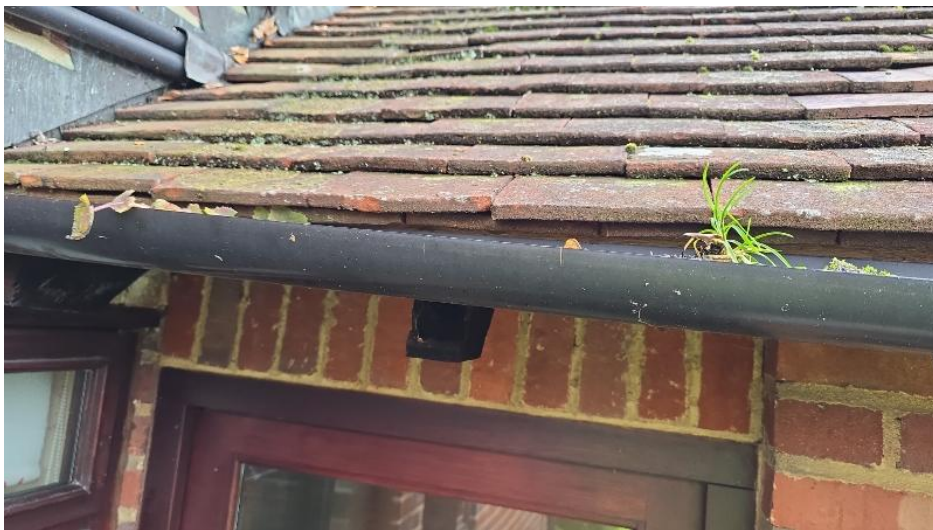
Displaced gutter as a result of defects to roof timber

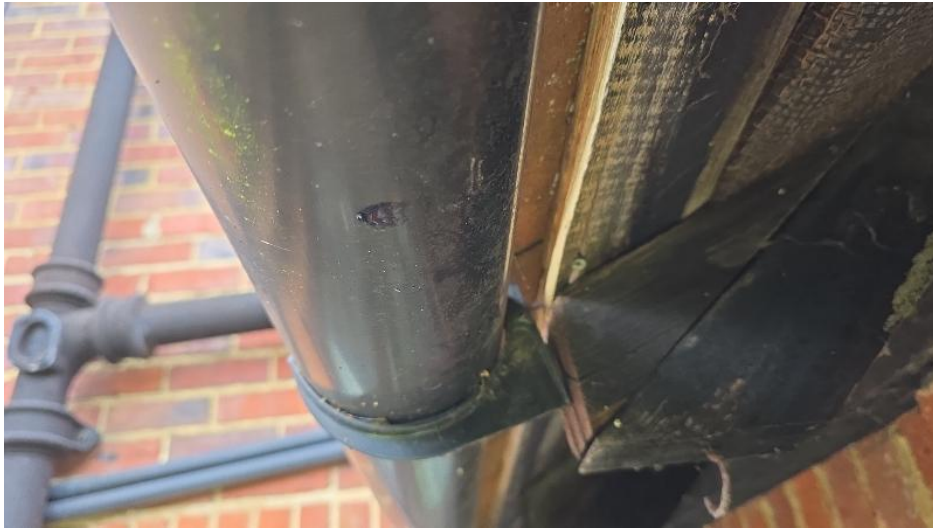
Gutter bracket fixing loose due to defective timber

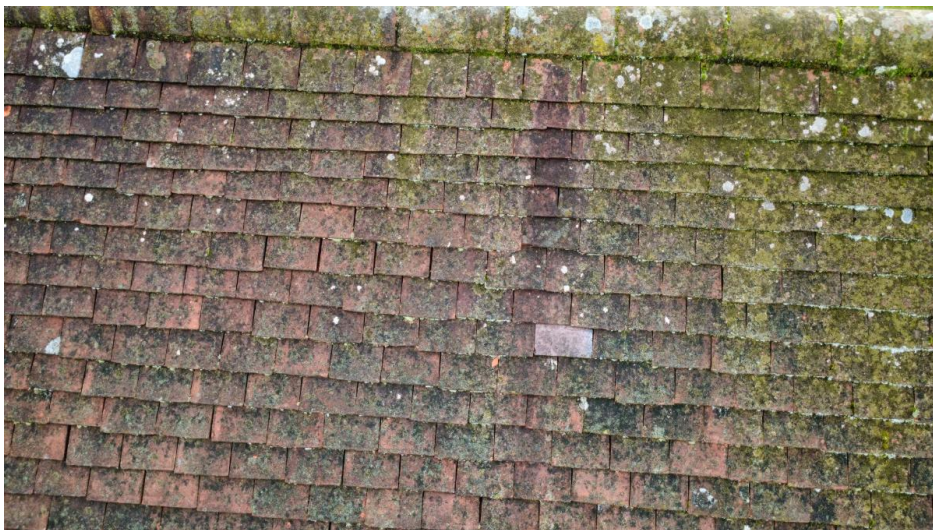
Moss growth, slipped and missing tiles

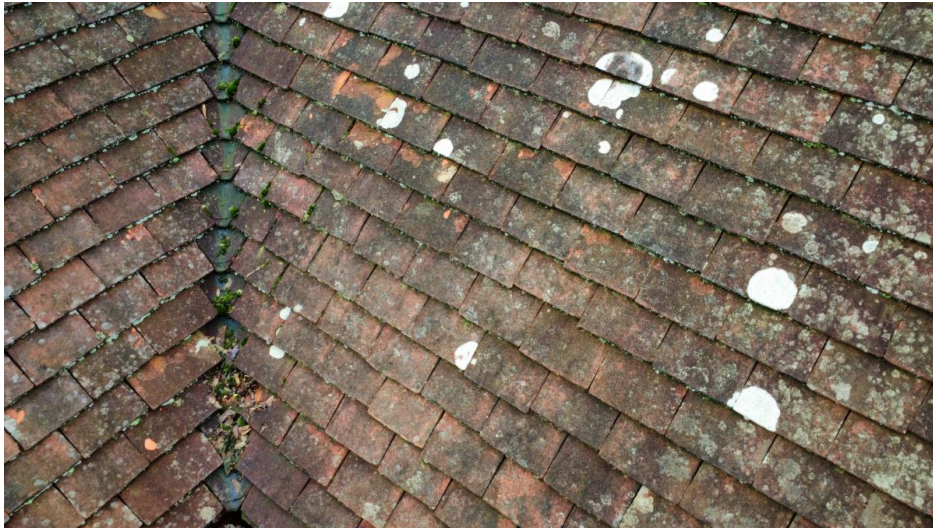
Spalled concrete tiles and debris to gutter

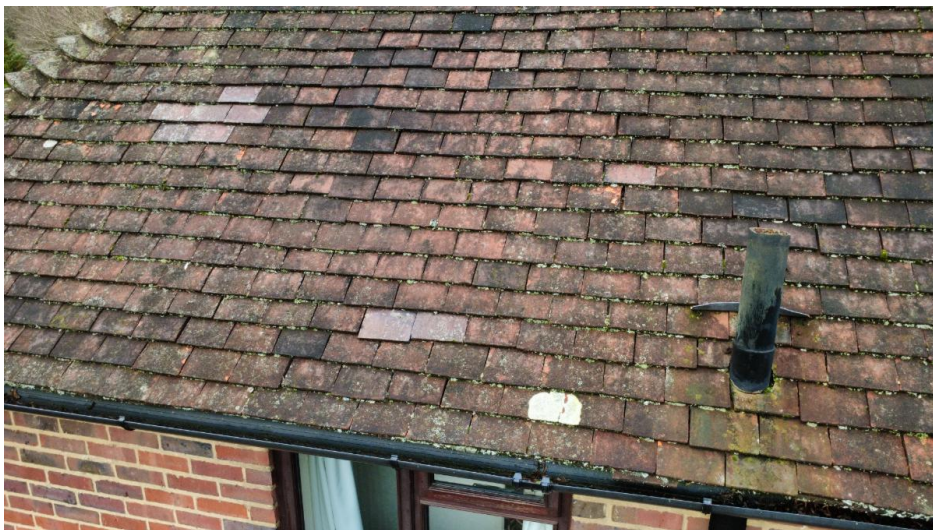
Spalled, slipped and broken tiles. Evidence of recent repairs

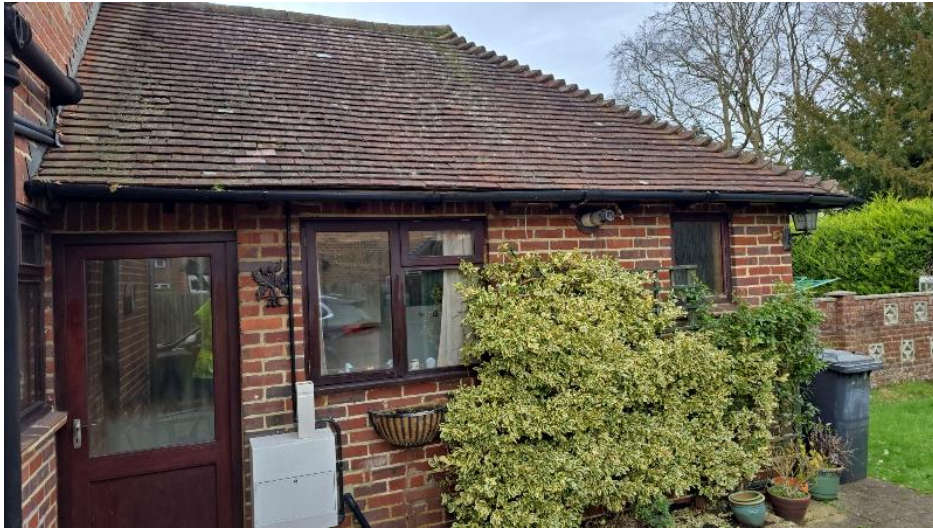
Undulation in gutter due to defective timber to eaves

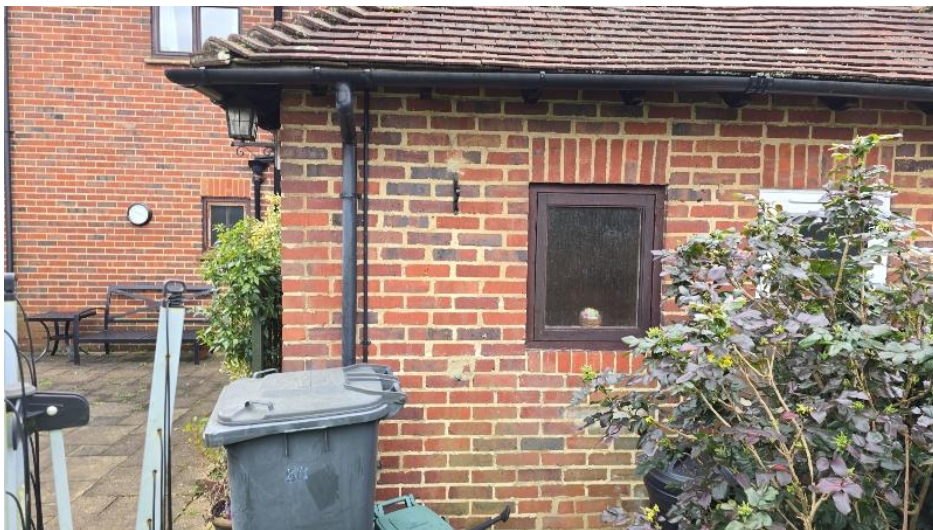
Undulation in gutter due to defective timber to eaves

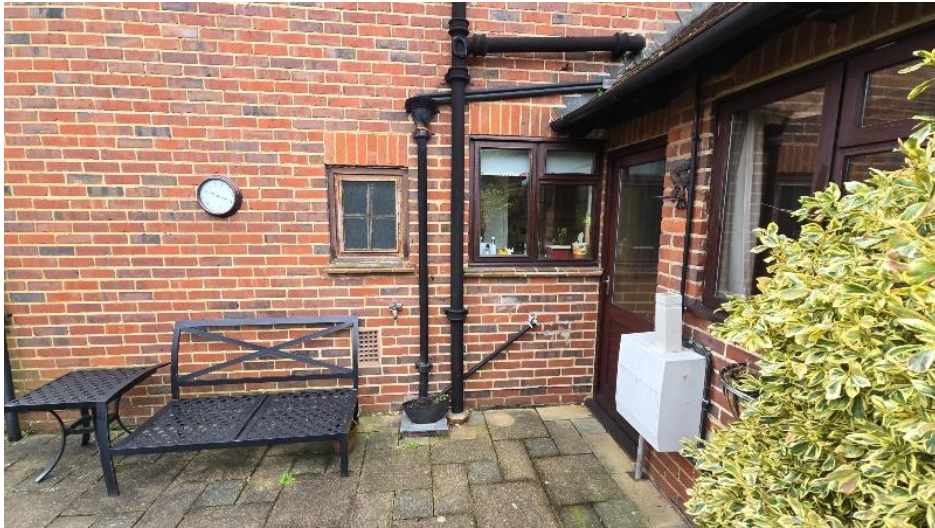
Cast iron downpipe and hopper repairs required

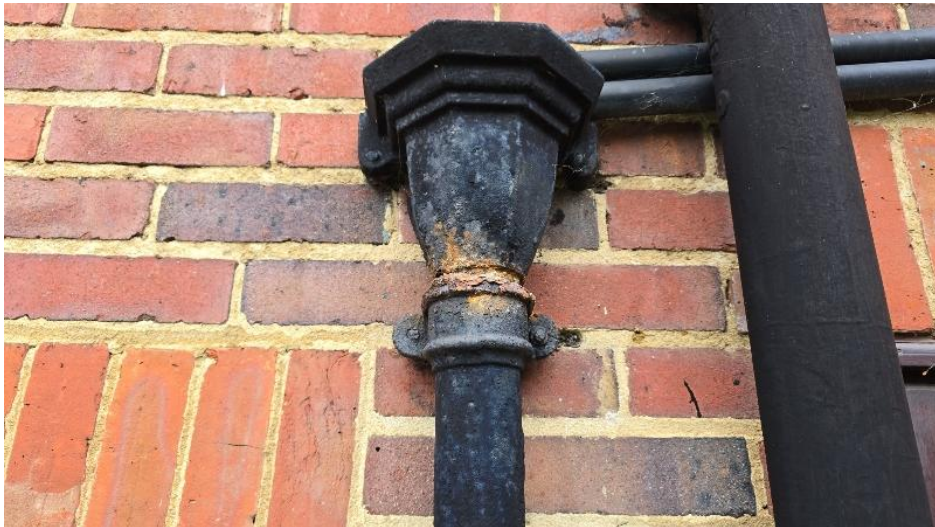
Cast iron downpipe and hopper repairs required

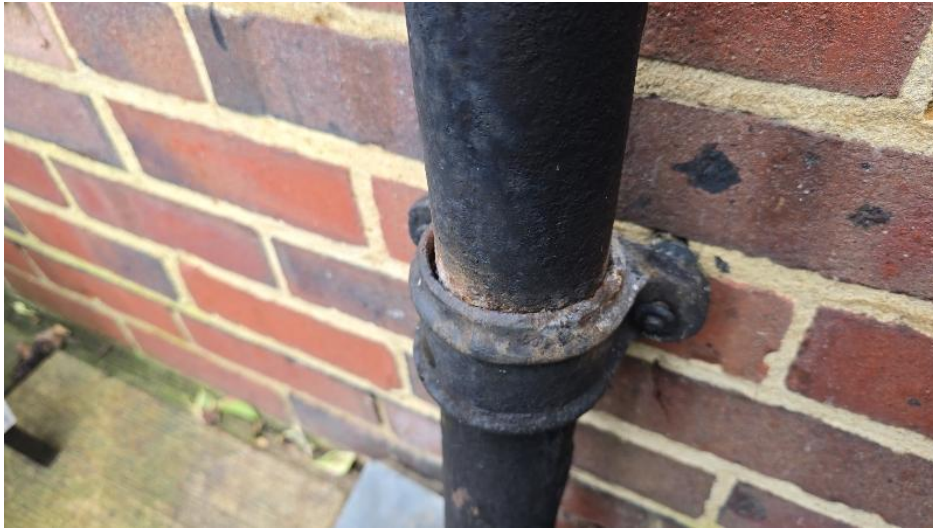
Cast iron downpipe and hopper repairs required

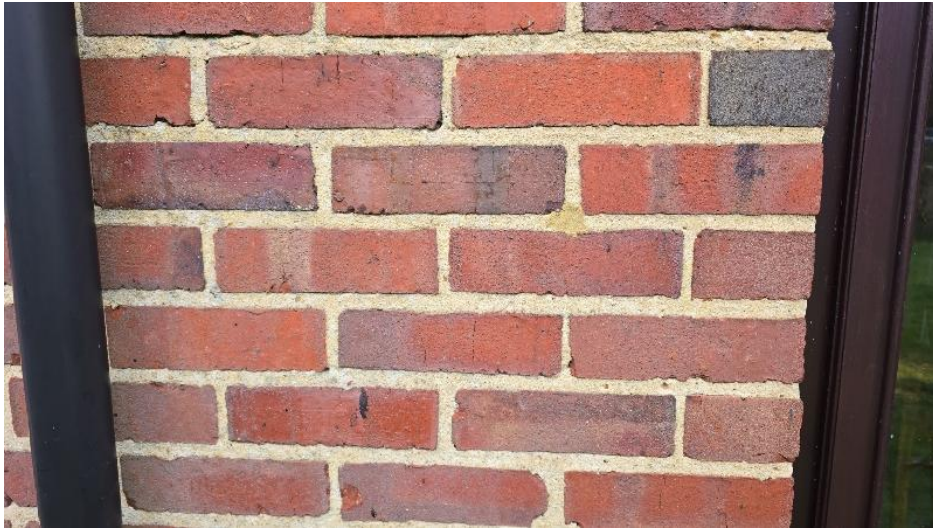
Typical mortar repair following retrofit cavity wall insulation

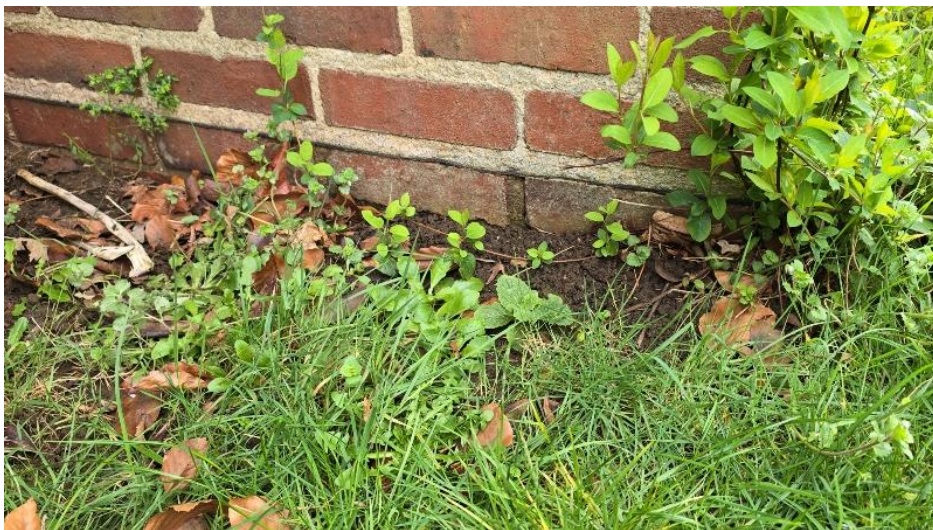
Raised plant beds close to DPC level

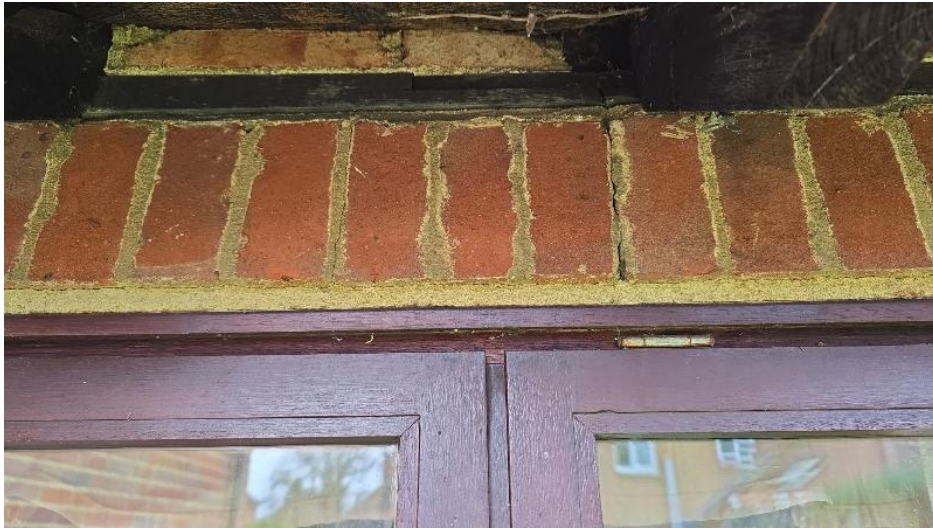
Cracking above utility window lintel

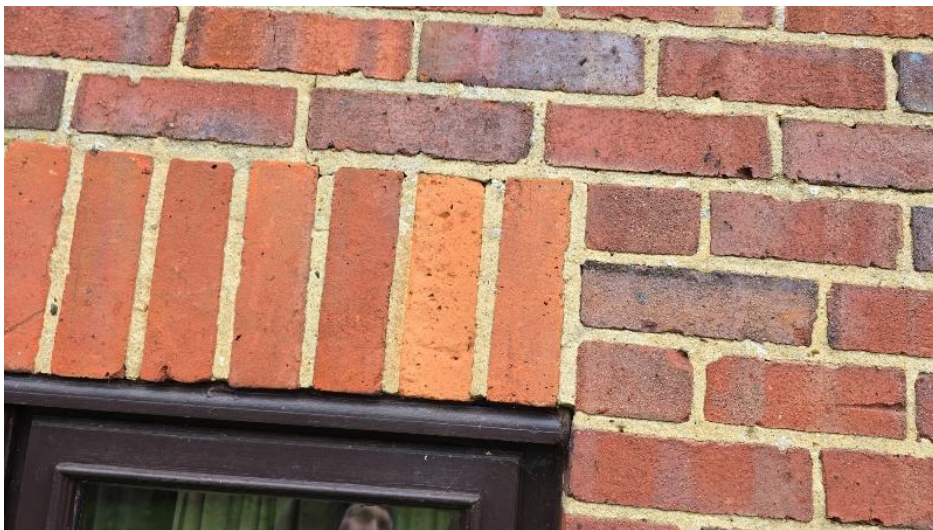
Minor crack above living room window

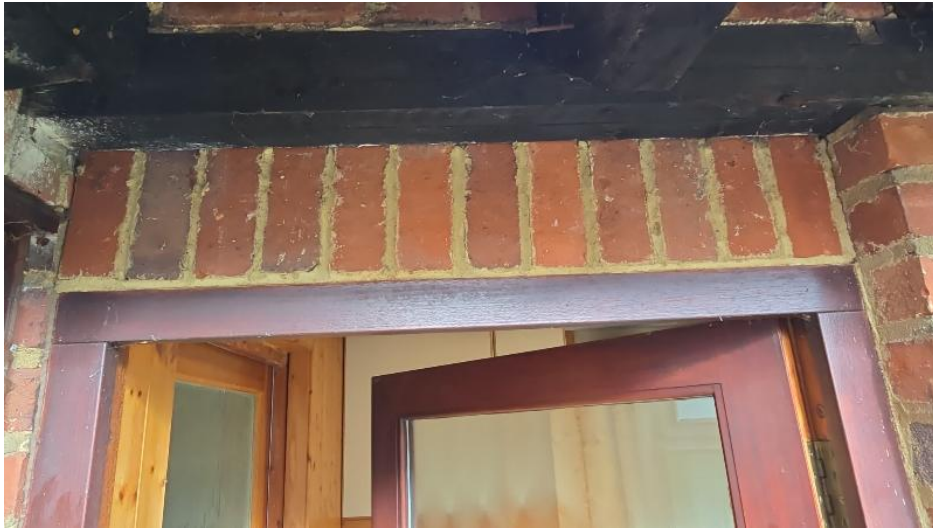
Cracking either end utility lintel

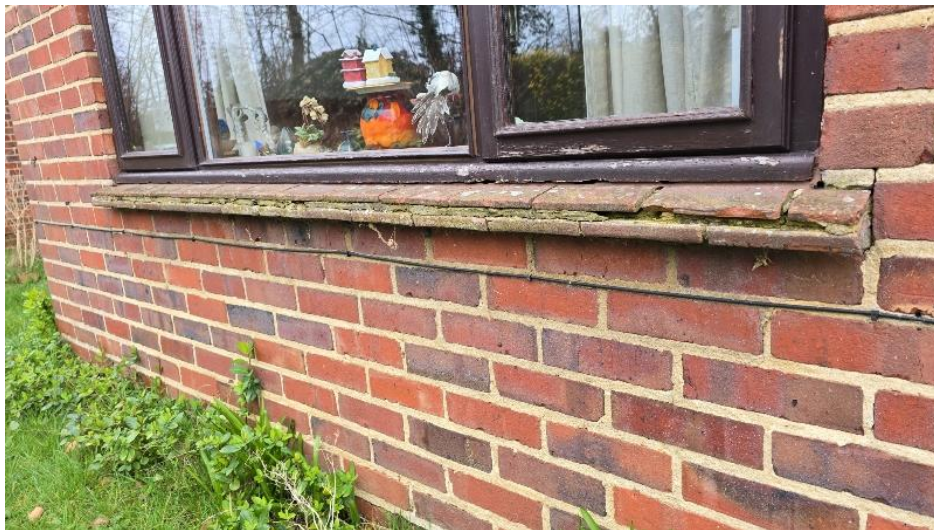
Repairs or replacement of creased tiled Living room window cill

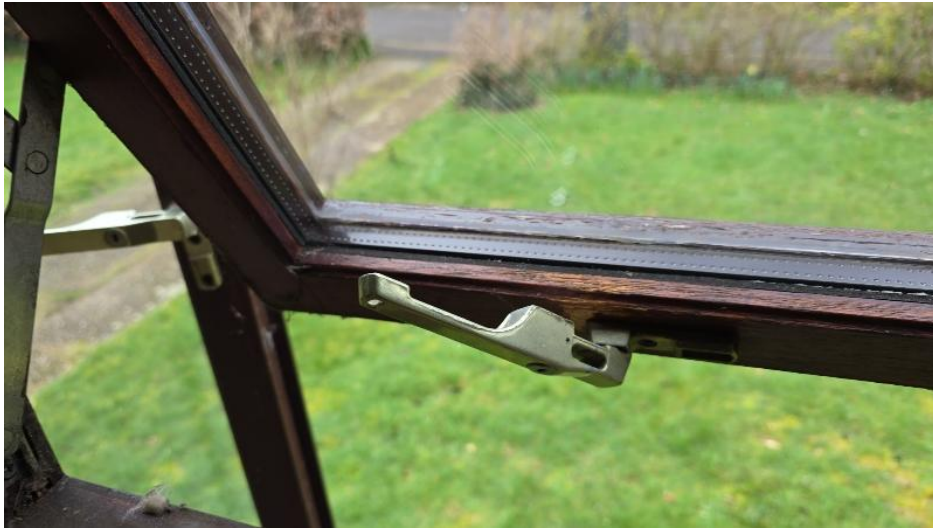
Loose fittings

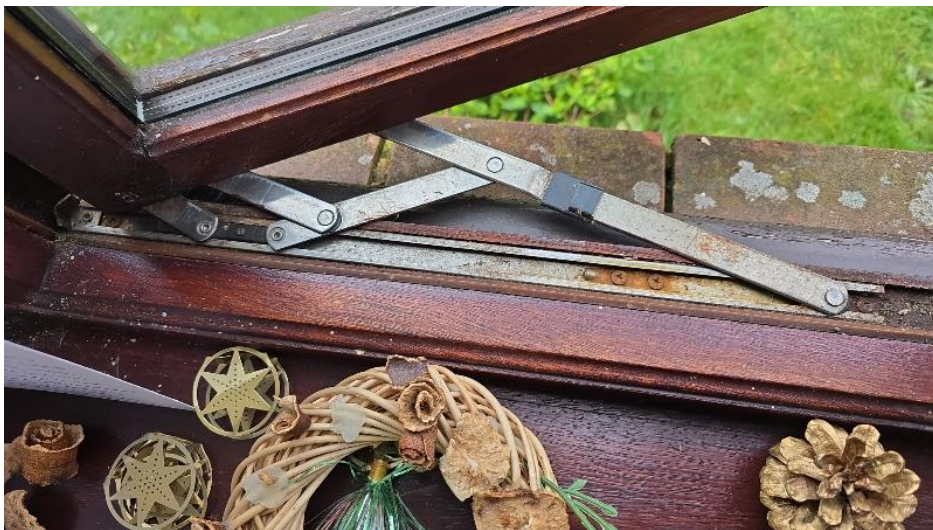
Corrosion to ferrous fixings

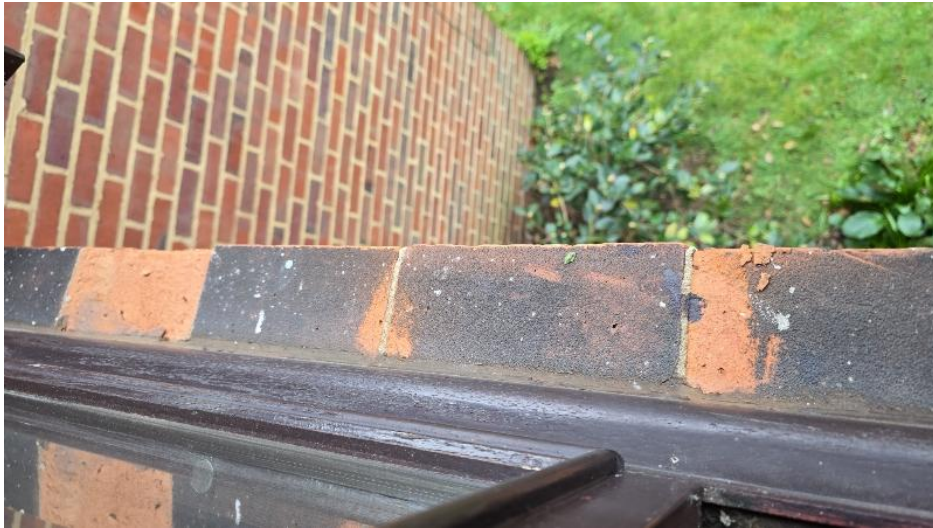
Spalling creased tile to front bedroom window

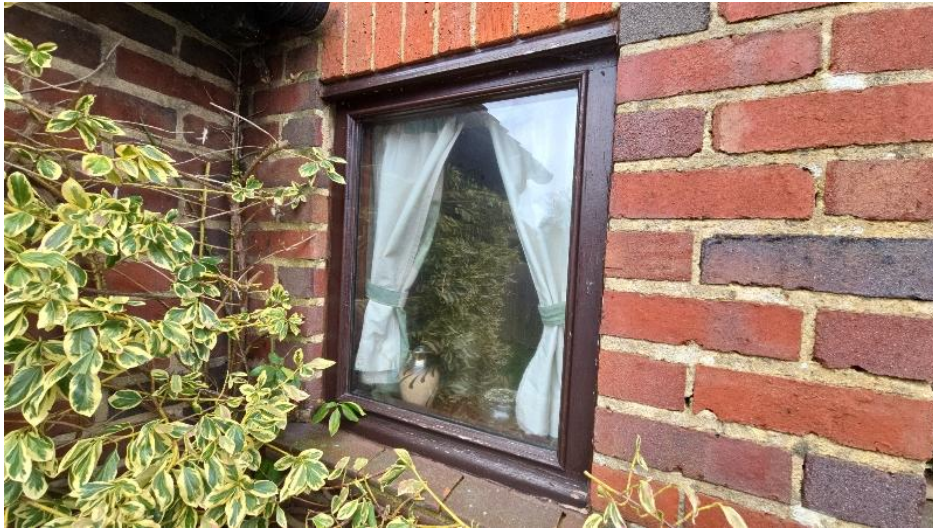
Failed double glazed seal units stairs window

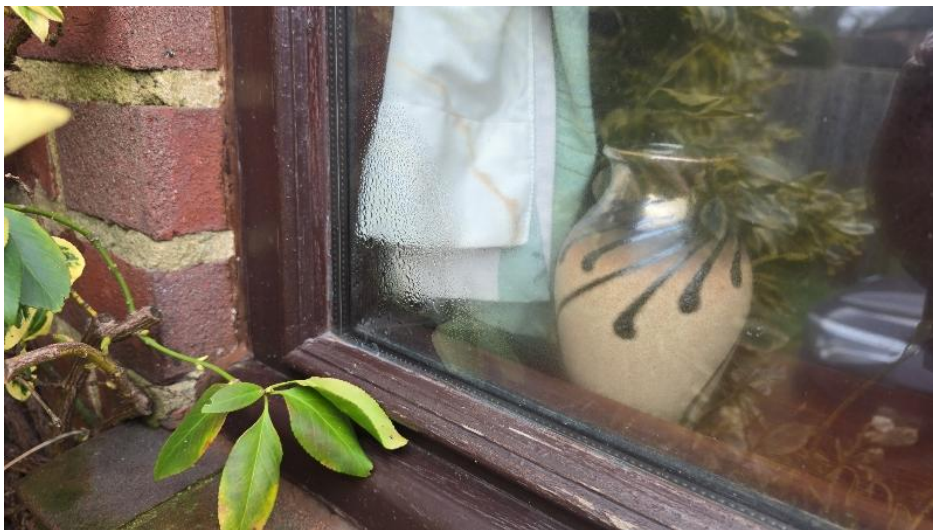
Failed double glazed seal units stairs window

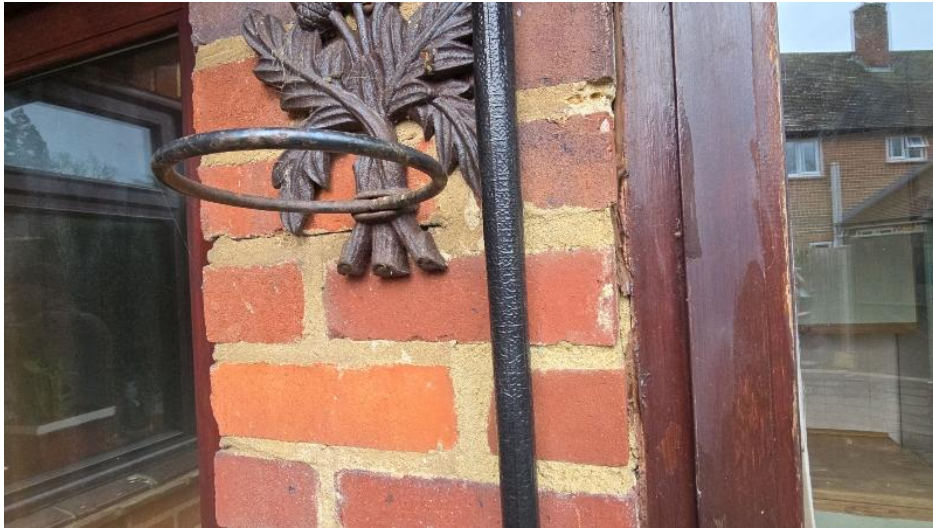
Failed mastic sealant to kitchen

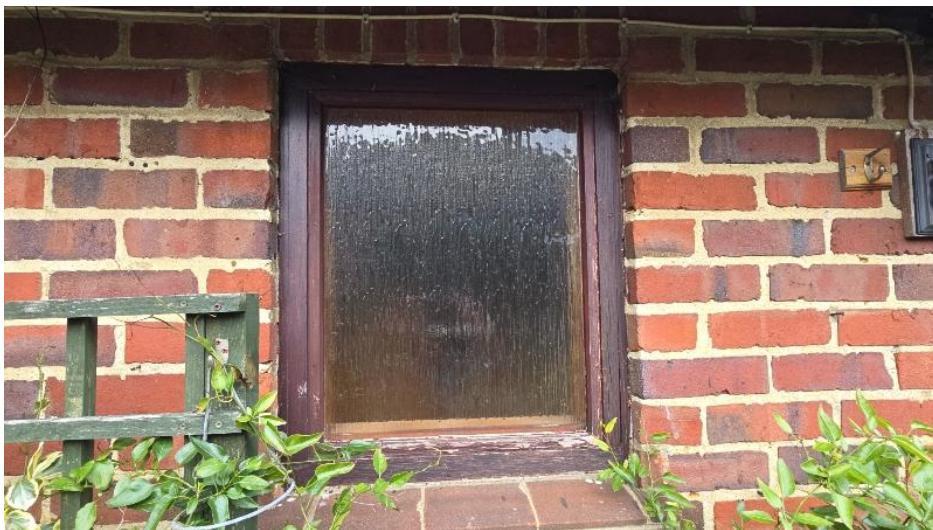
Single glazed kitchen

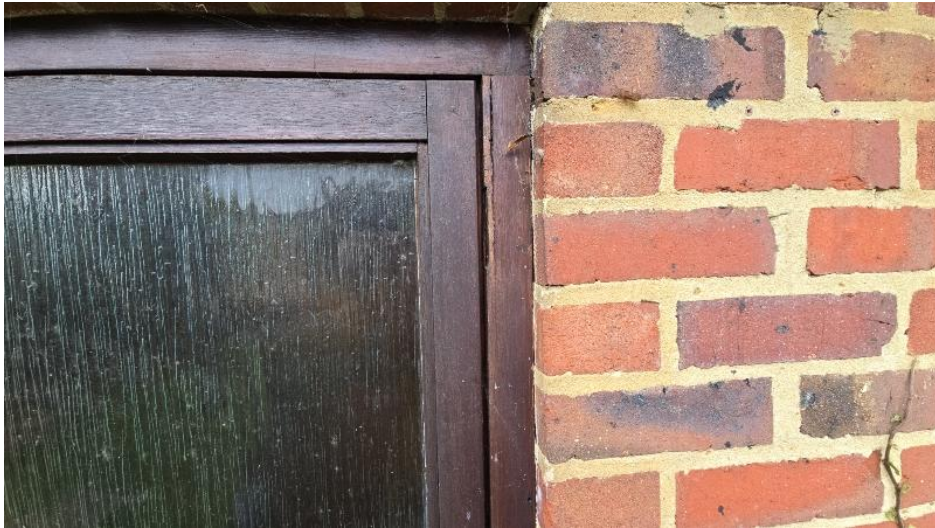
Damaged frame ground floor WC window

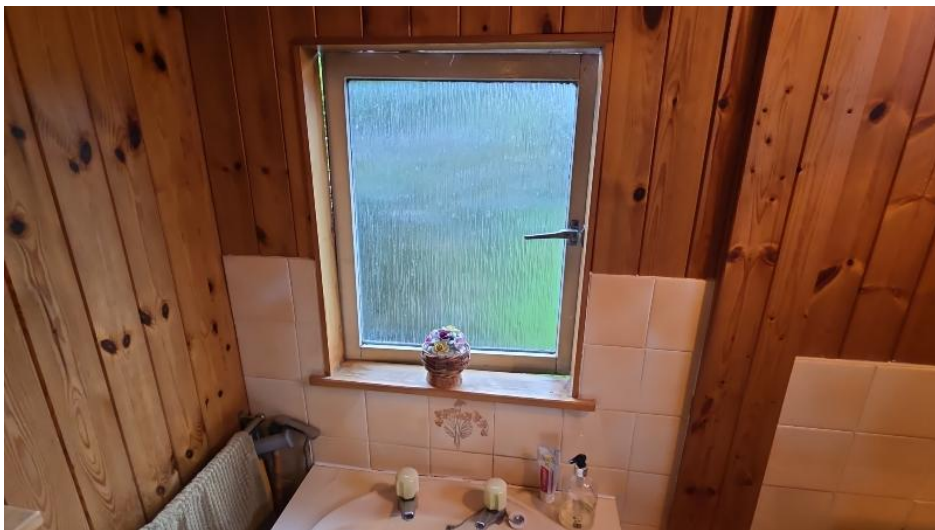
WC window frame broken and doesn't fully open

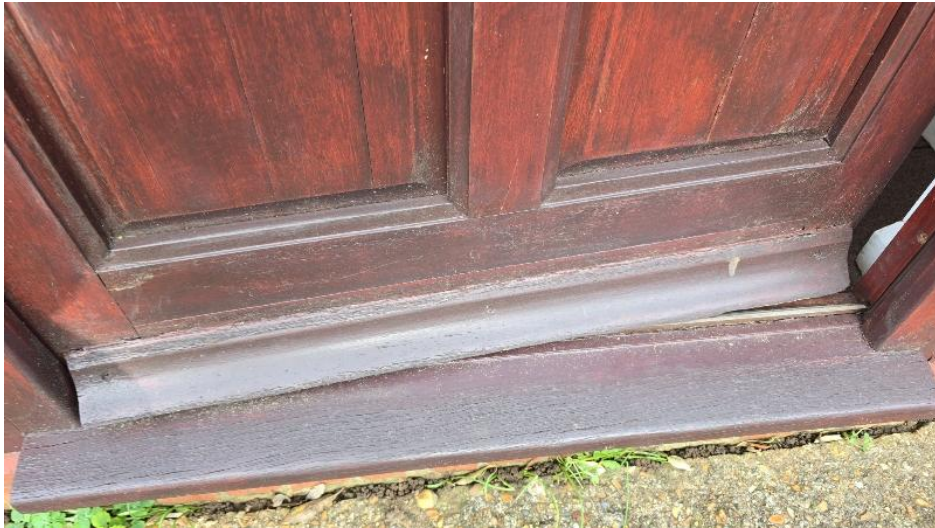
Repairs and redecoration required

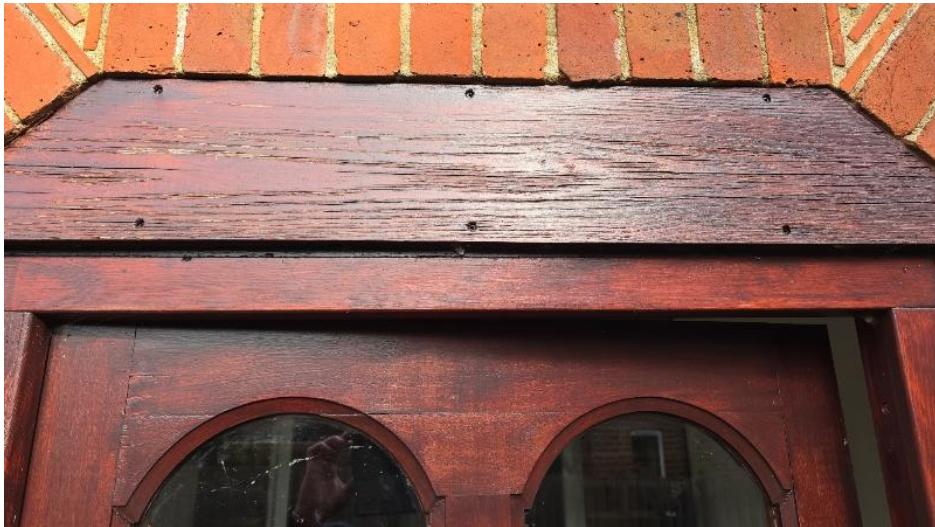
Repairs and redecoration required

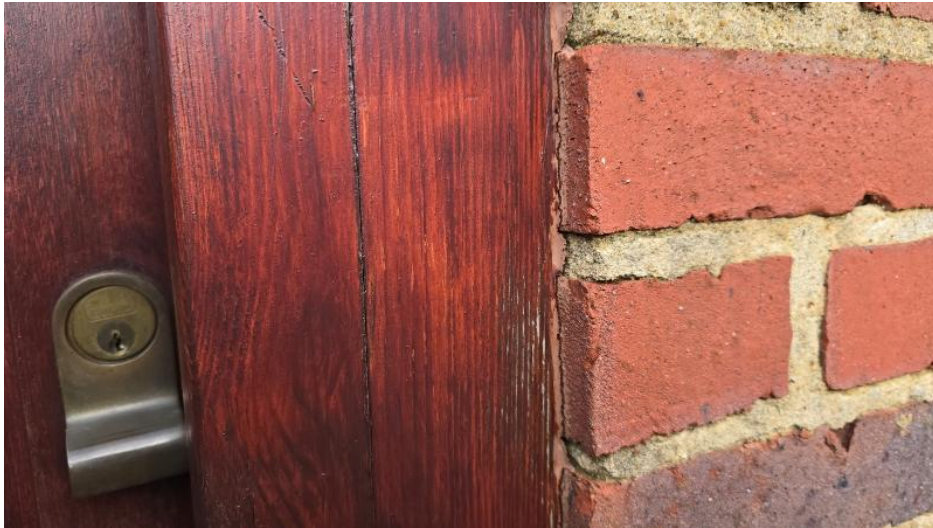
Mastic sealant replacement required

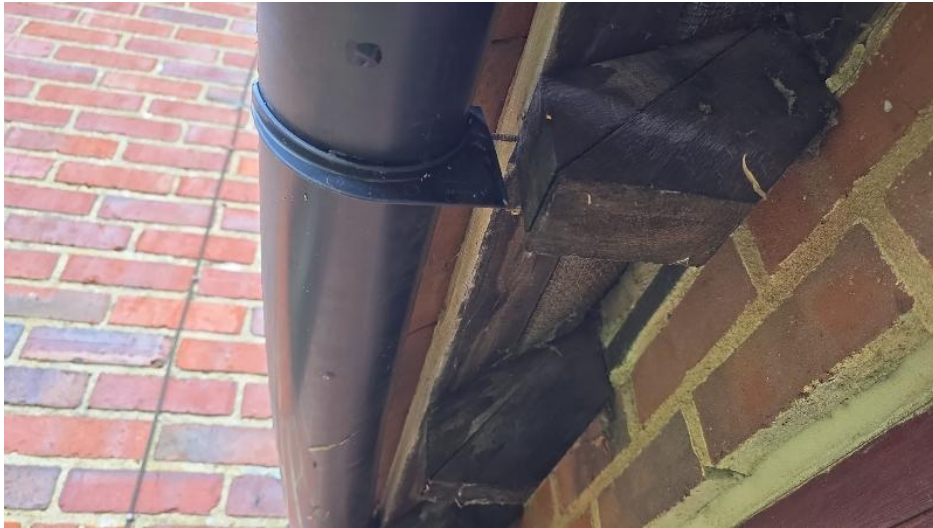
Defective timber to underside of eaves

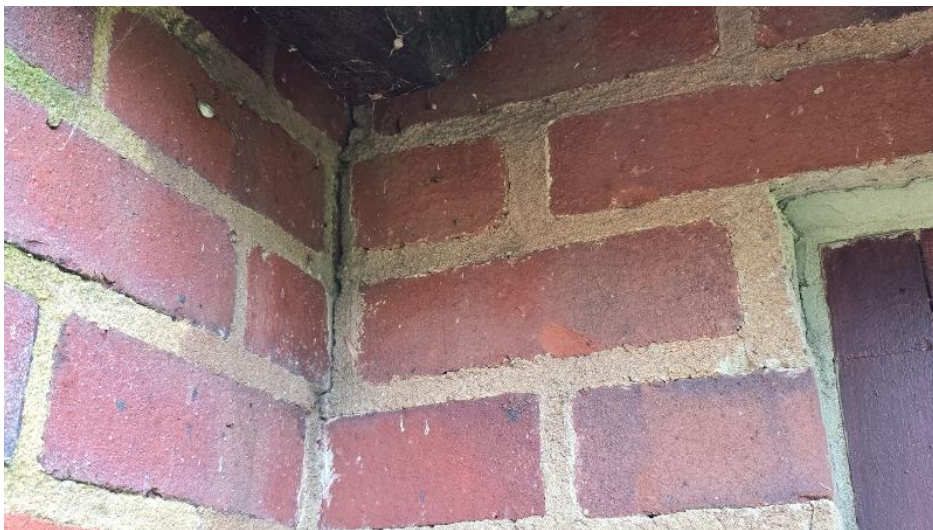
Vertical cracking where porch adjoins main house

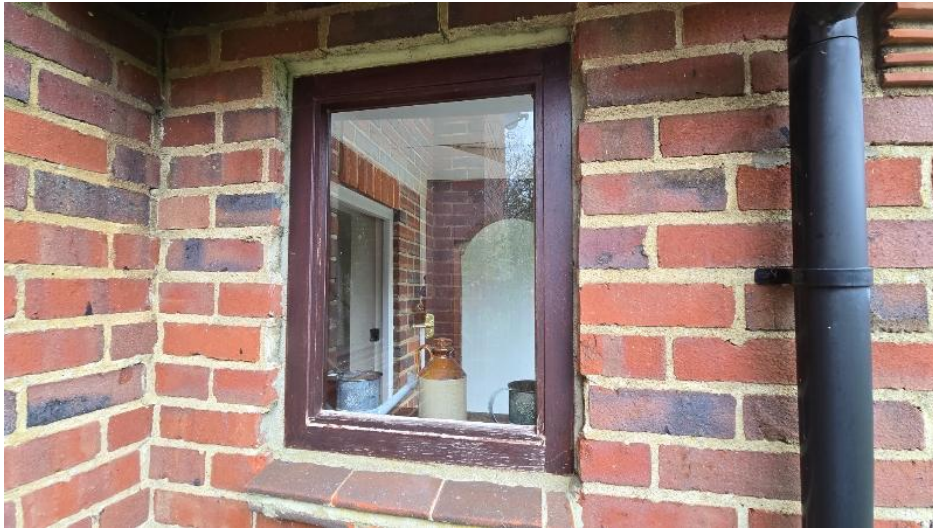
Recent repairs around window

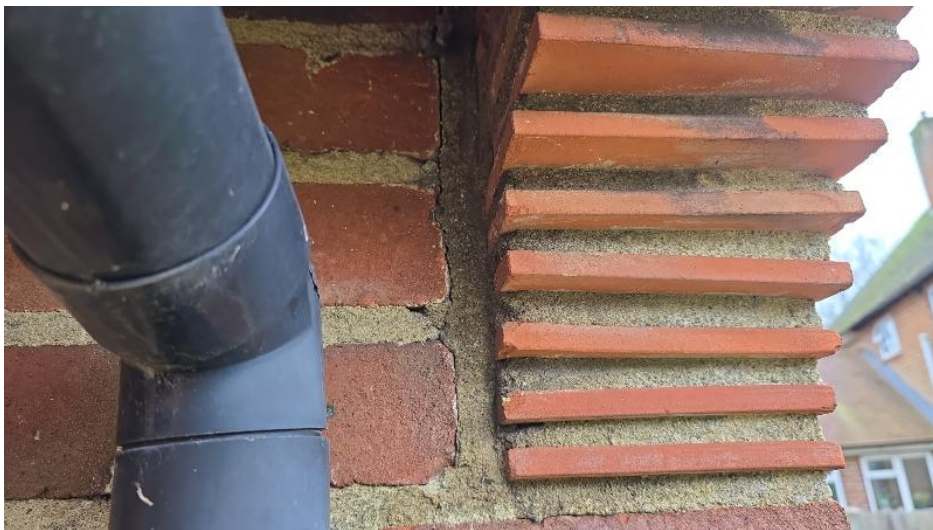
Vertical cracking

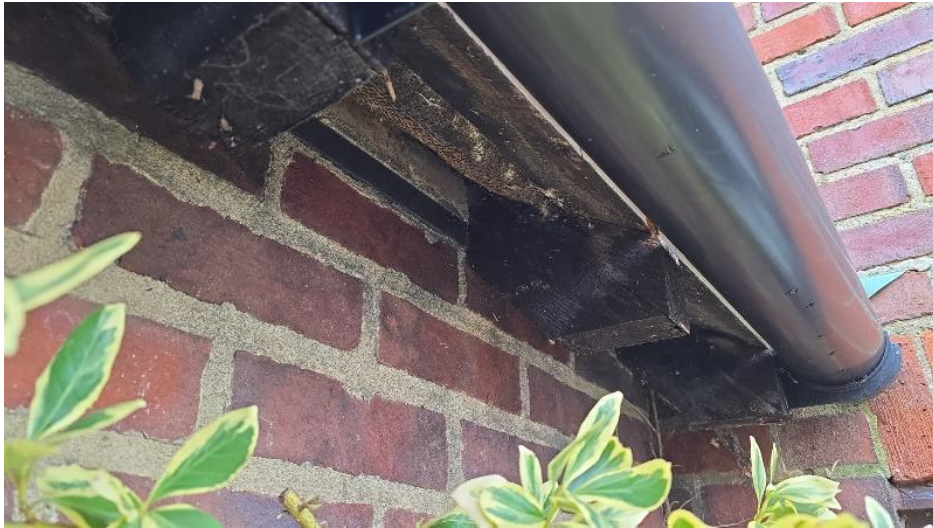
Defective timber to underside of eaves

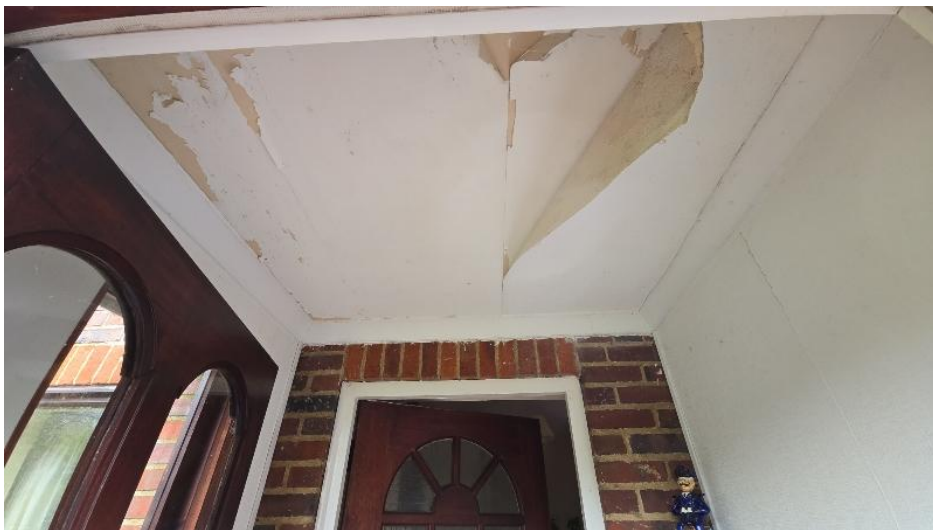
Condensation to ceiling in Porch

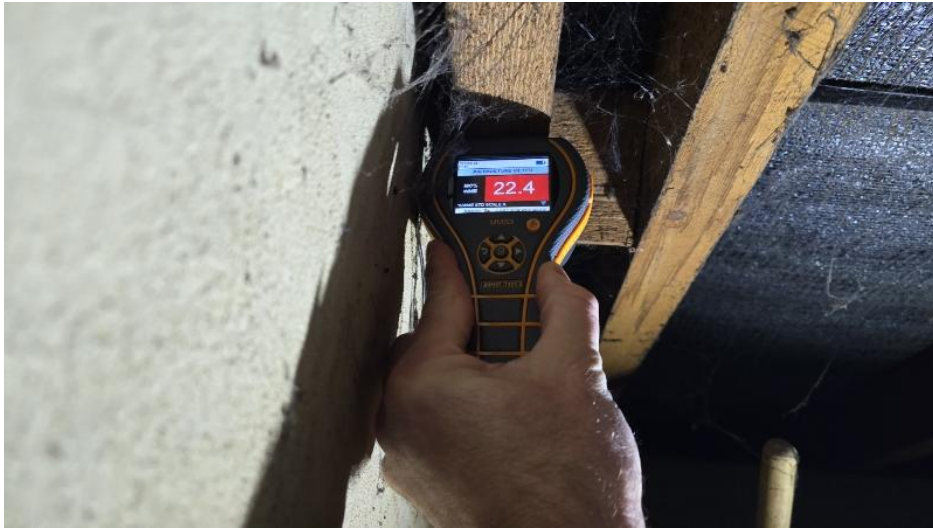
There was damp and rot noted to the shared party chimney stack timbers. A detailed inspection by a roofing contractor should be undertaken to establish the extent of remedial works required, taking into consideration the previous external defects to the roof covering and chimney directly above.

High moisture reading to shared chimney timbers
