LEVEL 3

Your survey report...

Inspection Date

20/02/2026

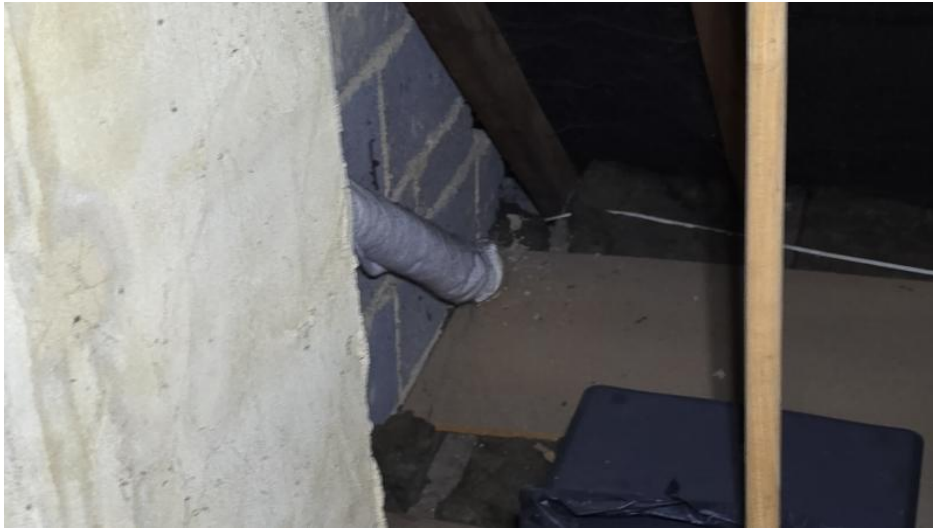
Incomplete party wall

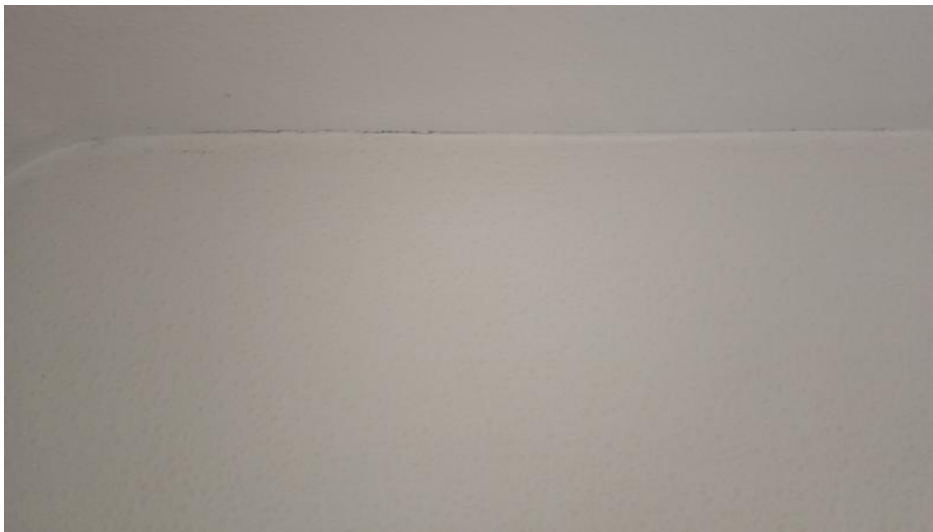
Minor cracking ceiling bedroom 2

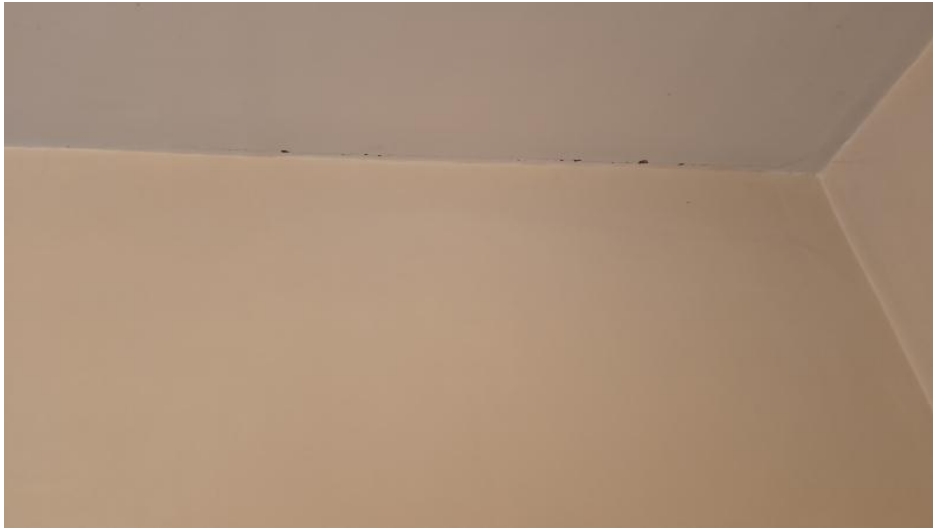
Cracking to ceiling in bathroom

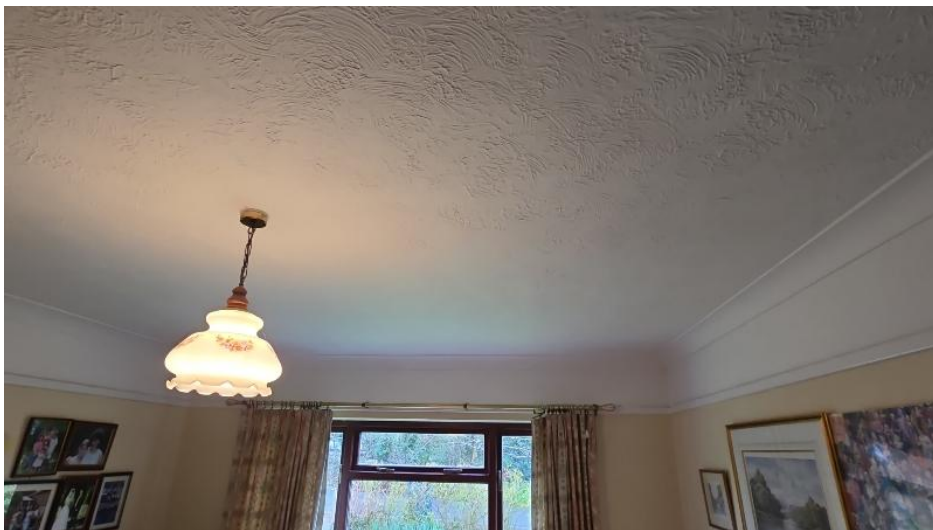
Living room textured coatings

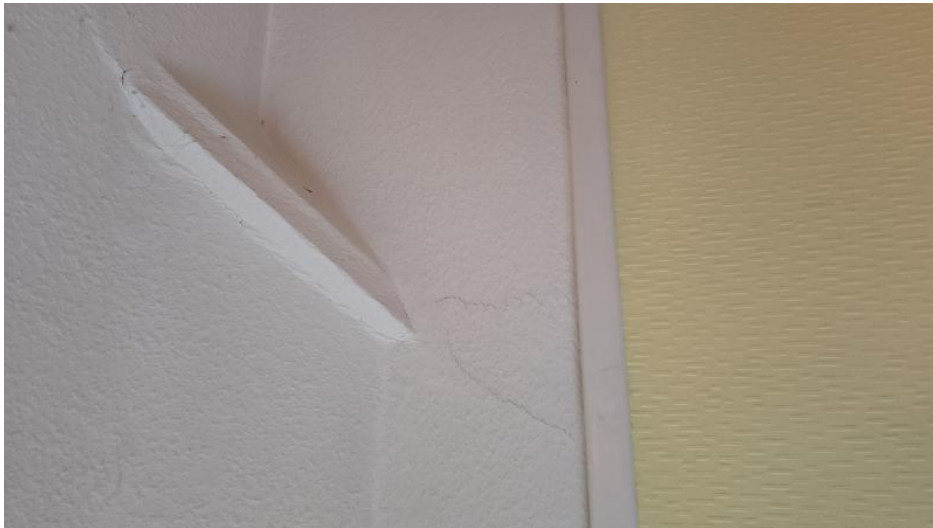
Cracking to wall in Bedroom 1

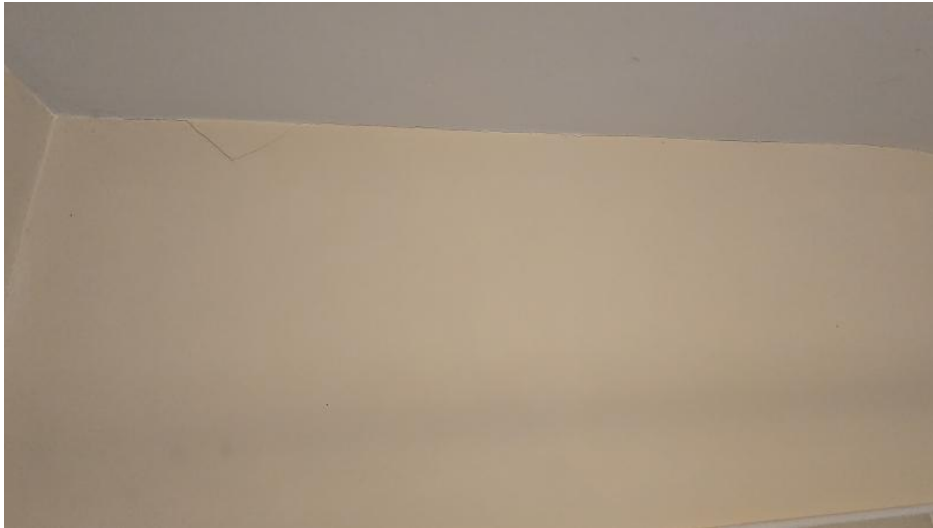
Cracking to bathroom party wall

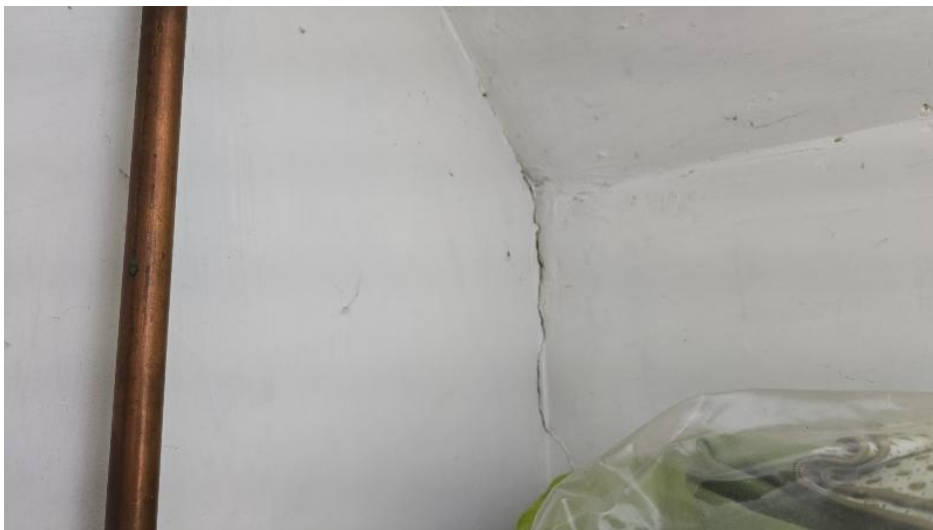
Cracking to external airing cupboard wall

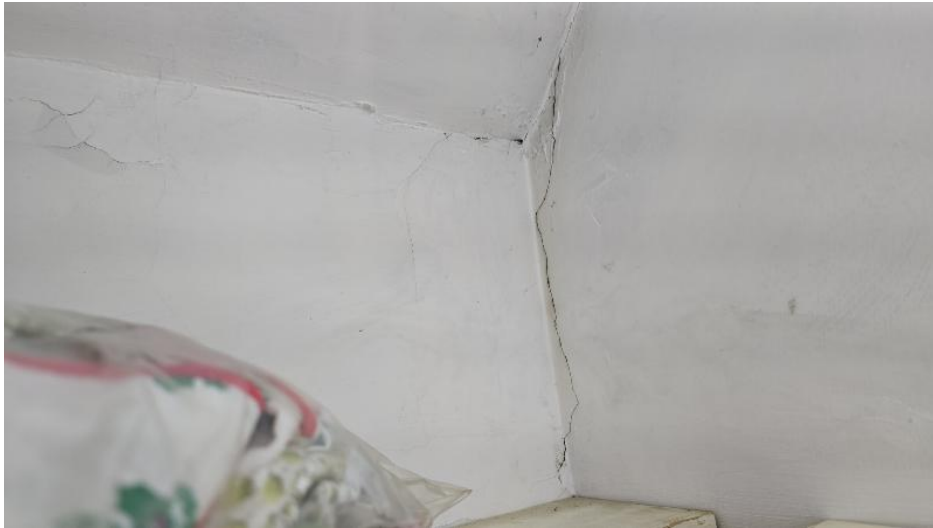
Cracking to external airing cupboard wall

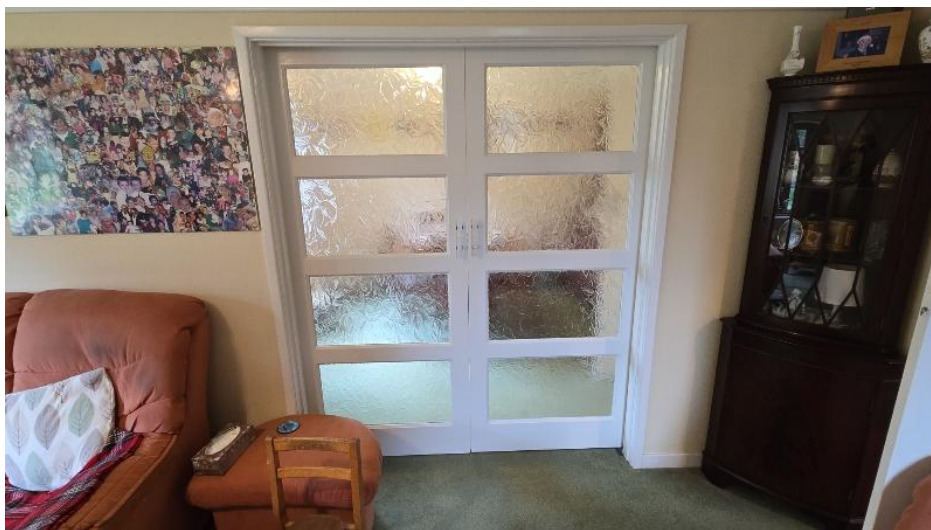
No safety marking visible

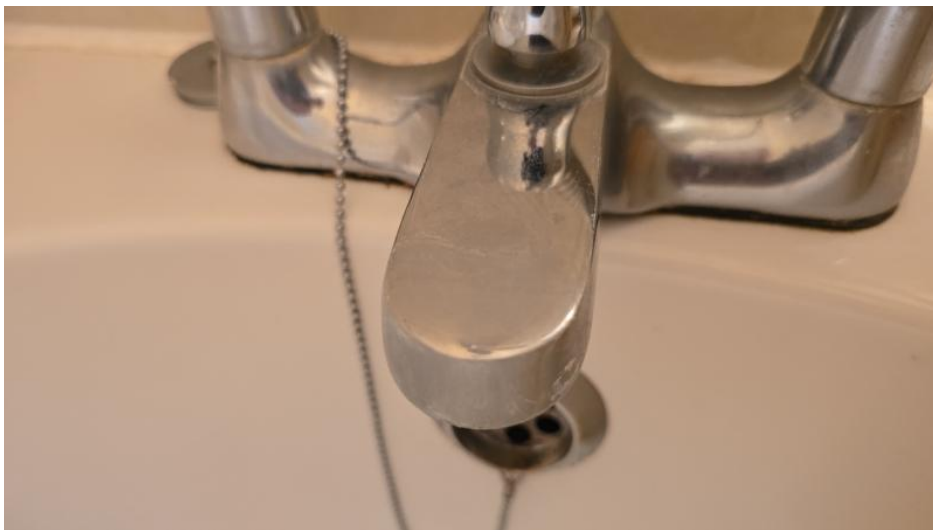
Ill fitting bath tap

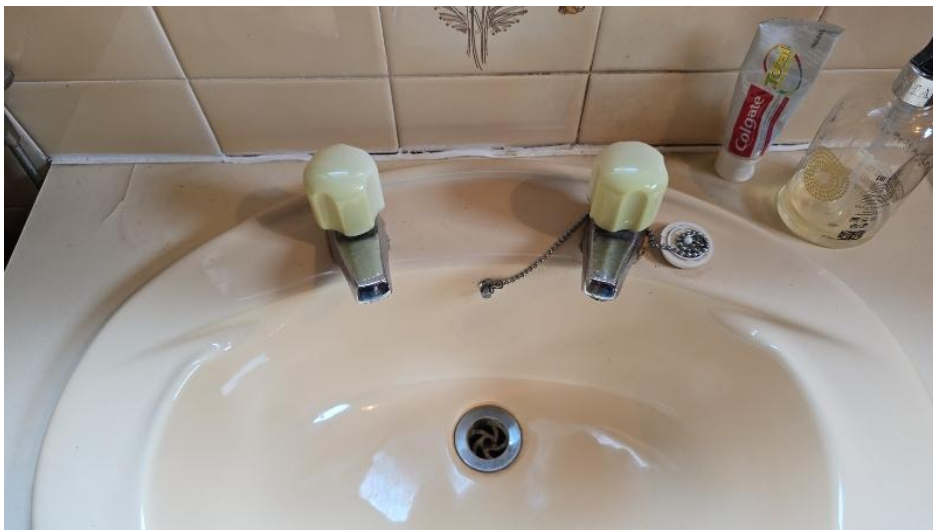
Defective sealant to wash hand basin and damage to countertop

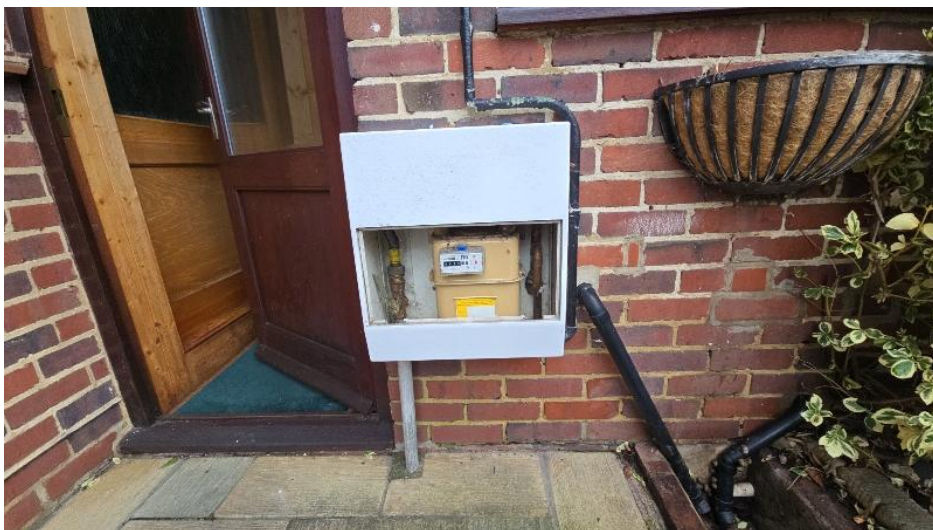
Mains gas is connected to the meter in an external cabinet. The cabinet door is broken and should be replaced.

Gas meter with damaged access door

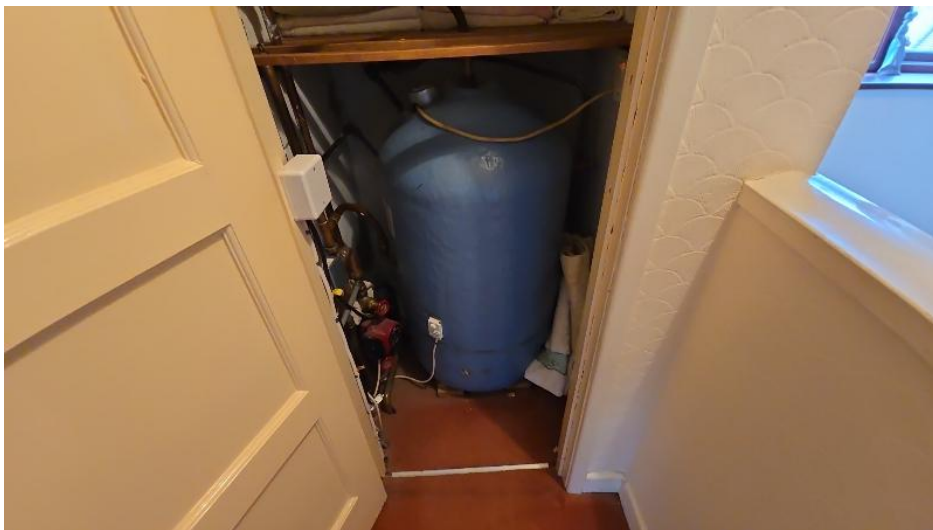
The system as installed is dated. We recommend that you have a suitably qualified specialist heating engineer provide a report on improvements or replacement, along with an estimate of the cost.

Existing hot water cylinder

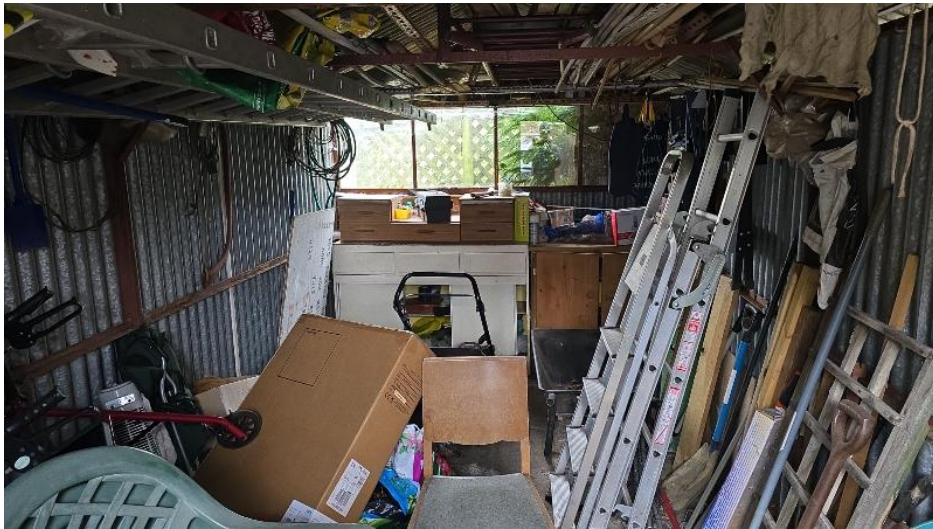
Store items and corrosion to steel frame and fixings

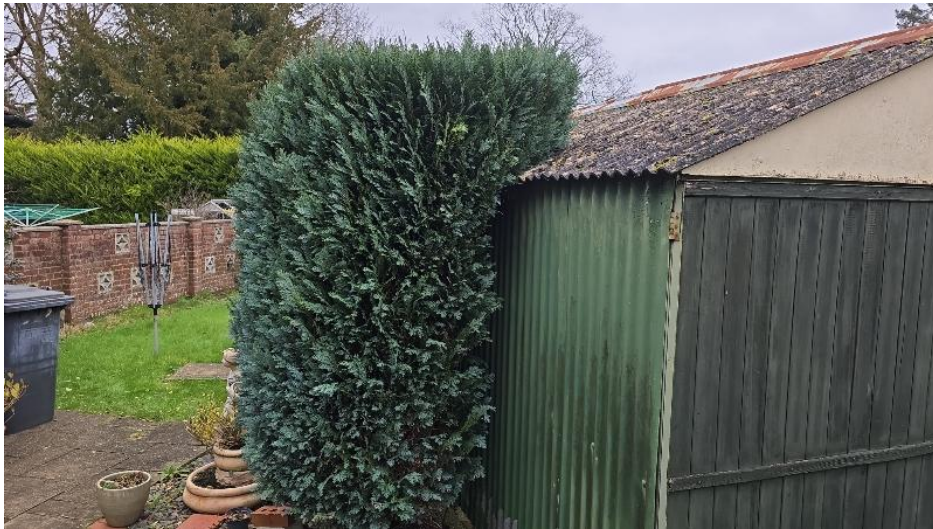
Asbestos roof in poor condition

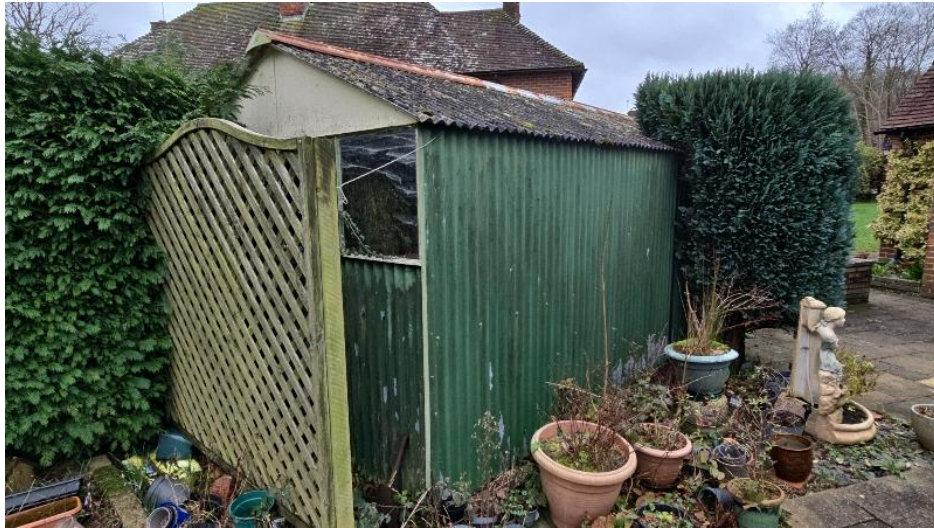
Asbestos roof in poor condition

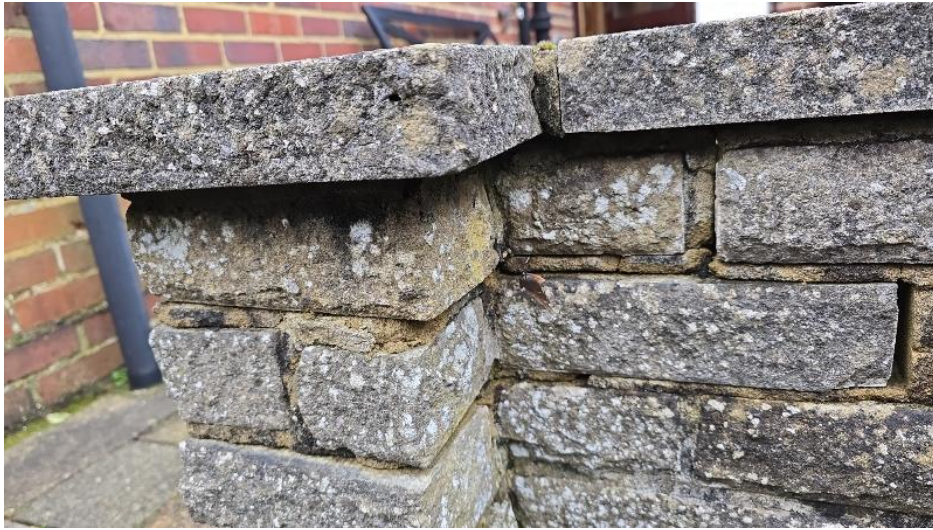
Structural movement/impact damage to low level wall off garage

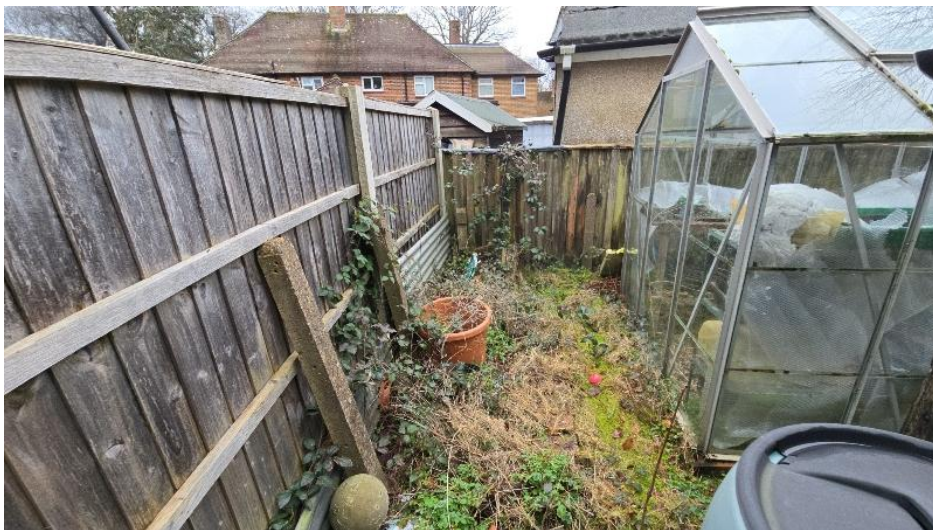
Damaged section of fencing to rear of garden

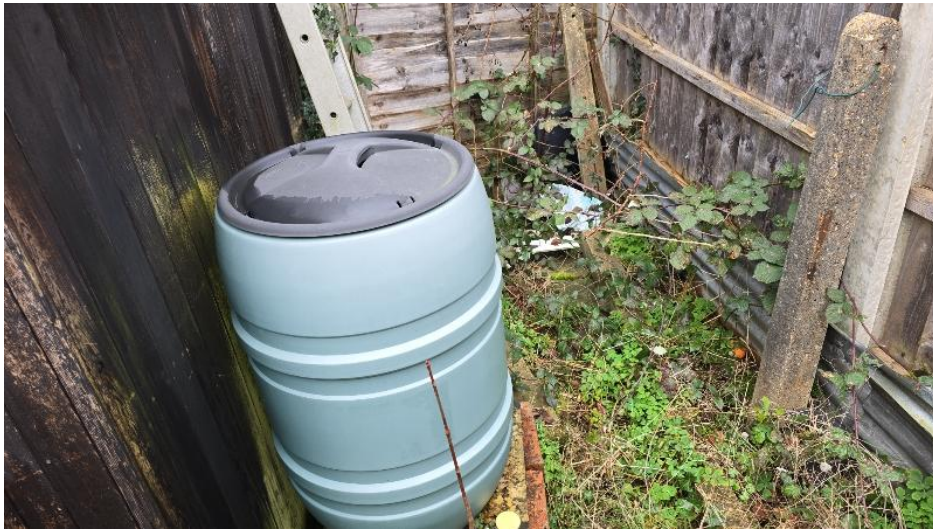
Vegetation growth limiting inspection

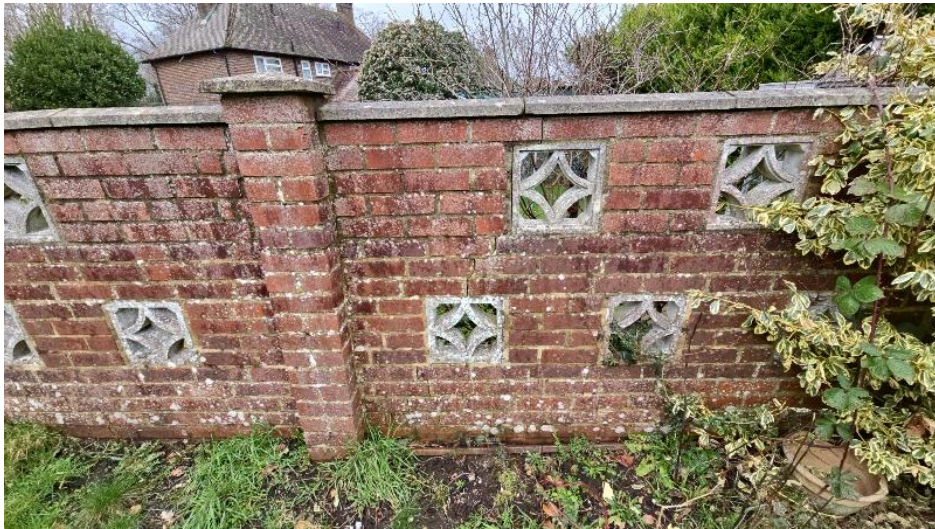
Cracks to boundary wall full height. Further investigations

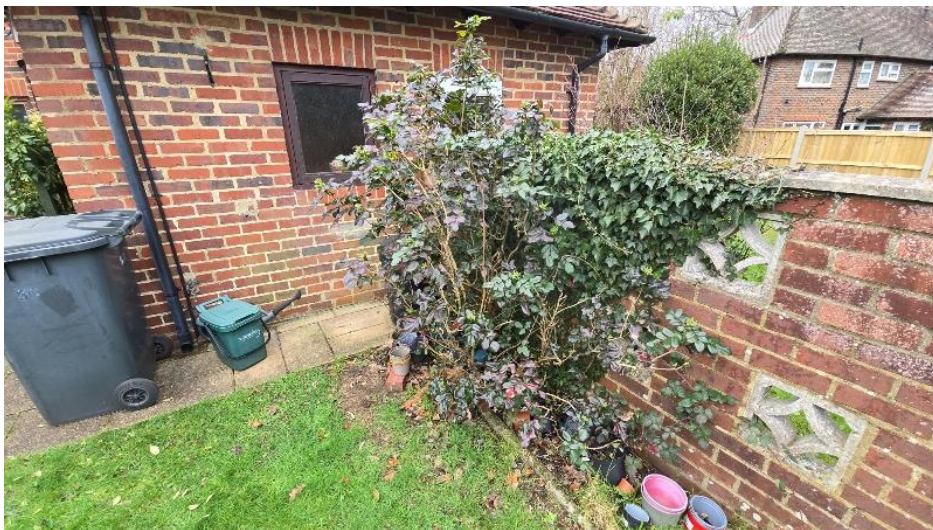
Vegetation to be removed to ascertain extent of remedial works to wall

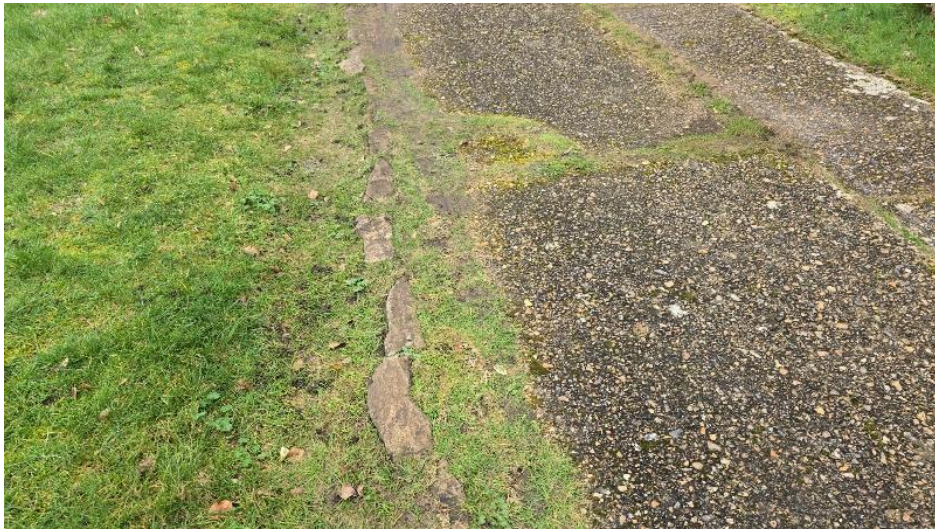
Driveway repairs required

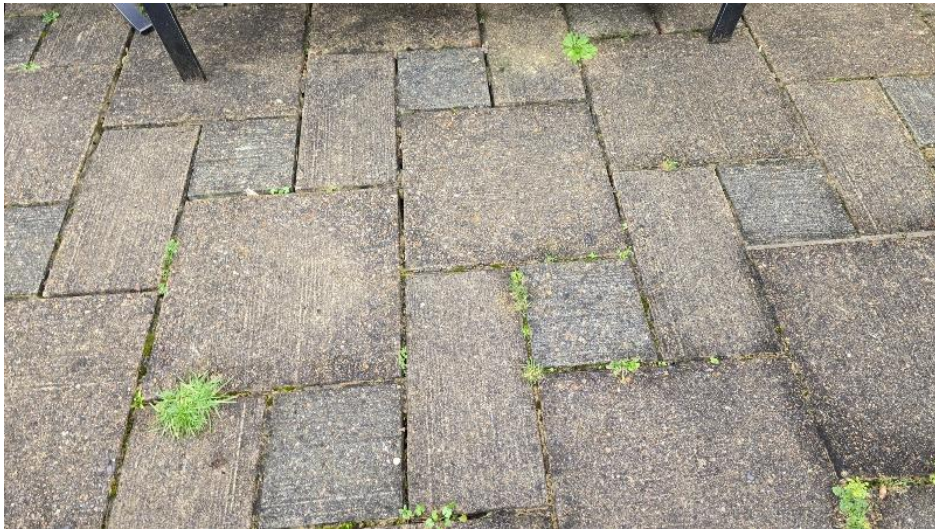
Repairs required to patio
