LEVEL 3

Your survey report...

Inspection Date

20/02/2026

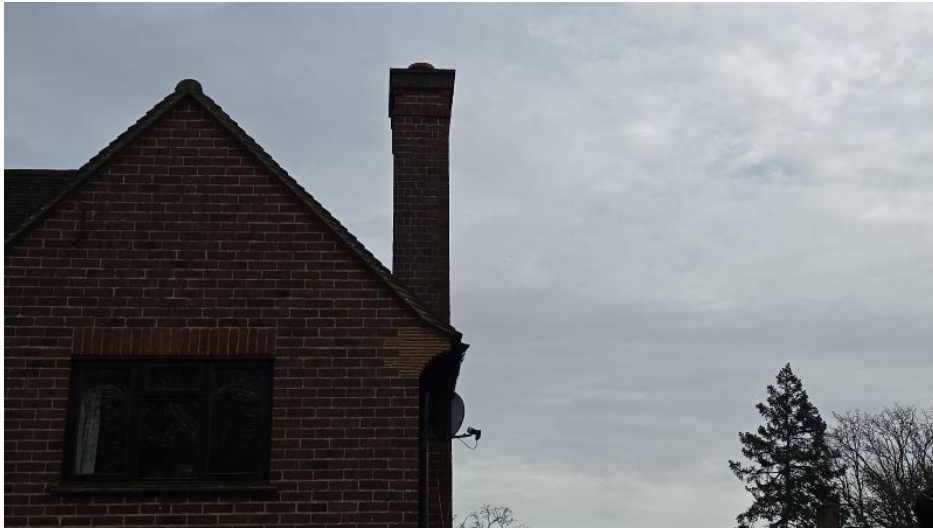
Slight lean towards top of chimney

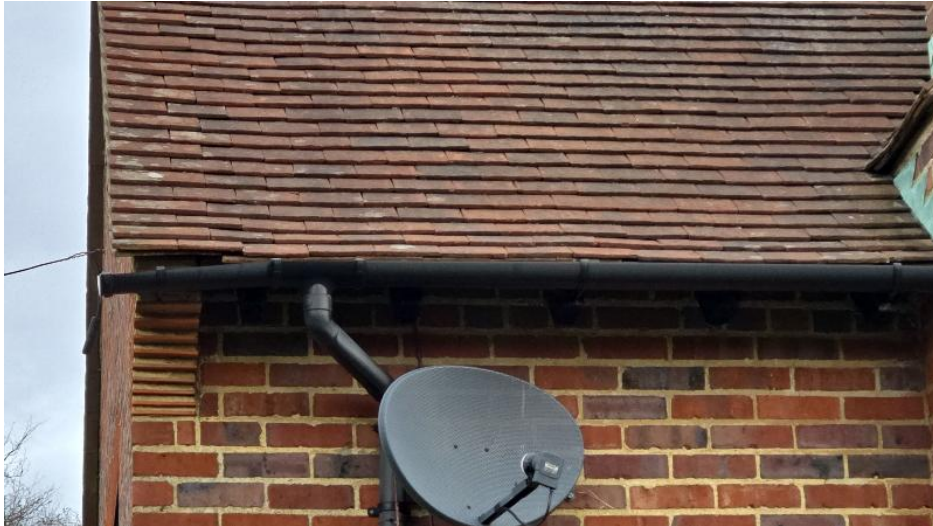
Defective timber at eaves and disconnected gutter bracket

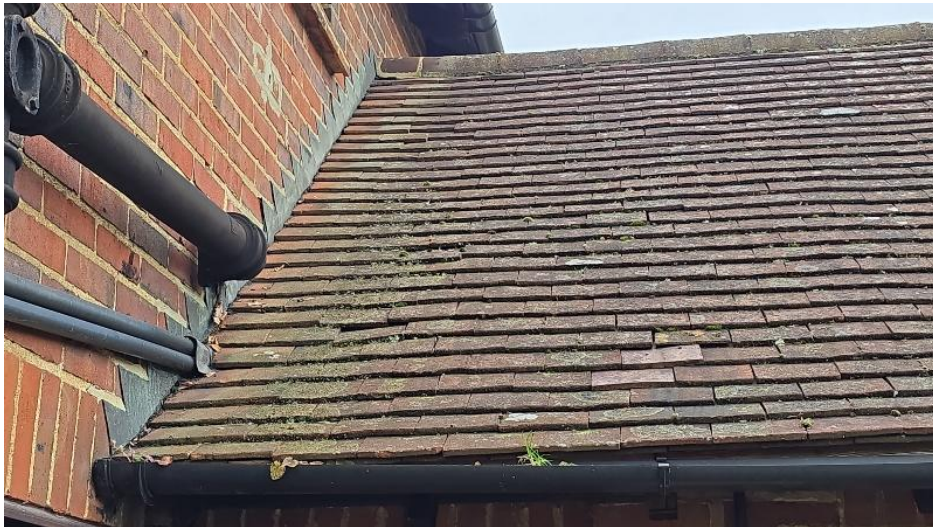
Slipped and missing tiles to utility room roof

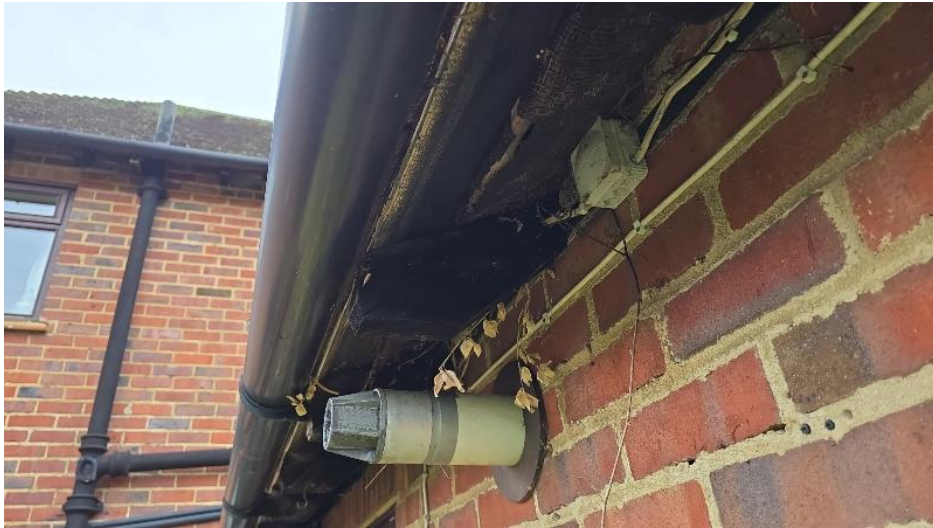
Boiler flue close to underside of roof timbers

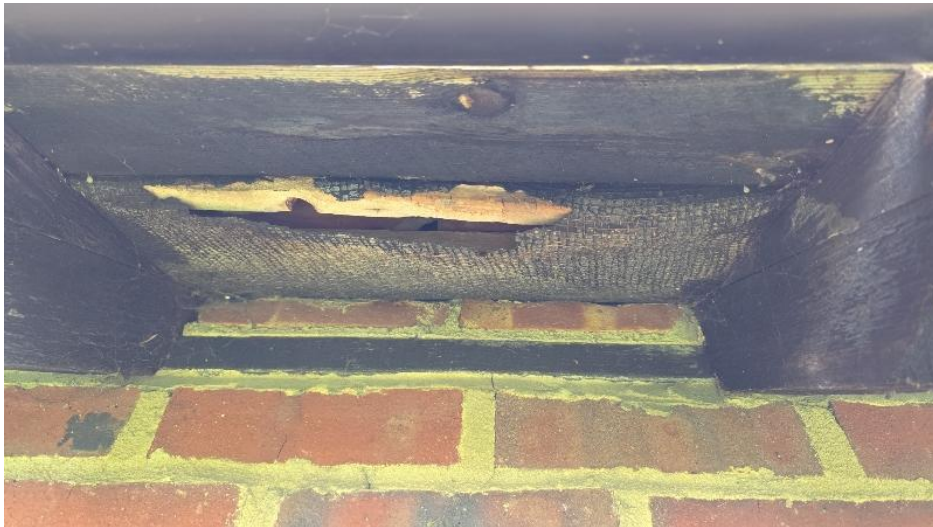
Defective timber to eaves. Will require removal of courses of tiles to rectify.

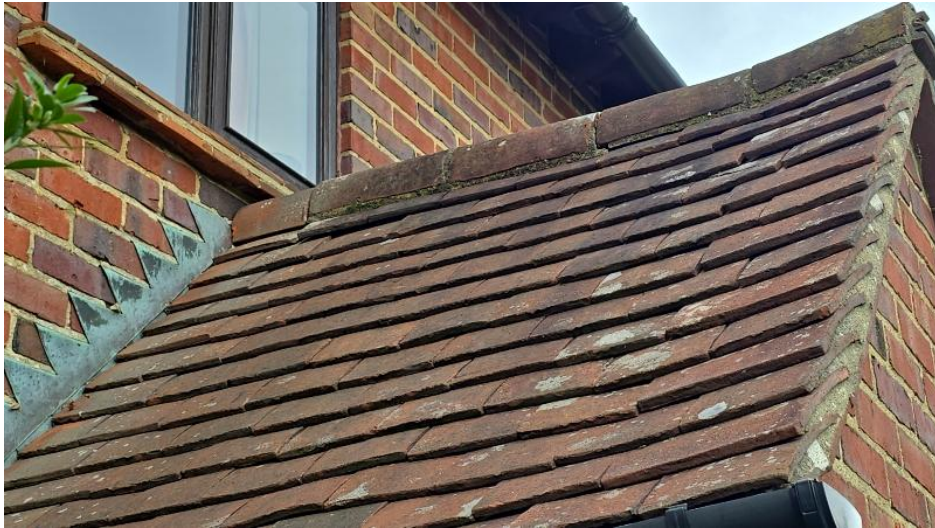
Undulation of porch ridge inspect when replacing tiles

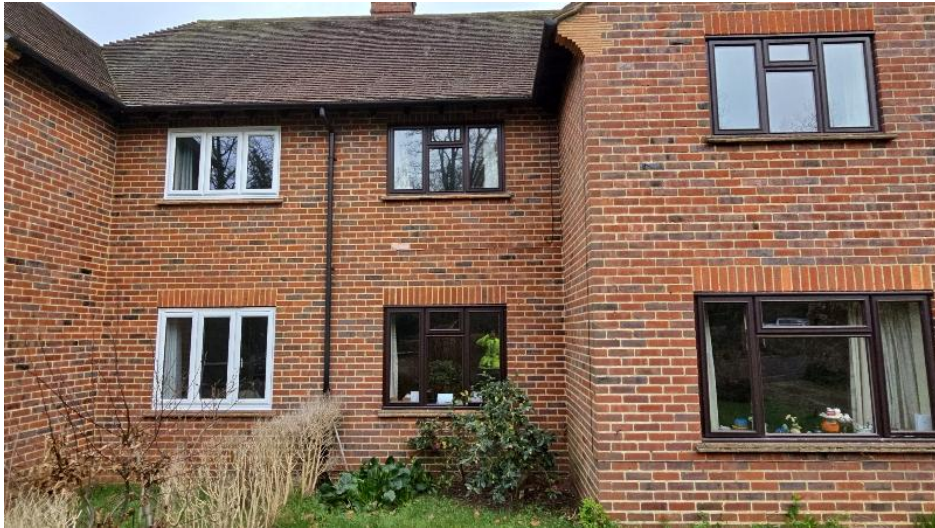
Shared rainwater goods with neighbouring property

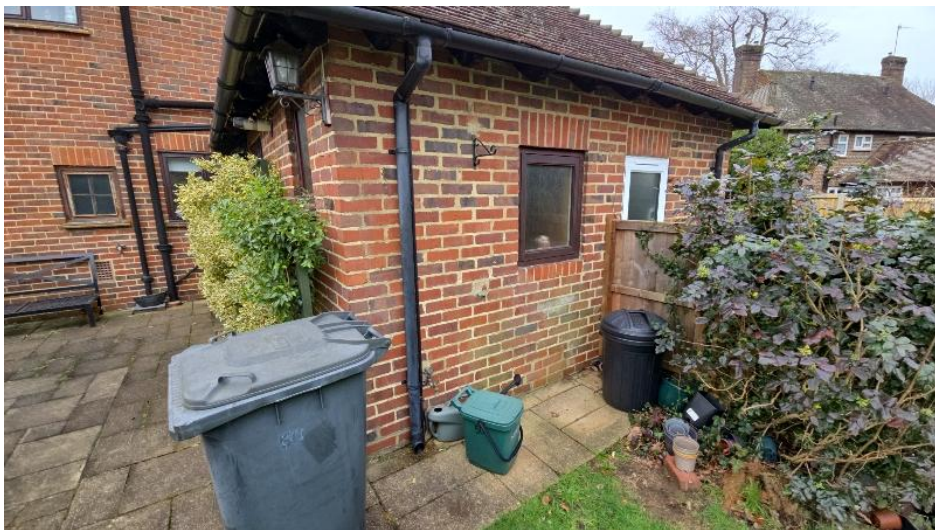
Alterations to existing gutters. Downpipe discharges directly to ground

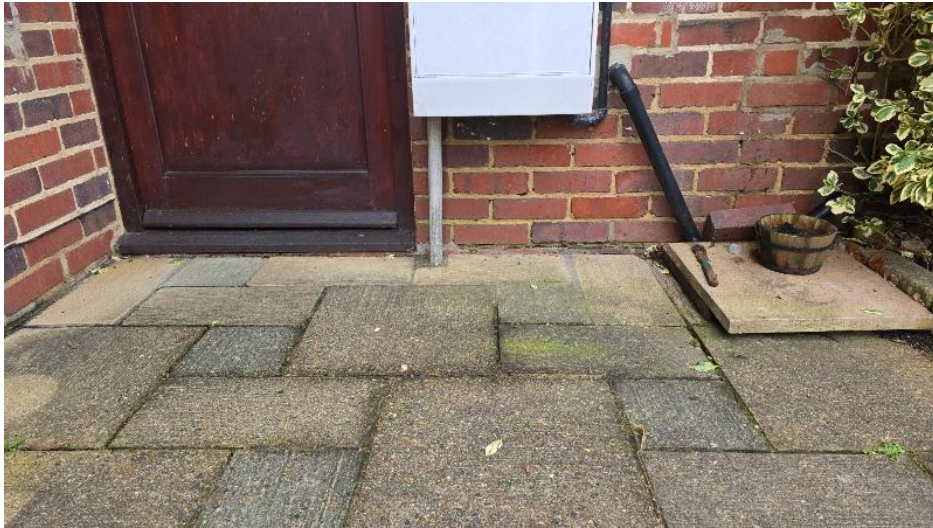
External ground level off rear needs reducing

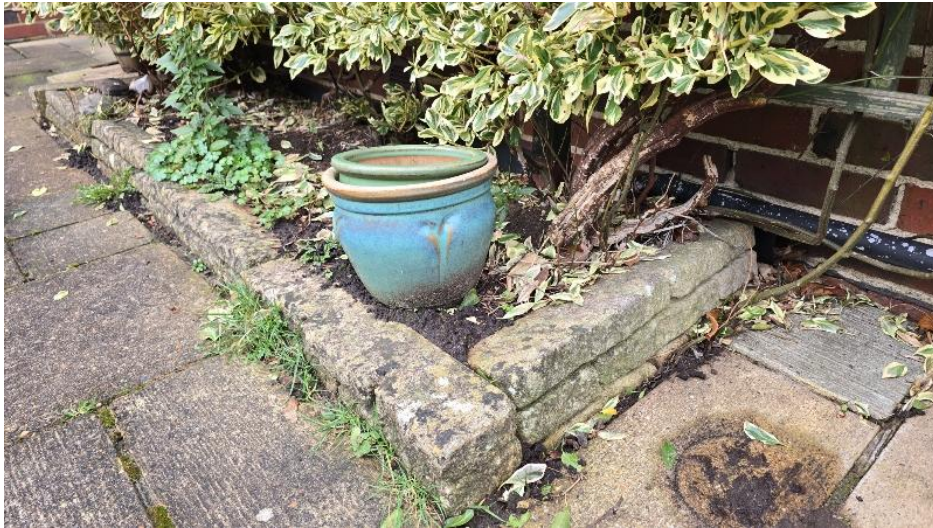
External ground level off rear needs reducing

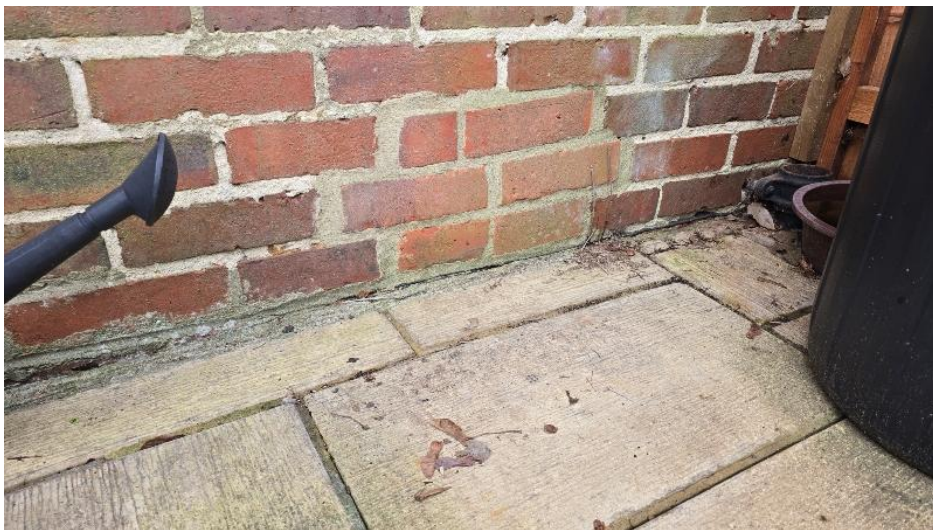
External ground level off rear needs reducing

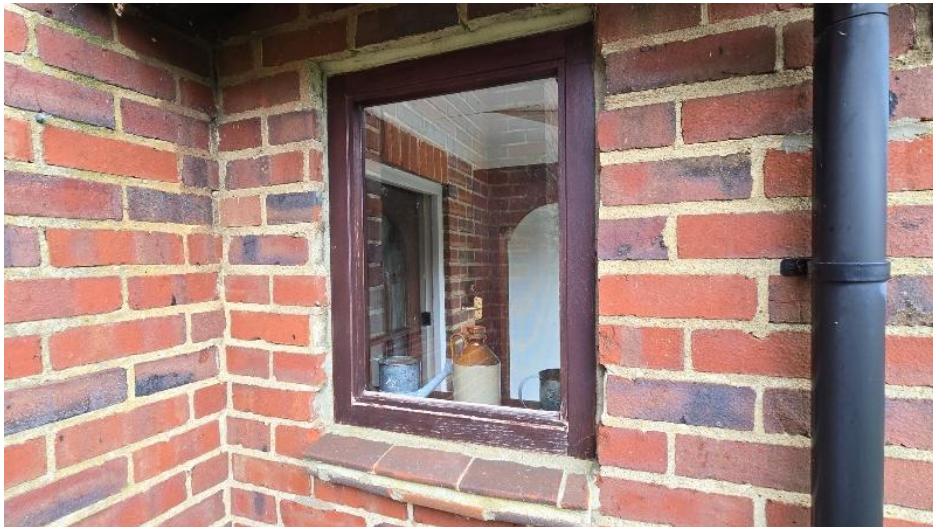
Single glazed porch window

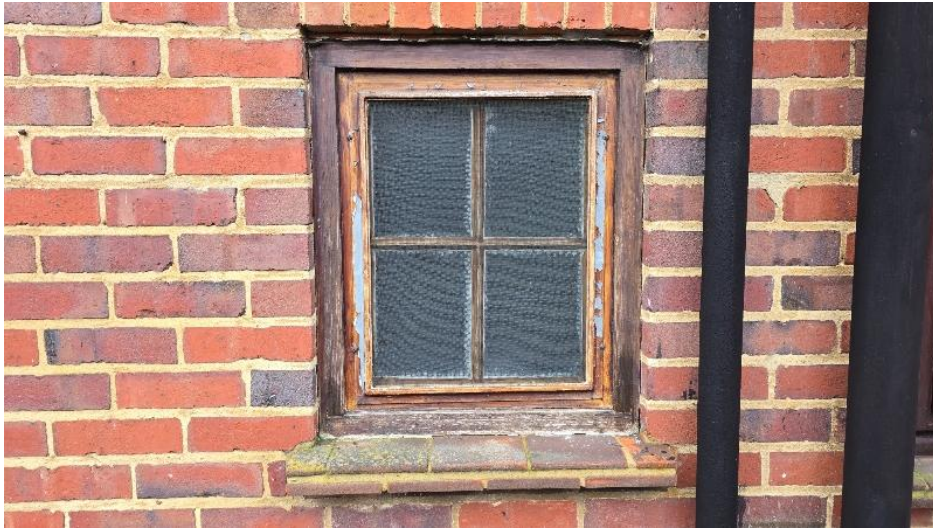
Metal single glazed window to larder

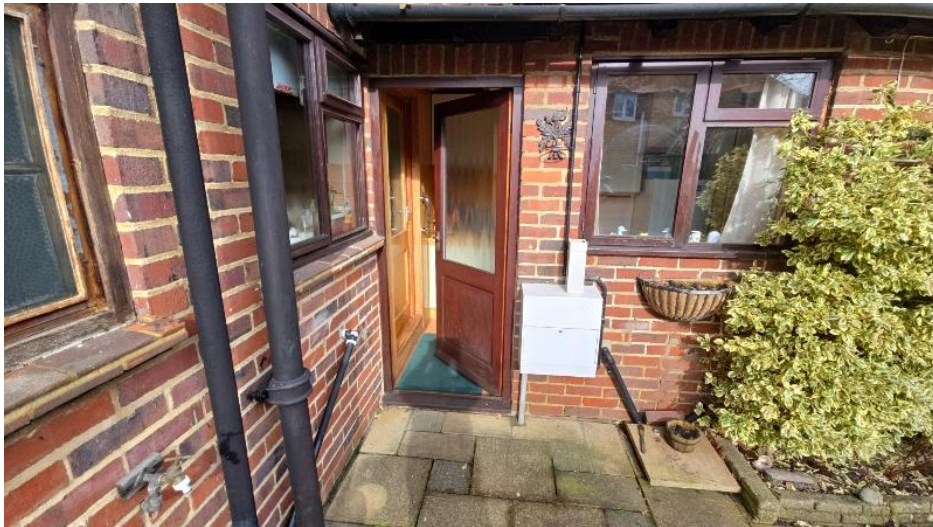
Repairs and redecoration required

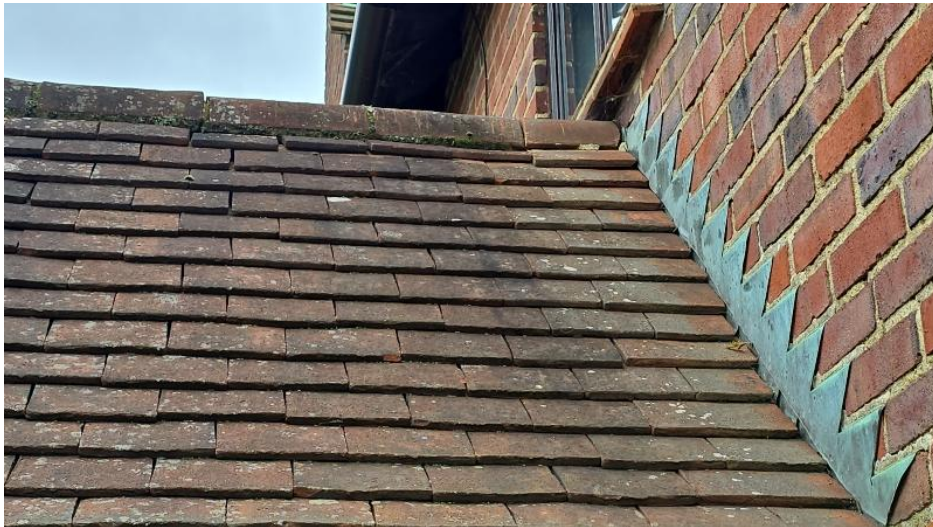
Ridge and roof repairs required

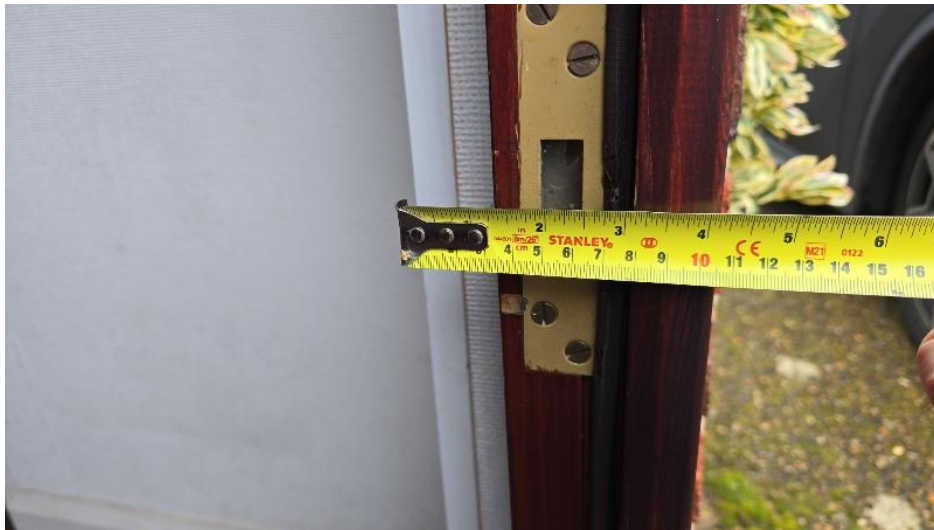
Single brick thick Porch wall with fibre board lining internally

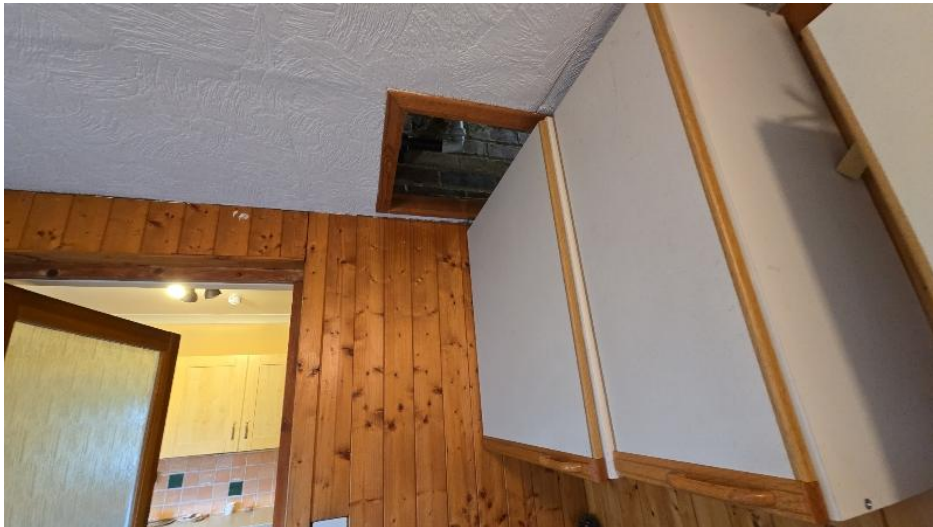
Partially concealed loft access to utility room

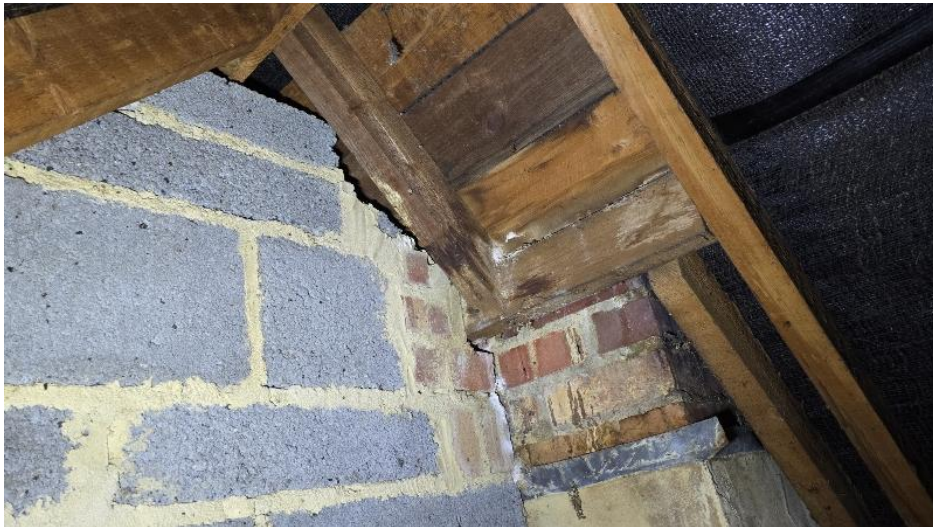
There was damp and rot noted to the shared party chimney stack timbers. A detailed inspection by a roofing contractor should be undertaken to establish the extent of remedial works required, taking into consideration the previous external defects to the roof covering and chimney directly above.

Incomplete party wall and rot to chimney timbers

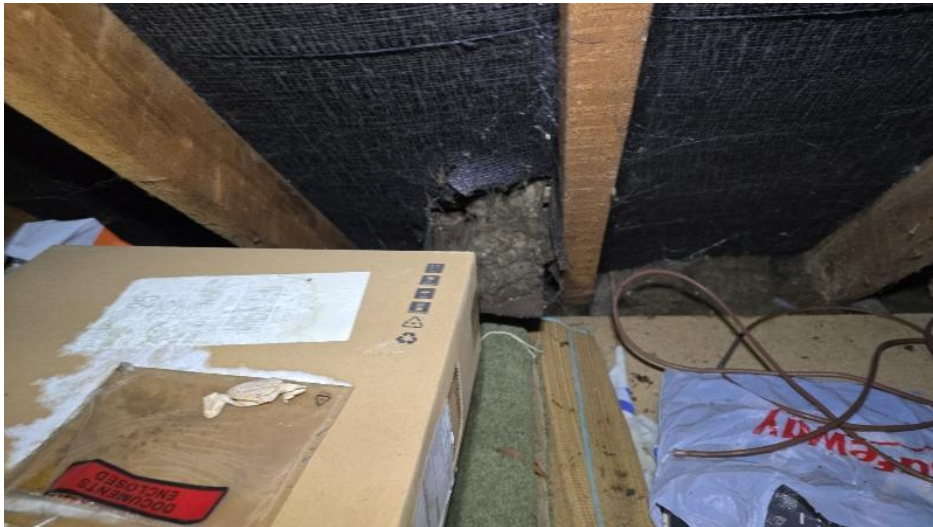
The lining on the underside of the roof covering is damaged in places. Water may enter the roof void, and repairs should be undertaken.

Tear to roofing felt

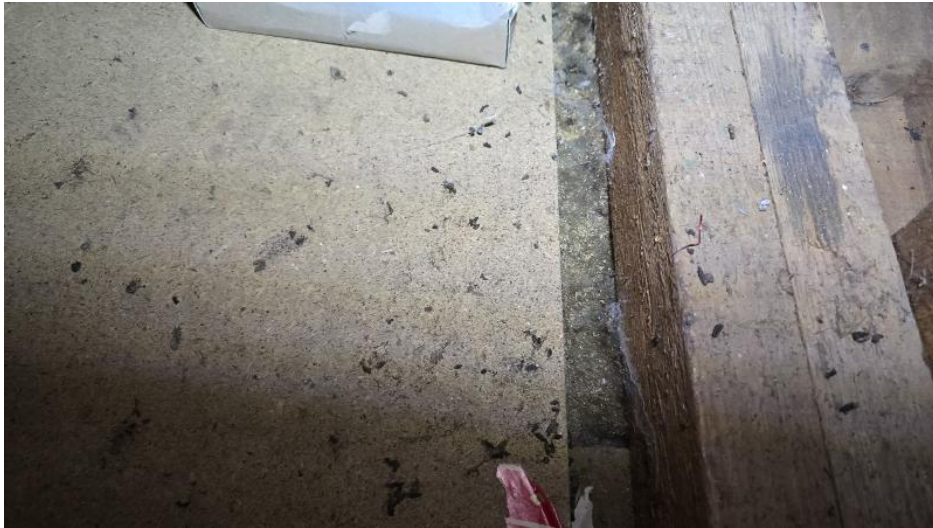
There is evidence of wood boring beetle infestation in some timbers. Treatment by a Member of the Property Care Association is recommended. This person should be asked to inspect the entire property as a precaution and provide you with a quotation for treatment if it is deemed necessary. It should be noted that the loft has been mostly boarded over so there is likely to be further areas infected that are concealed. A detailed inspection of the loft space is recommended.

Vermin faeces and evidence of wood boring insects

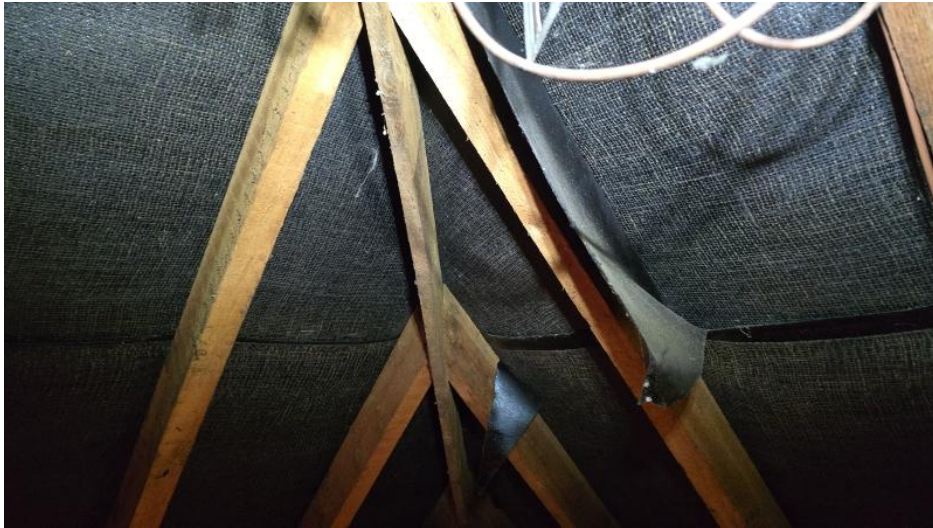
Tear to roofing felt

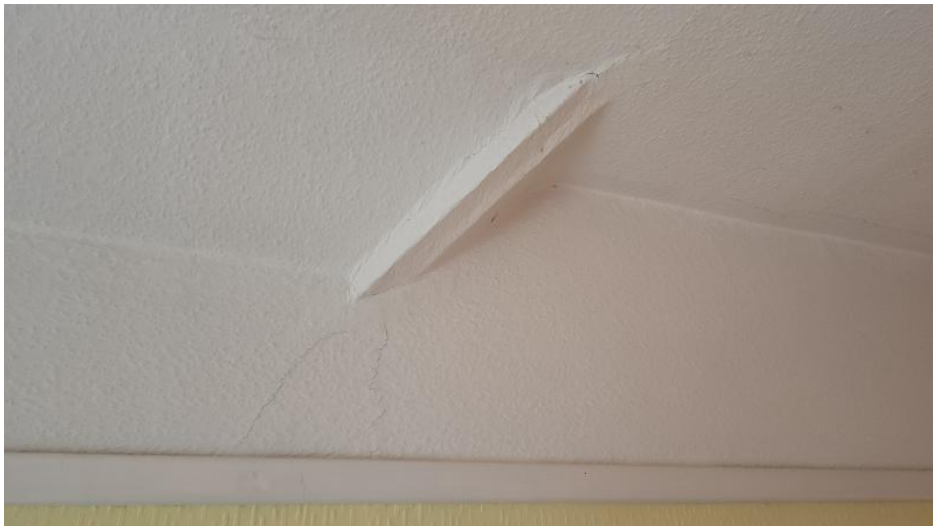
Cracking to ceiling around roof timbers in Bedroom 1

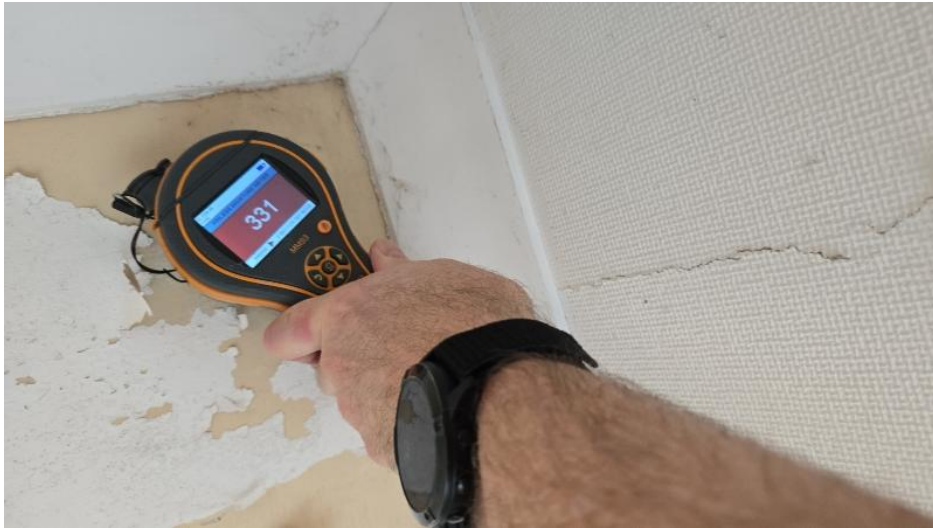
High moisture readings were noted to to the ceiling of the porch and this should be investigated further to establish the whether this is condensation or damp and agree the remedial works.

Damp to Porch ceiling

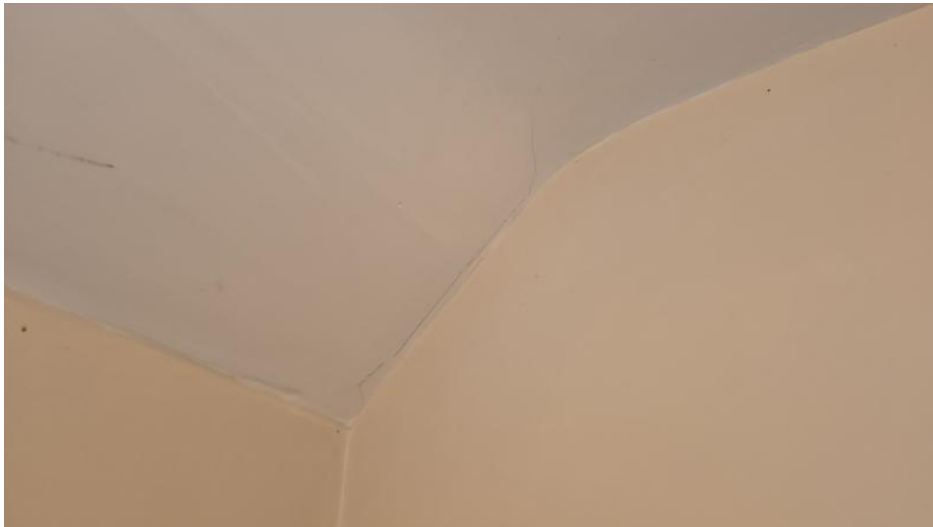
Cracking to ceiling in bathroom

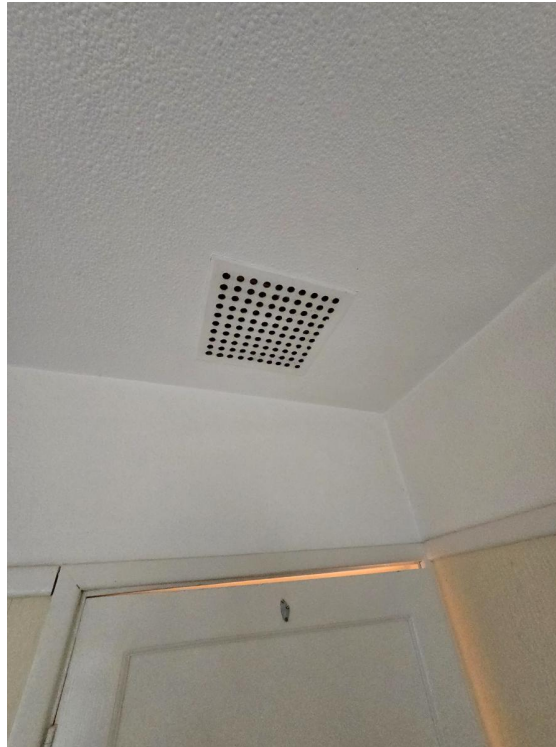
Old presumed warm air vent ducts located throughout the property.

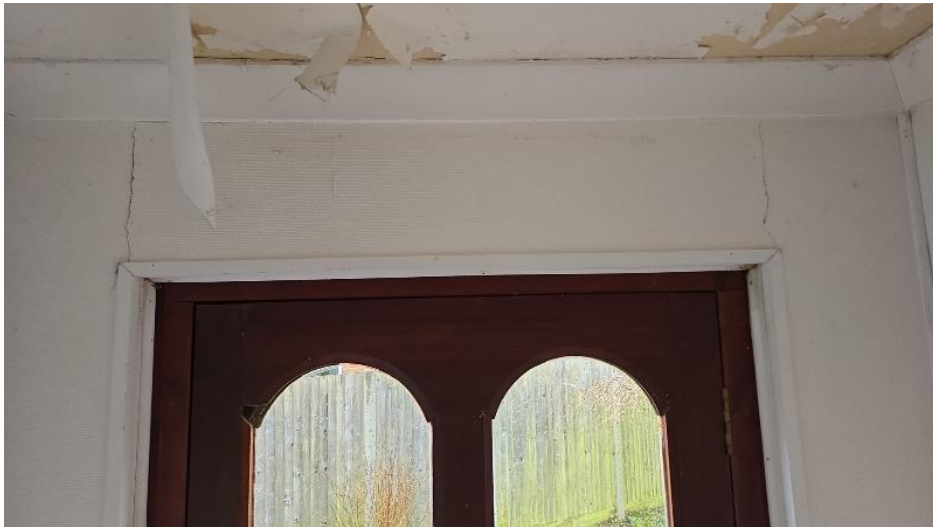
Cracking dry lined walls above door

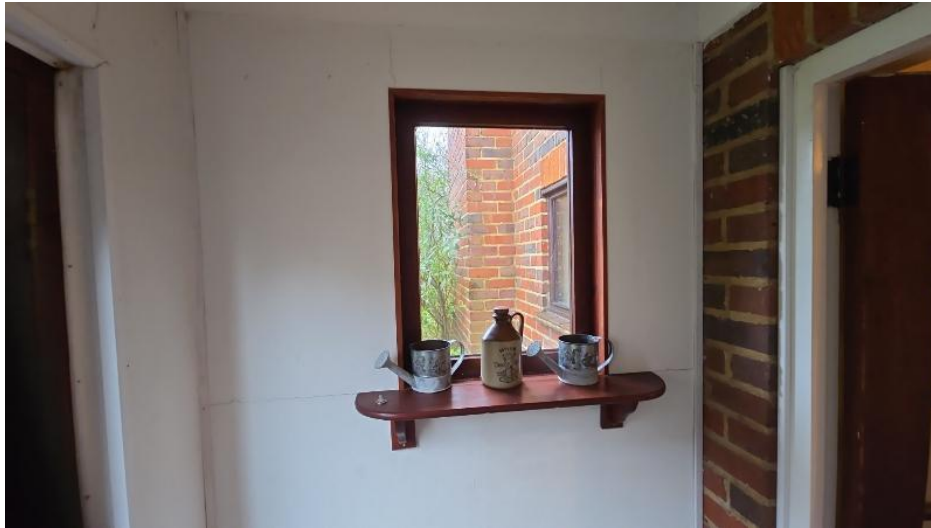
Cracking dry lined walls

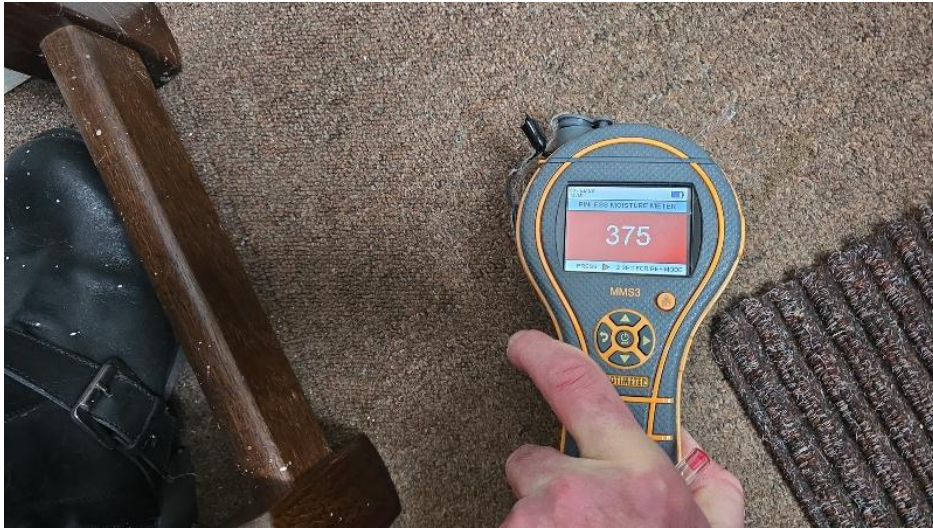
Dampness was found to the Porch floor. While dampness is discussed here only in terms of its effect on this building element, it affects multiple elements, including concealed timbers and adjacent walls. You should obtain a report from a Property Care Association (PCA) member to identify the cause and for the cost of remedying and any associated making good. A transferable insurance-backed guarantee should cover all work. squeaking flooring, which should be rectified.

Damp readings to porch floor

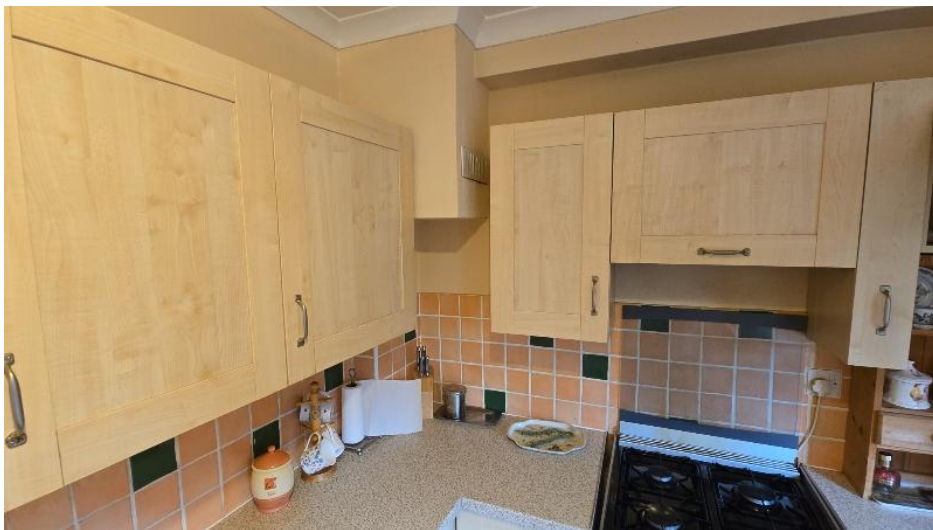
Shared party chimney part visible in kitchen no supports visible and may/may not be concealed

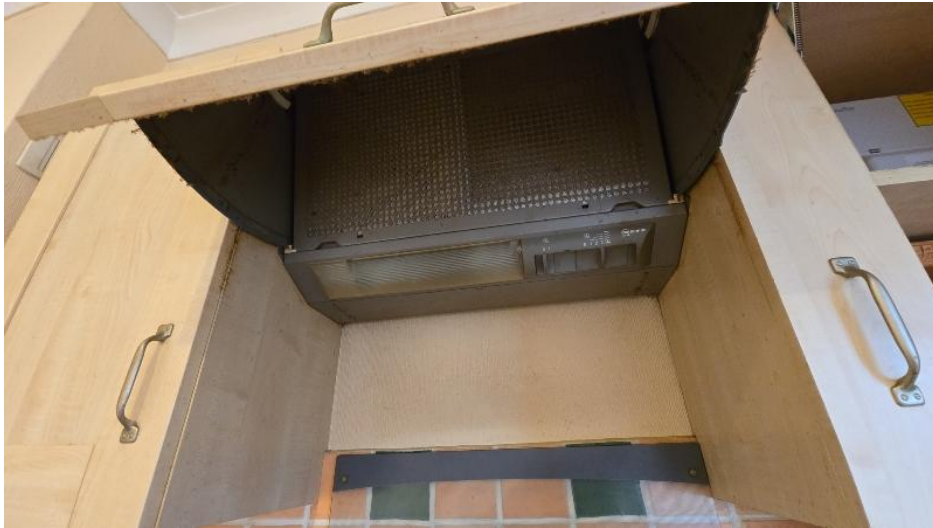
Confirmation as to whether extractor hood is vented due to gas appliance

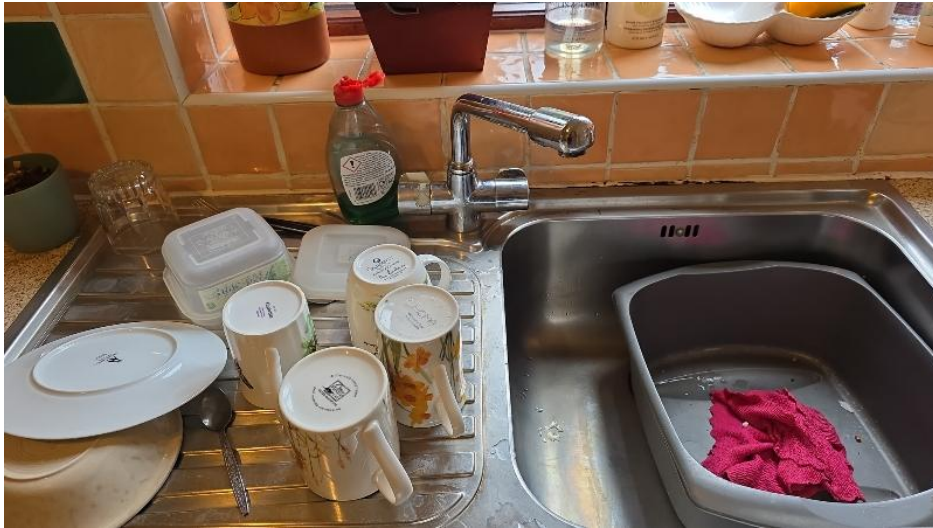
Sealant and repairs required to kitchen worktop

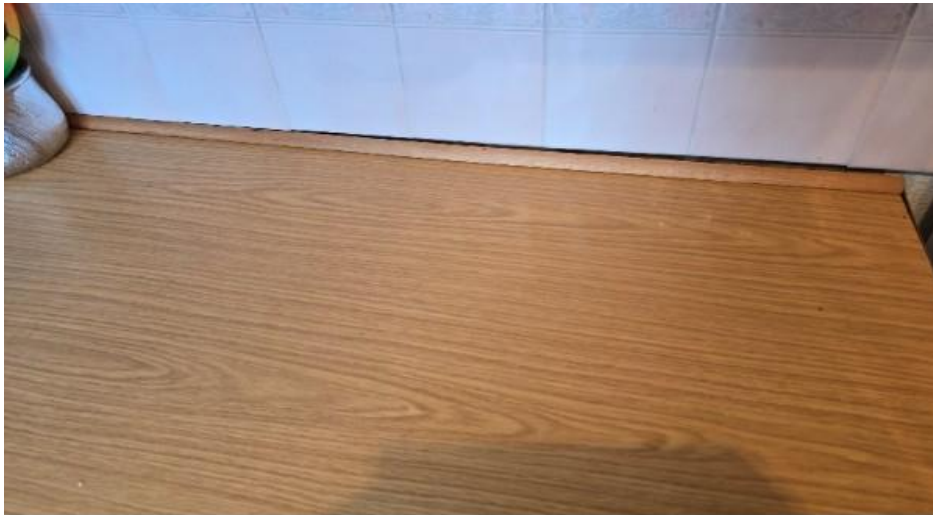
Damaged quadrant beading to utility worktop

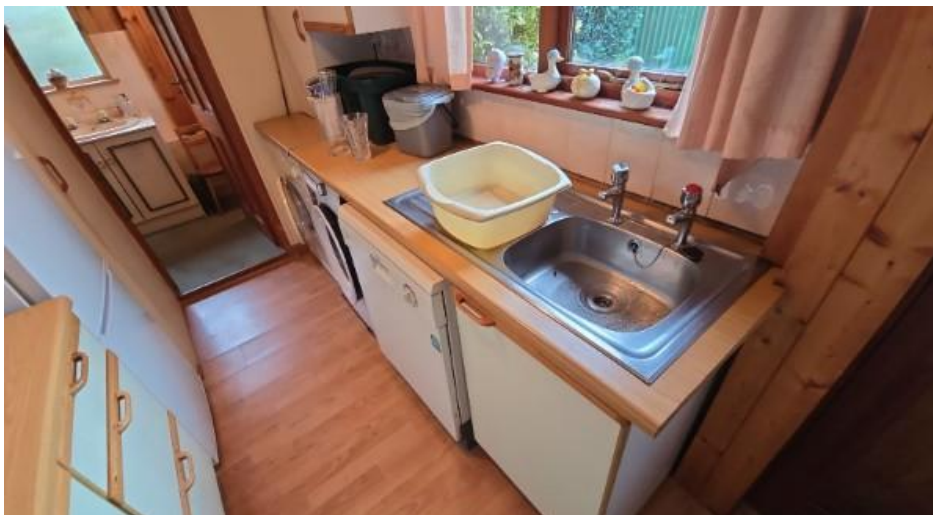
Damaged quadrant beading to utility worktop

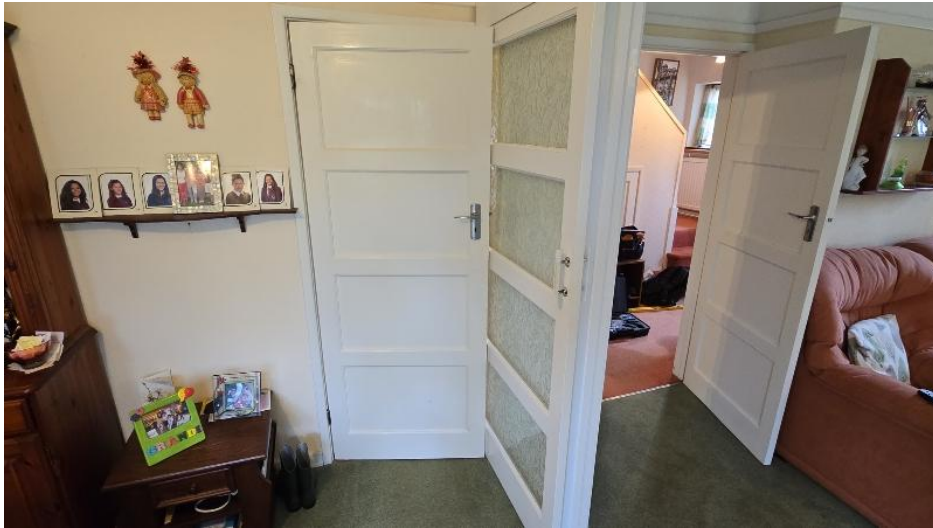
Dining room sliding glazed doors clash with kitchen door. Need to rectify

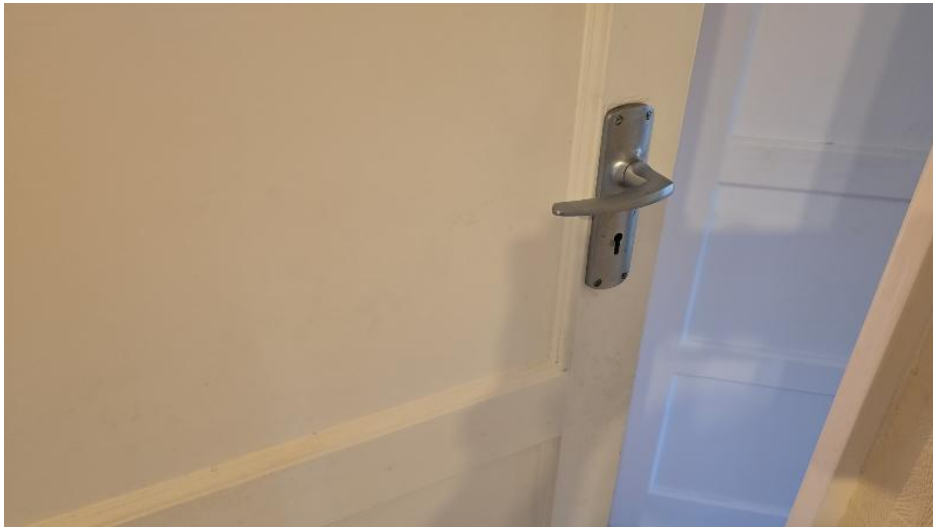
Doors general ironmongery repairs or replacement throughout

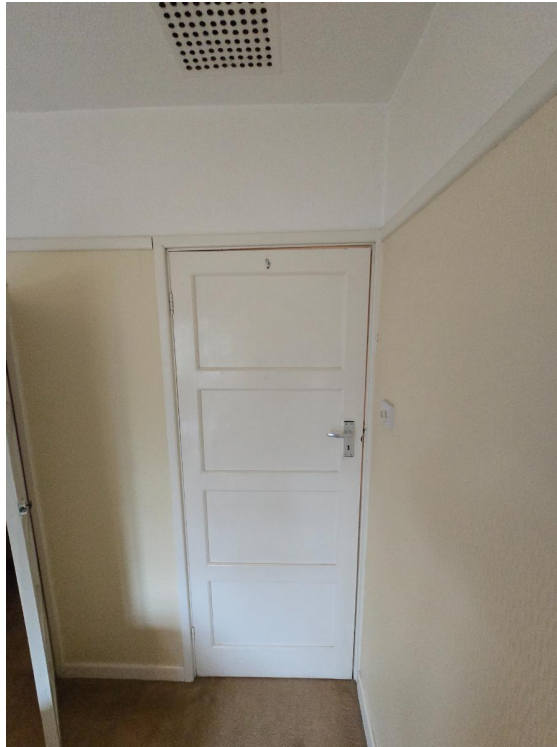
Bedroom door not square

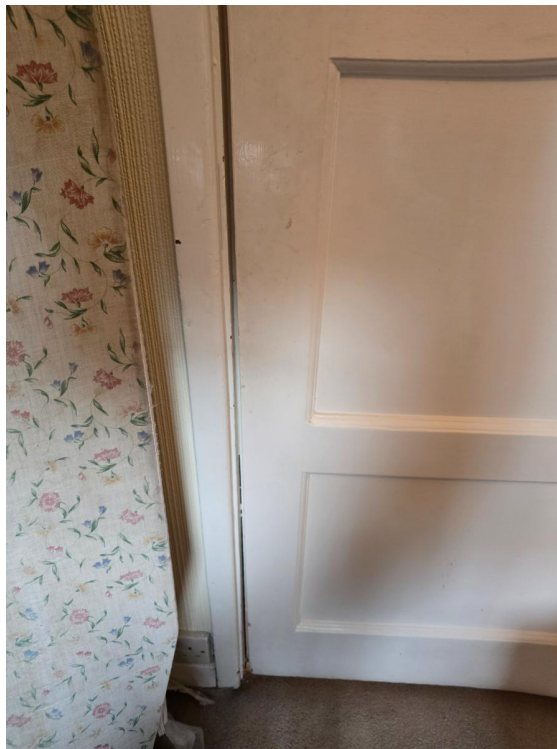
Excessive gaps to bedroom door replace

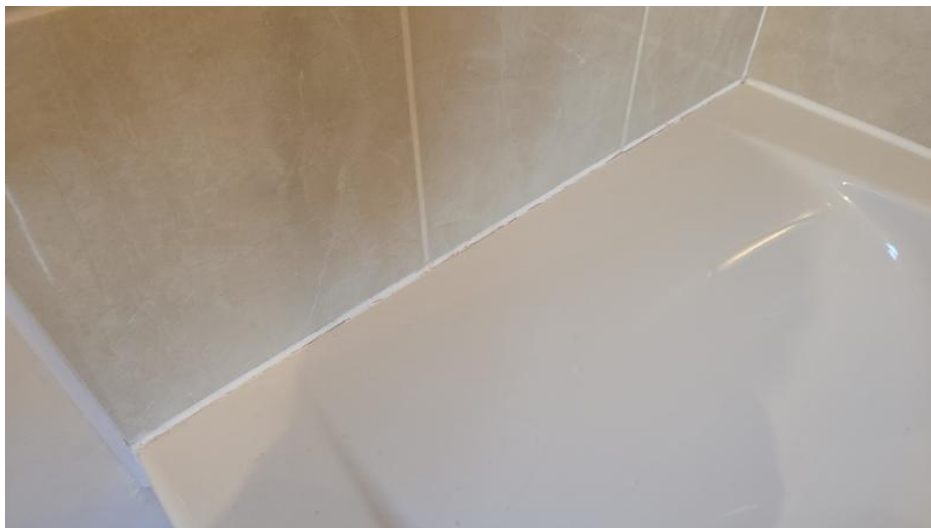
The sealants to the fittings require replacement. Defects in concealed areas can arise from water penetration, causing rot to cabinets, floors and fittings.

Defective sealant to bath

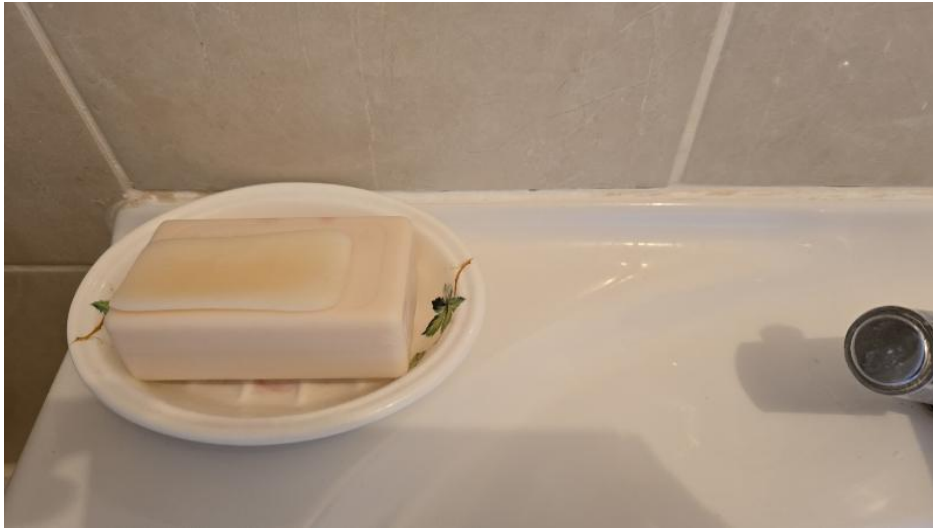
Defective sealant to wash hand basin

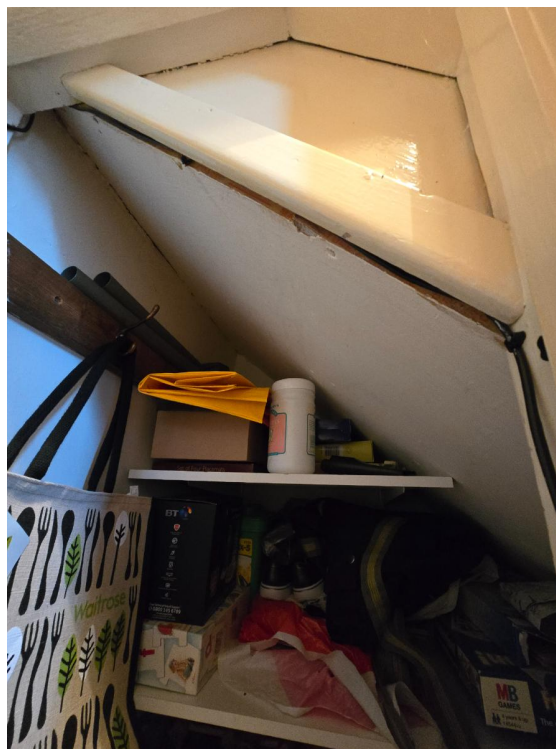
We have not been able to ascertain the ceiling's composition, but asbestos is suspected to the underside of the stair cupboard. There may also be other areas of asbestos in the property that are concealed and not visible as part of the inspection. We recommend that an Asbestos survey is undertaken and an approved laboratory analyse a sample to determine its precise composition. Note that the store items and fixed furniture and fittings will restrict the asbestos survey. This should be discussed with the Asbestos consultant prior to their inspection to advise on the extent

Presumed asbestos to soffit of understairs cupboard

The material must not be worked on or removed, and specialist asbestos contractors should be used for any proposed work. The Health and Safety Executive provides further advice.

The presence of asbestos can affect a property's value and reduce its marketability. You should consider using a specialist contractor to remove the material.

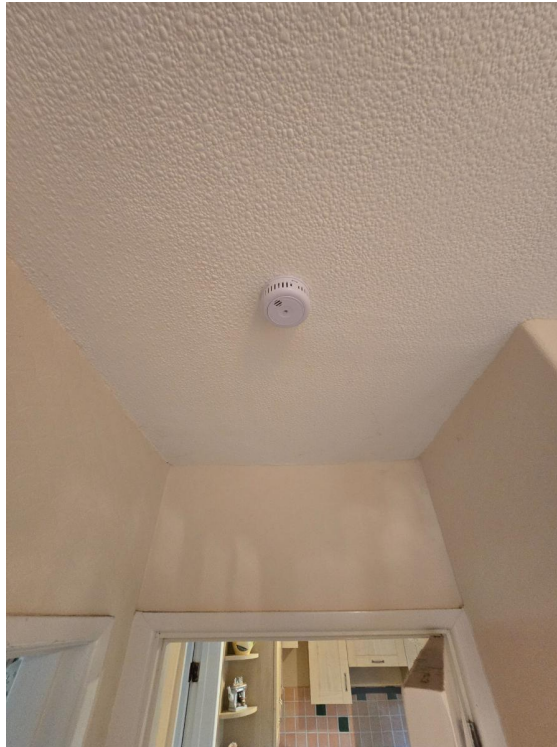
Battery powered smoke alarm ground floor hall

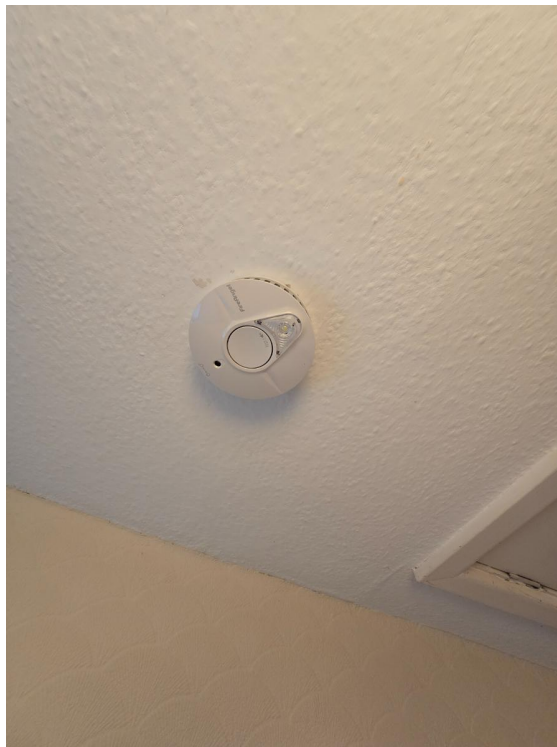
Battery powered smoke alarm 1st floor landing

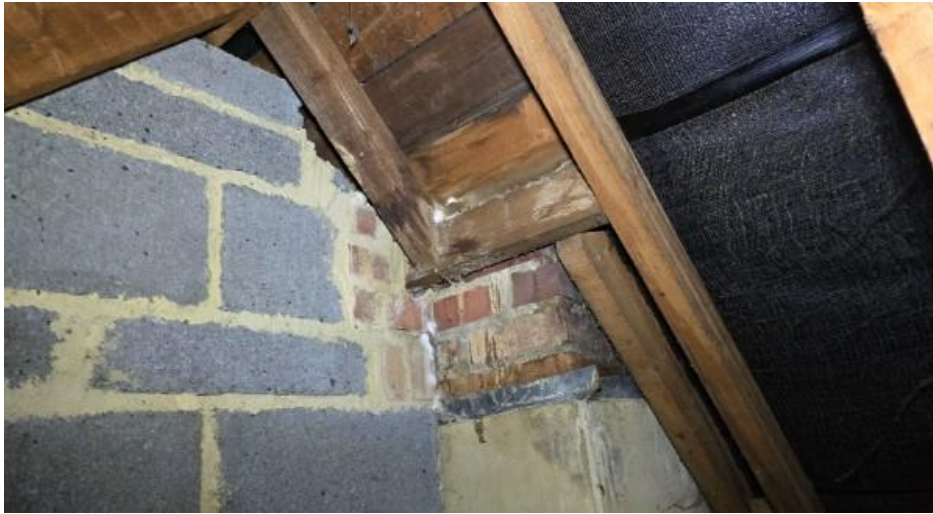
Incomplete fire compartmentation party wall to roof void

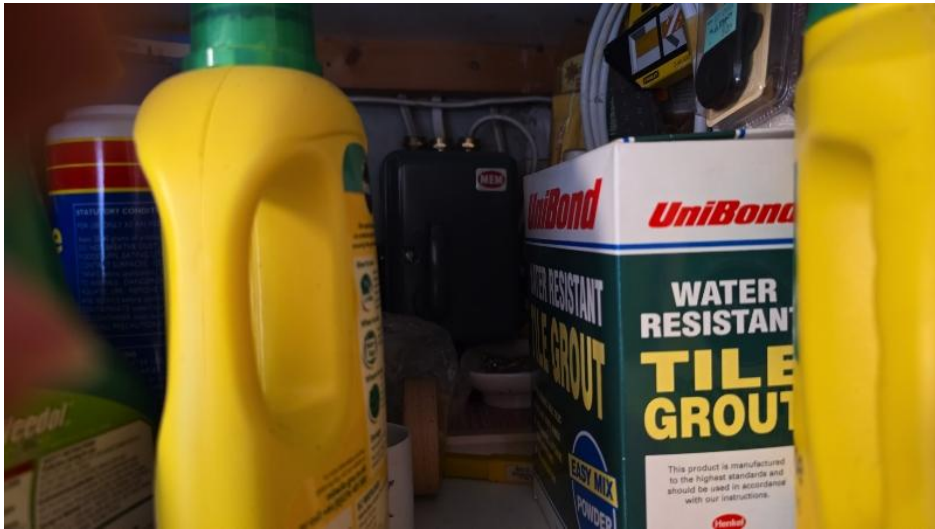
Electrical switch isolator concealed in utility cupboard

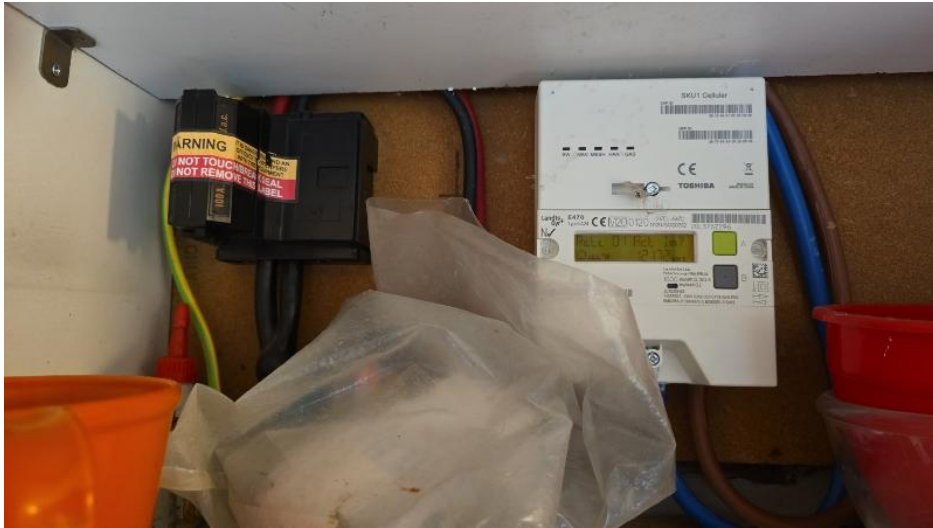
Electrical main fuse and meter utility cupboard
