LEVEL 3

Your survey report...

Inspection Date

20/02/2026

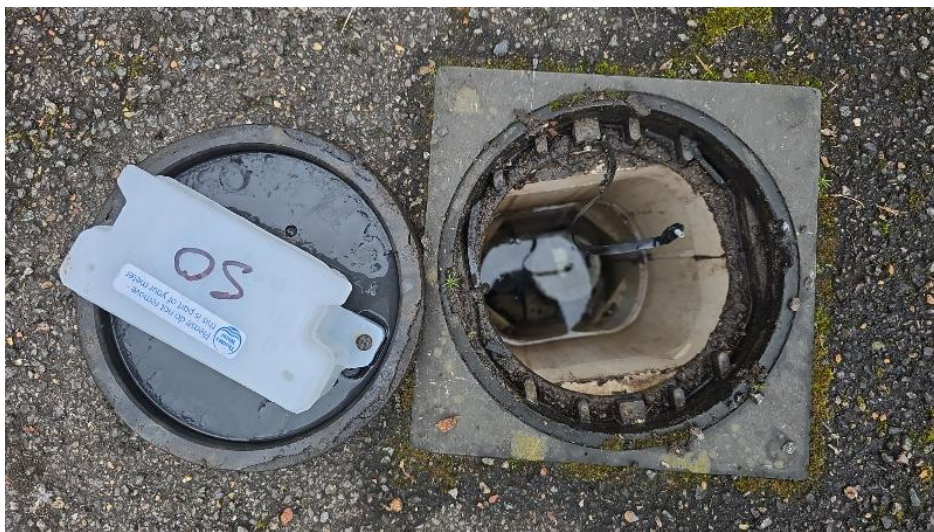
Water meter and external stop valve

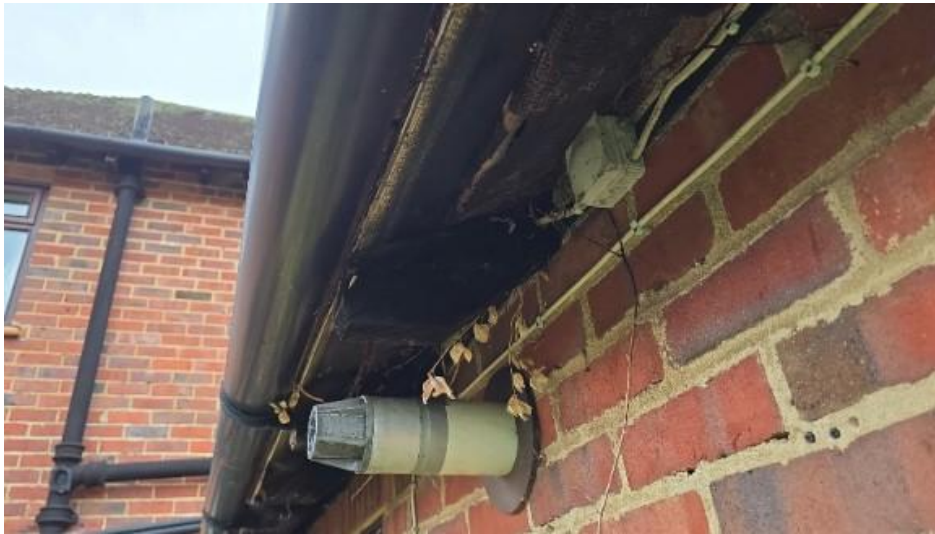
There is a Baxi Solo 3 PFL 50 non condensing boiler in the utility room. This type of boiler supplies hot water to traditional heating radiators, the domestic kitchen and bathroom, and other hot water taps throughout the property. The flue terminal is directly under eaves and gutters. Review of correct location should be considered on replacement of the boiler. The gas safe engineer should inspect the existing external flue and advise on any immediate remedial works.

Non condensing boiler flue close to eaves and guttering

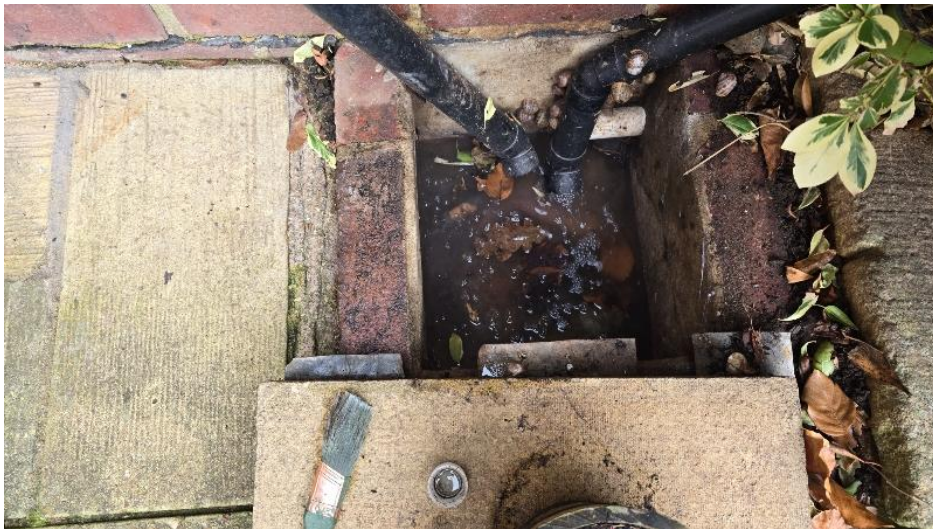
Some defects, including blockages, and general repairs are required.

Kitchen gully blocked and overflowing

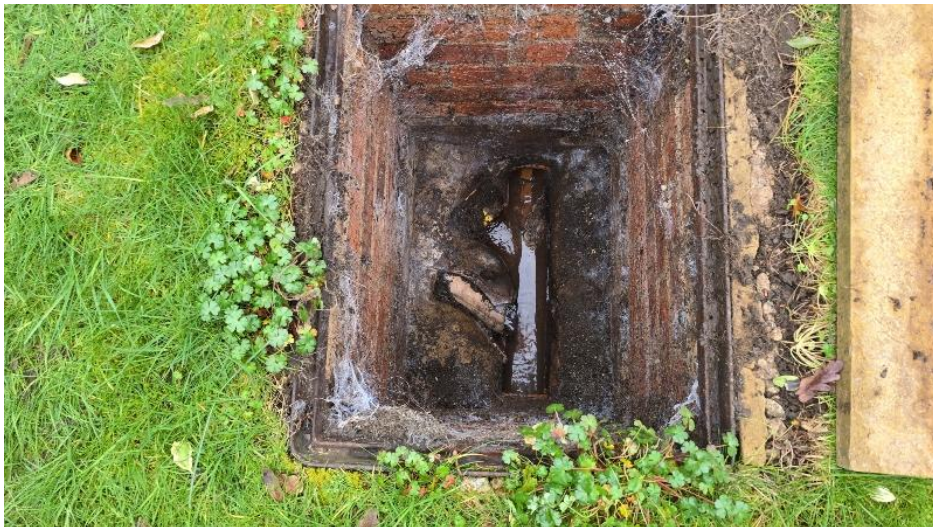
The property is believed to be connected to the main drainage system. Inspection covers were raised wherever possible and found to be free-flowing and clean. It should be noted that detritus and cob webs in the manhole limited the inspection of the condition of the masonry and haunching. This should be cleared and inspected as part of the drainage CCTV survey.

Manhole appears to be clear although detritus and cobwebs restricted the inspection

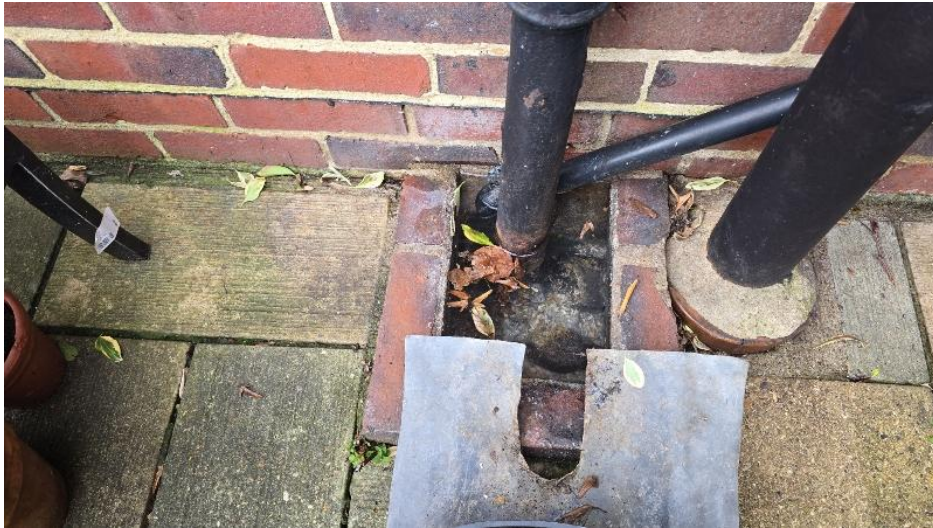
Utility room gully blocked and overflowing

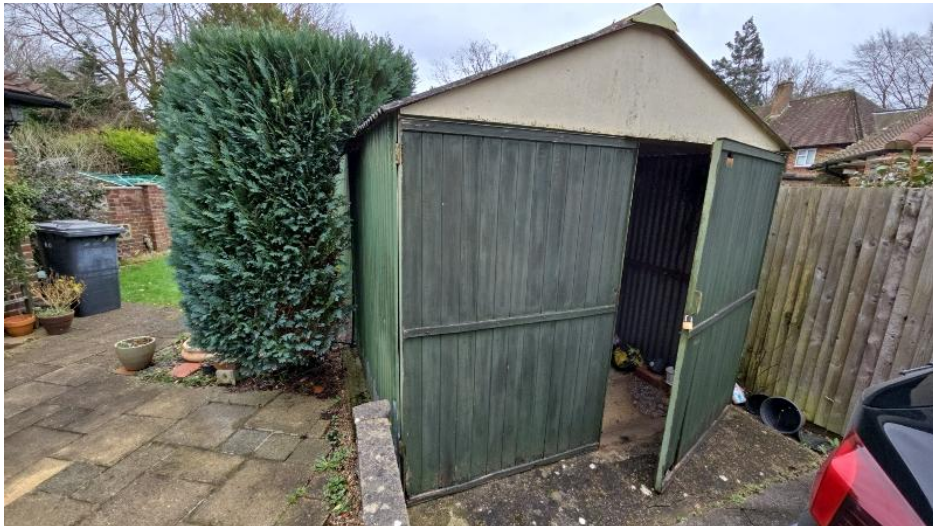
The garage is in poor condition. It may contain asbestos materials; when considering replacement, you should consult a Licensed Asbestos Contractor for further advice. It is illegal to dump asbestos-containing materials.

Garage in poor condition

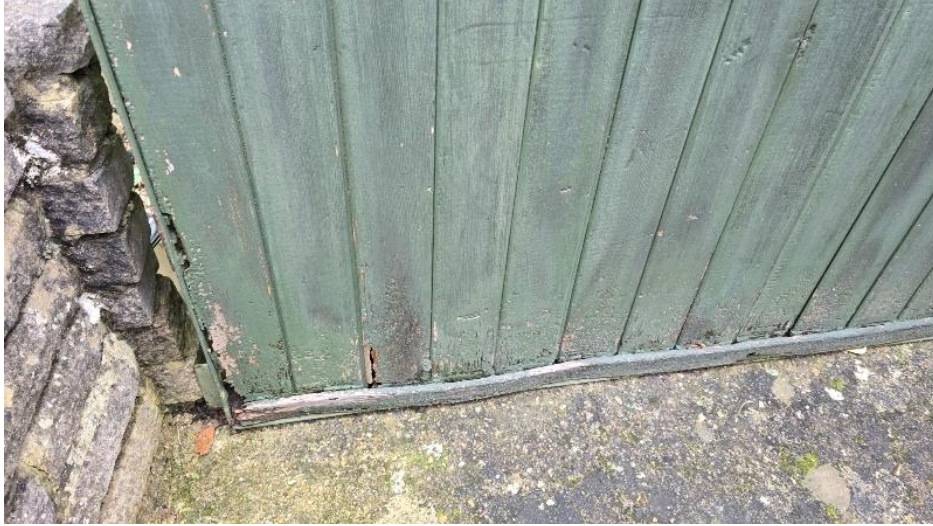
Defects were noted, including damaged asbestos panels, corrosion to metal frame and rotten timber, and you should obtain costs for the necessary replacement.

Rotten timber doors

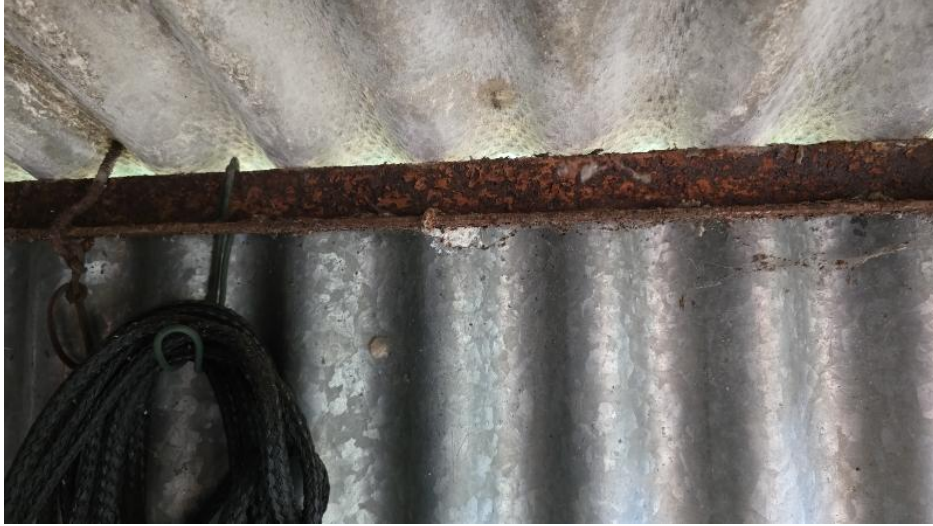
Corrosion to steel frame

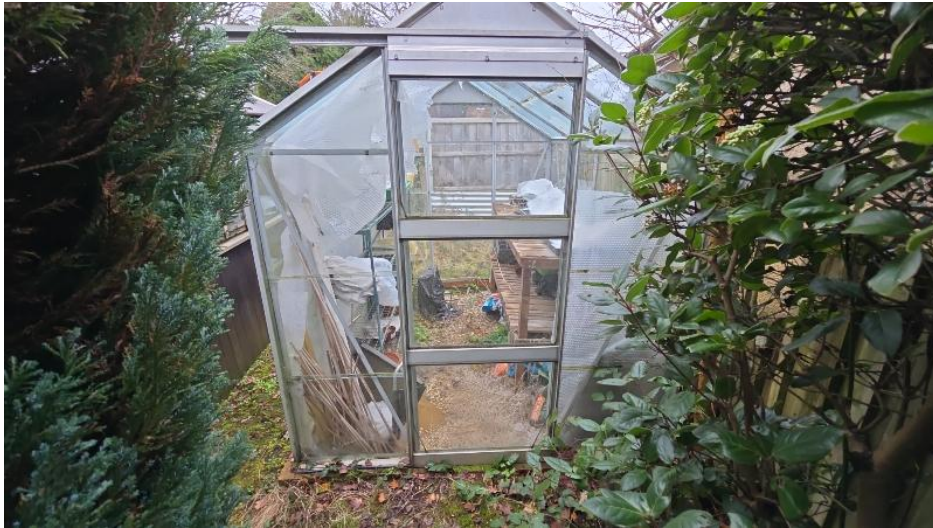
The greenhouse should be inspected for safety glazing marks and checks for condition of fixings and sliding door operations. If there is no safety glazing then this should be replaced as a matter of urgency.

Existing greenhouse inspect for safety glazing markings

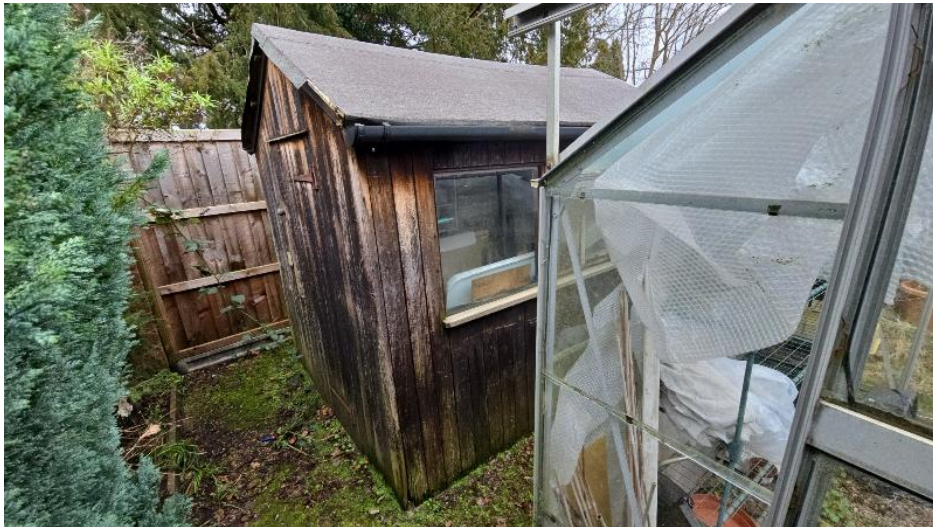
The existing timber shed was locked and externally is in a poor condition and should be replaced.

Dilapidated shed no access

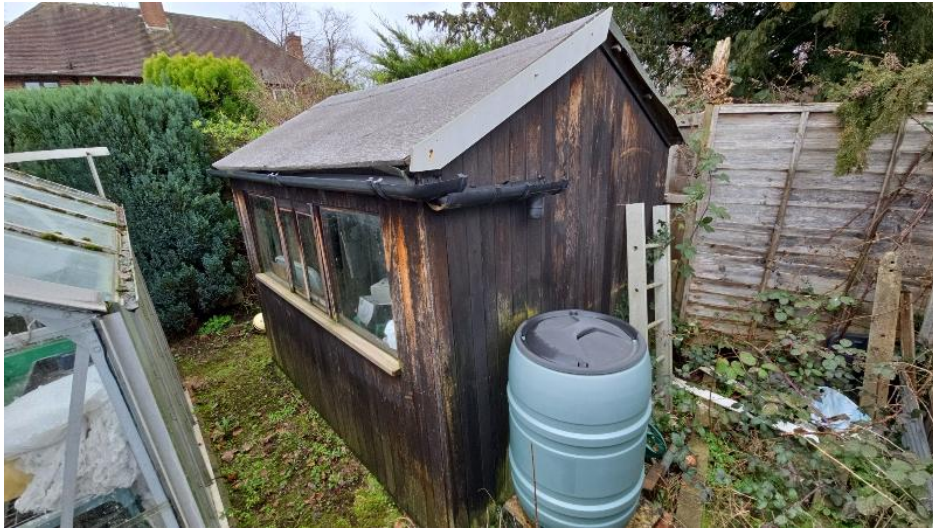
Dilapidated shed no access

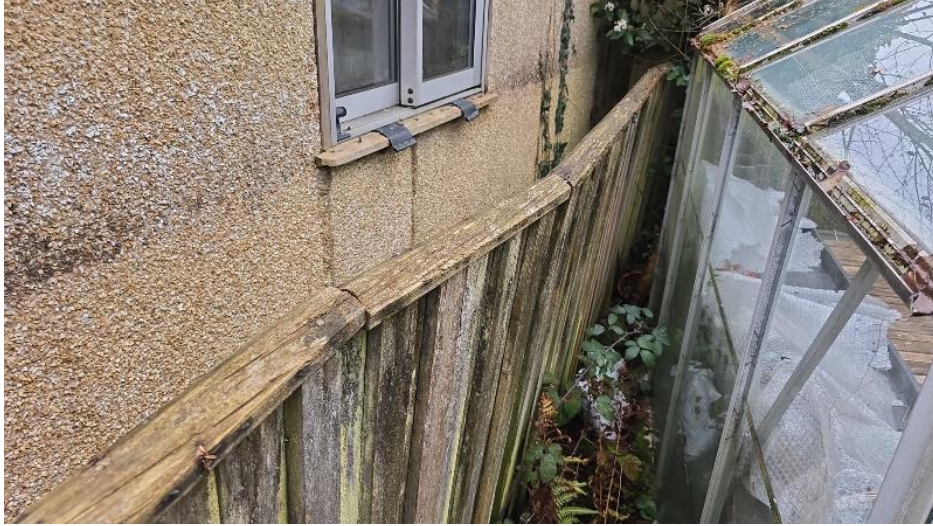
The boundaries are generally in a serviceable condition for their age and type, warranting routine maintenance. There are some localised defects including fences which are damaged and require repair/replacement. Low levels walls require rebuilding, which will restore architectural character.

Damaged section of fencing to side of garden

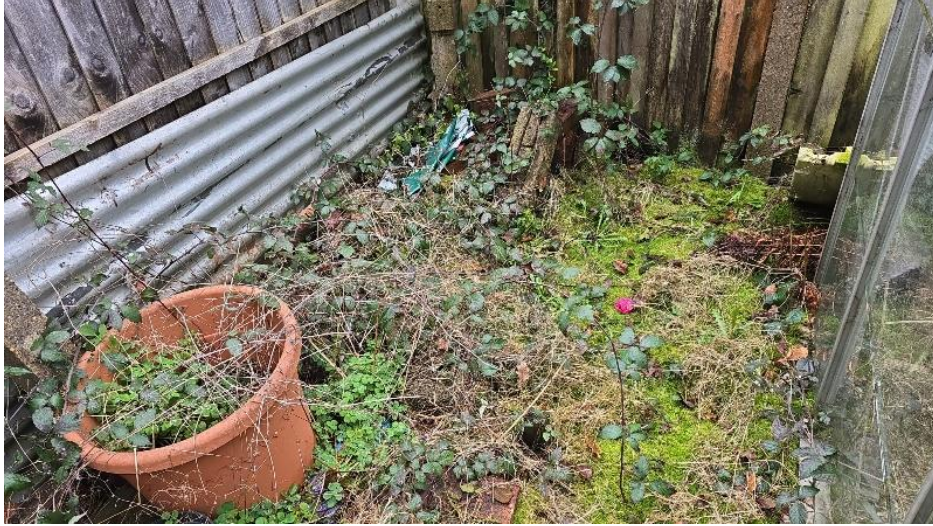
Vegetation growth limiting inspection

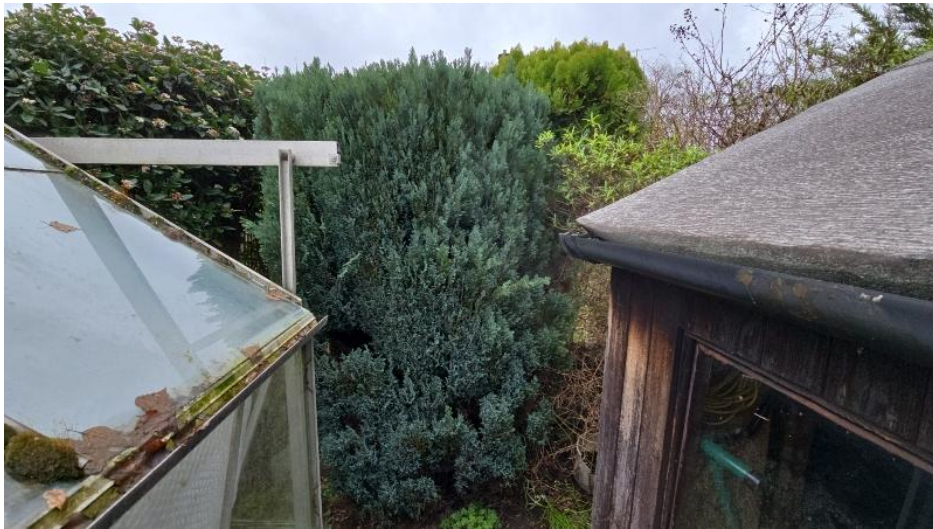
Vegetation growth limiting inspection

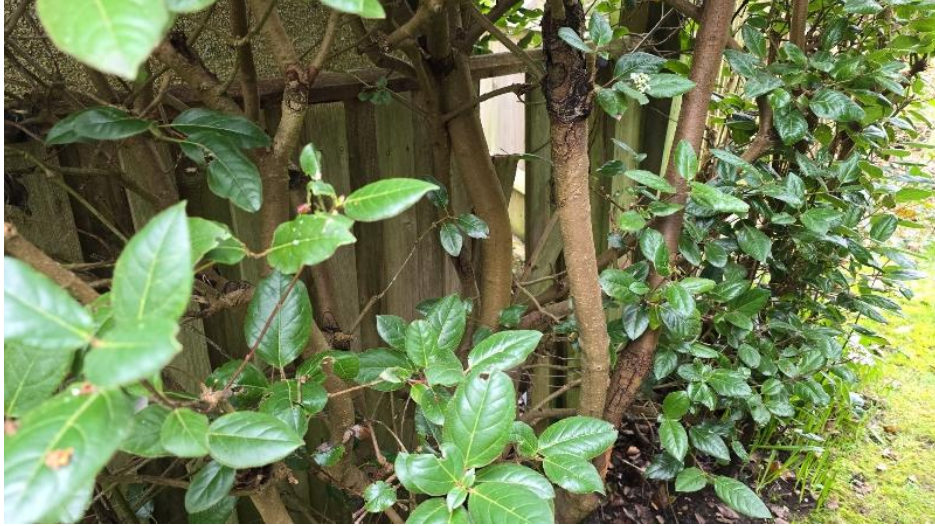
Damaged fence behind vegetation

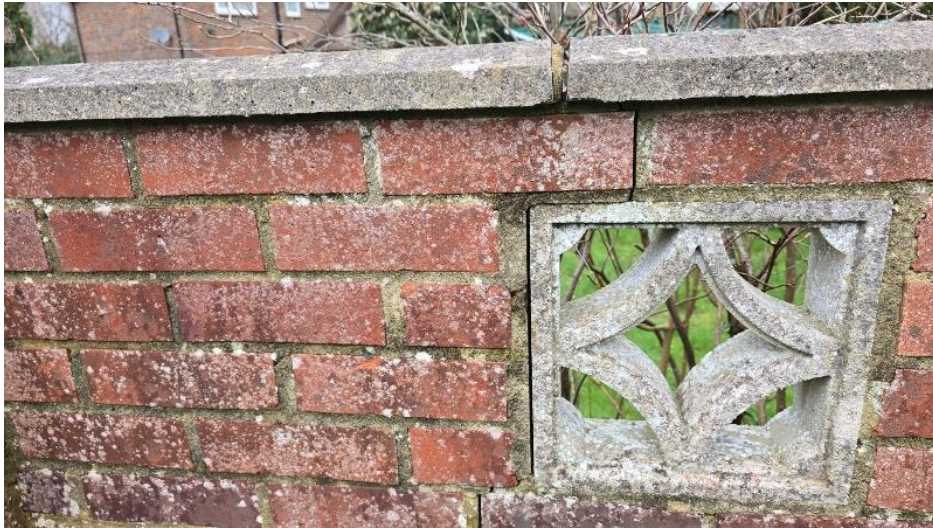
Cracks to boundary wall full height. Further investigations

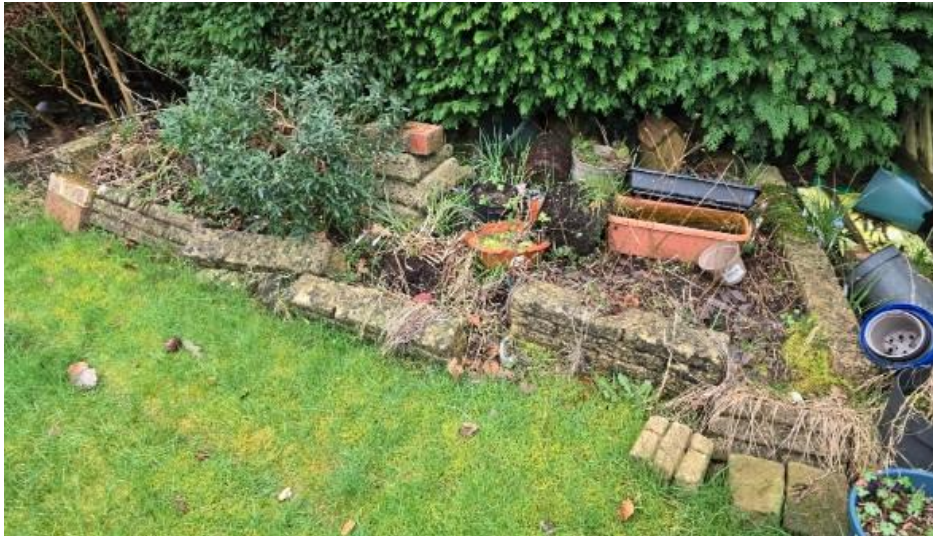
Dilapidated section of low level wall/raised bed to be rebuilt

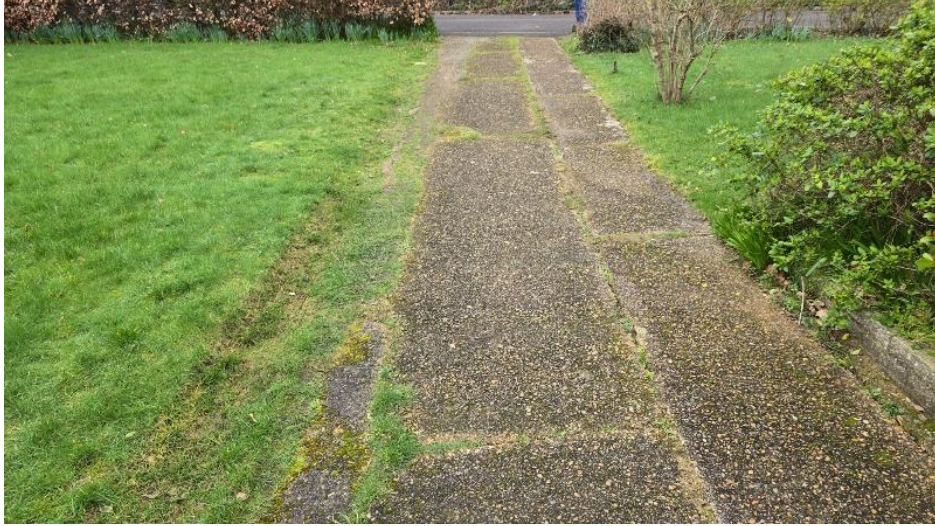
Driveway repairs required

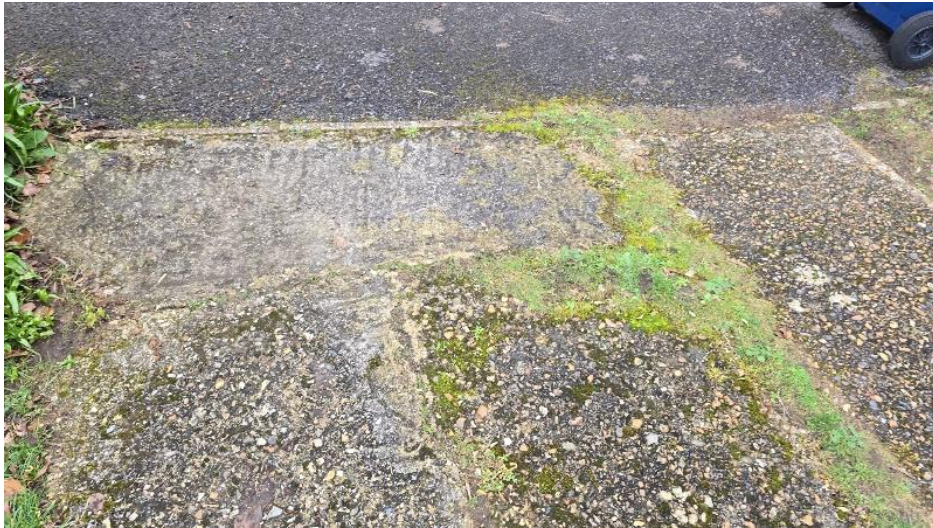
Driveway repairs required

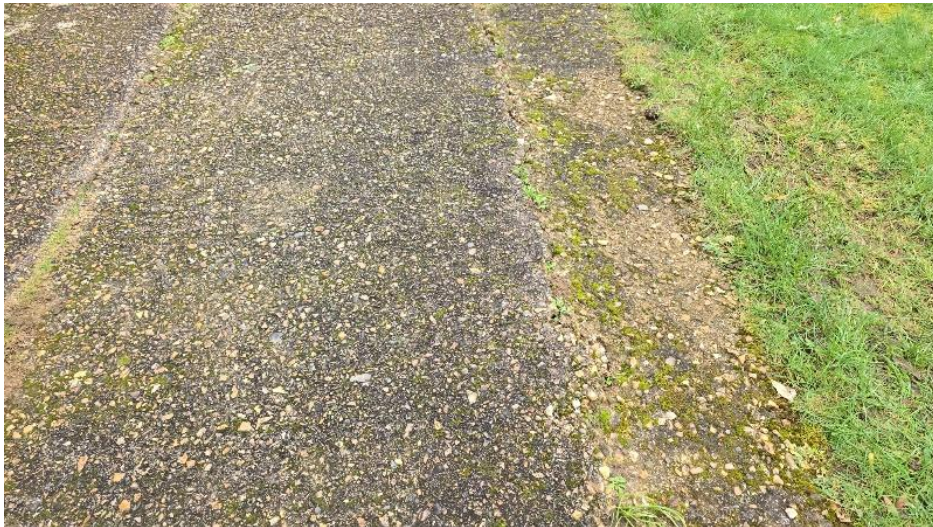
Driveway repairs required

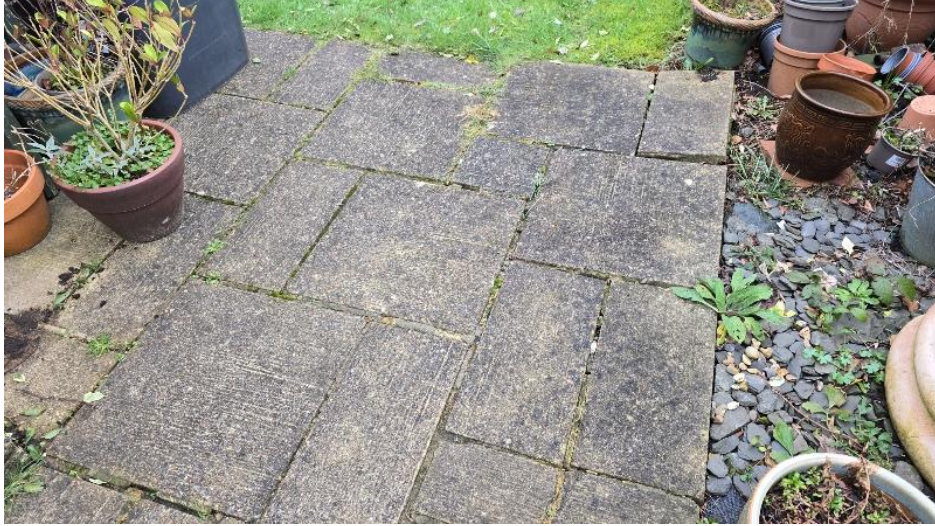
Repairs required to patio

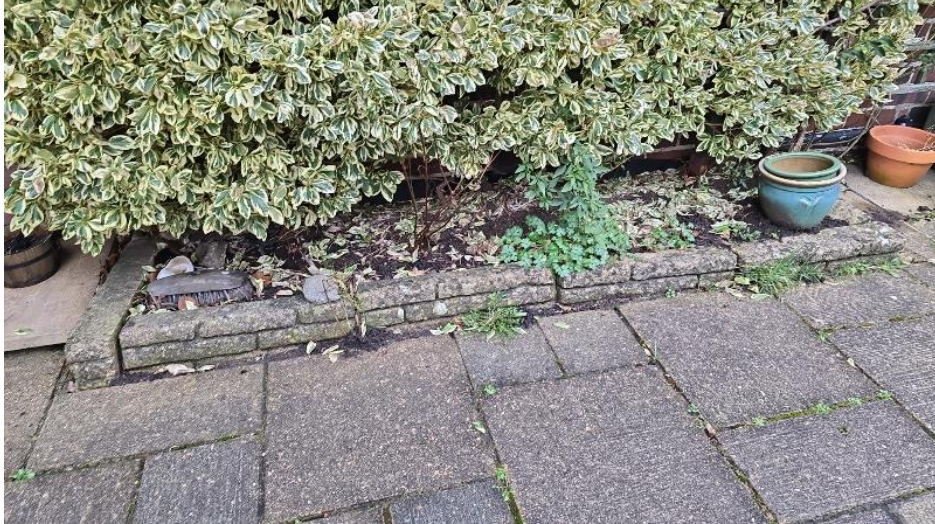
Vegetation to be removed where growing against walls. Raised beds to be removed

There are also a number of shrubs and small bushes planted against the main walls of the house. These should be removed along with the raised beds to prevent any damage to the building.

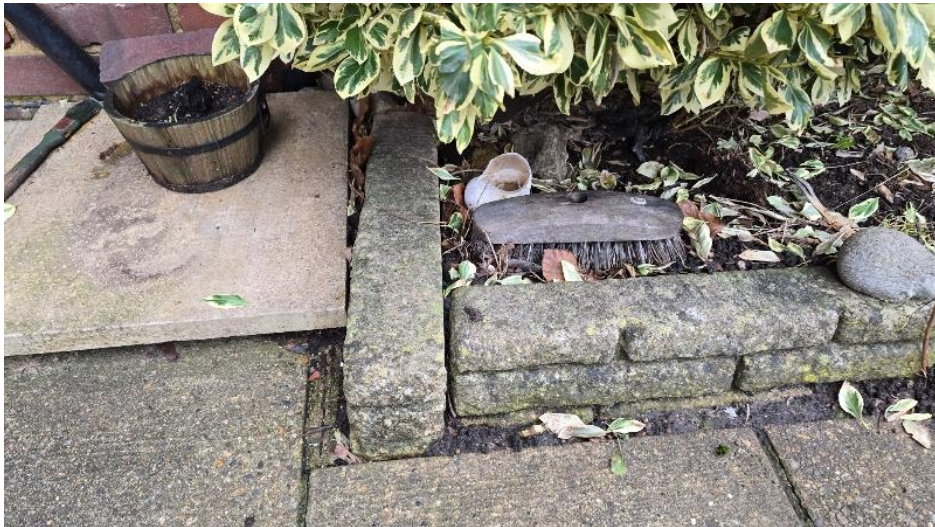
Vegetation to be removed where growing against walls. Raised beds to be removed
