LEVEL 3

Your survey report...

Inspection Date

20/02/2026

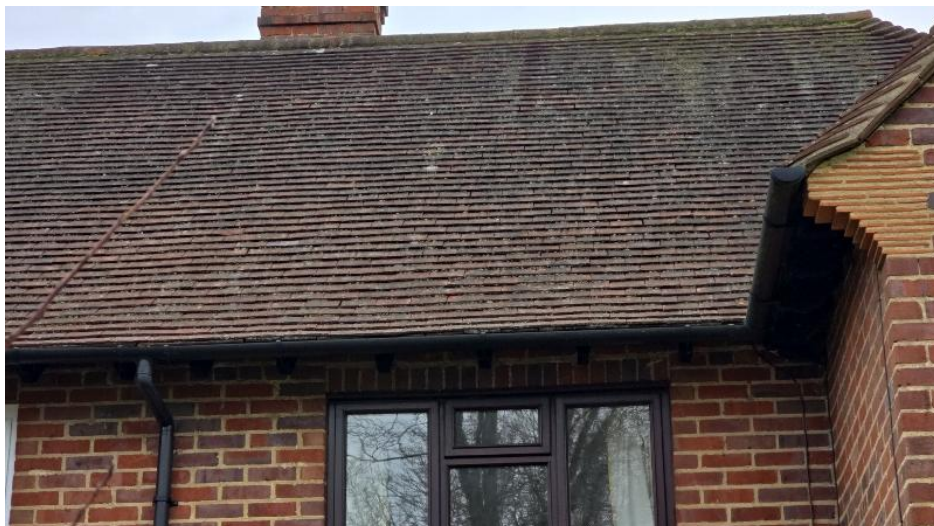
Undulation at eaves level, noted defective timber on lower elevations

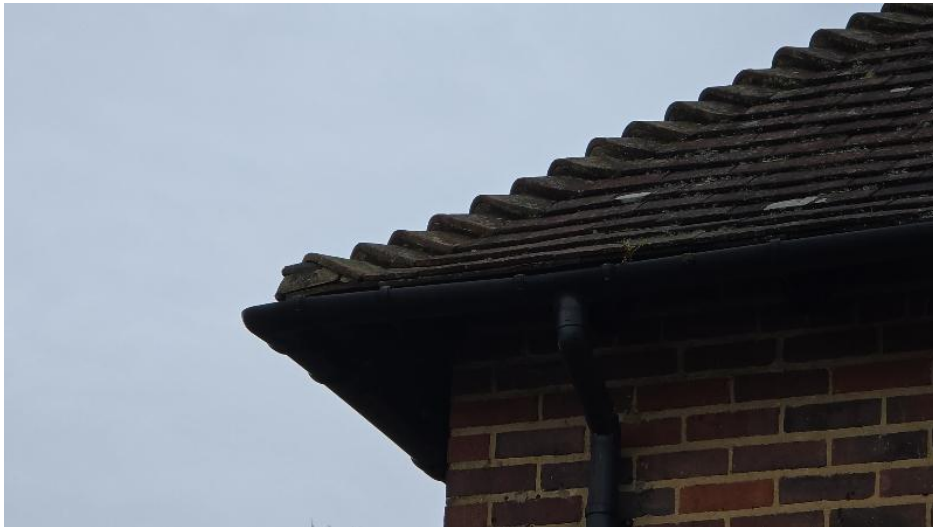
Hip tiles require rebedding

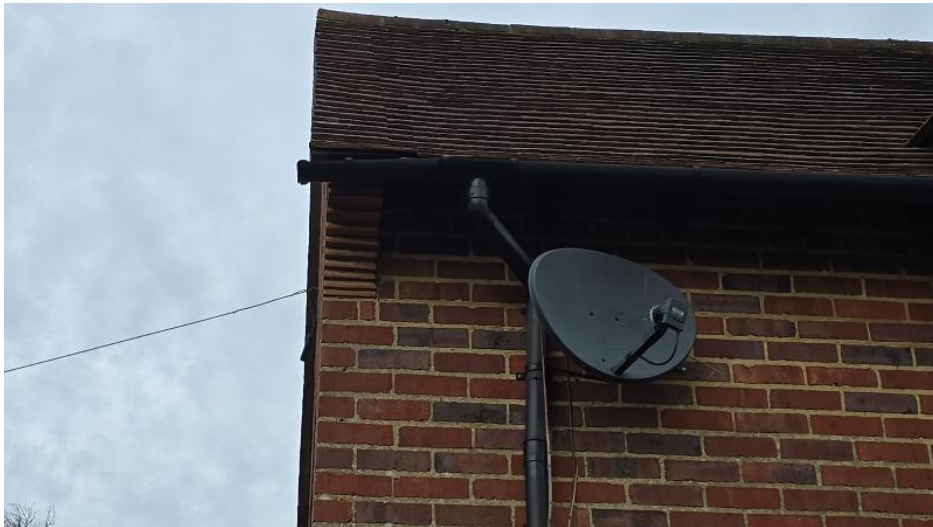
Undulation in gutter due to defective timber to eaves

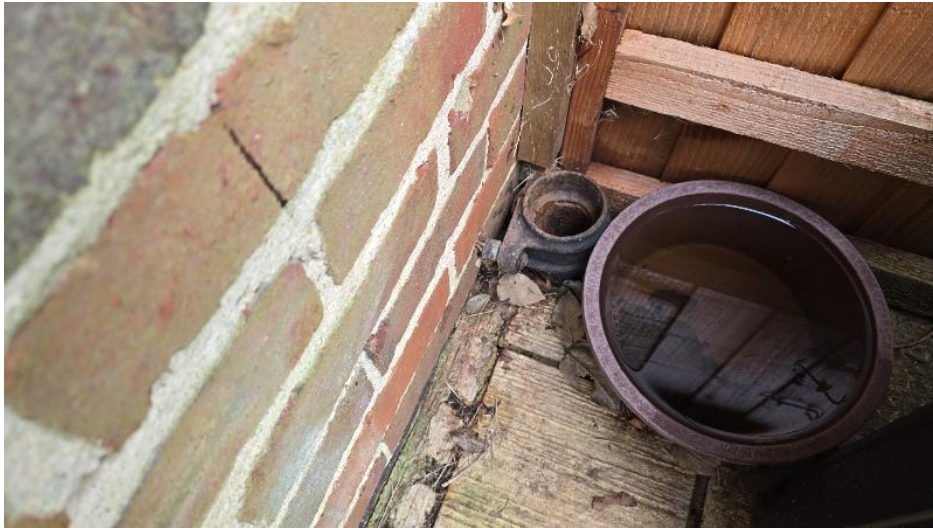
Existing downpipe disconnected. Investigate if still connected to underground waste

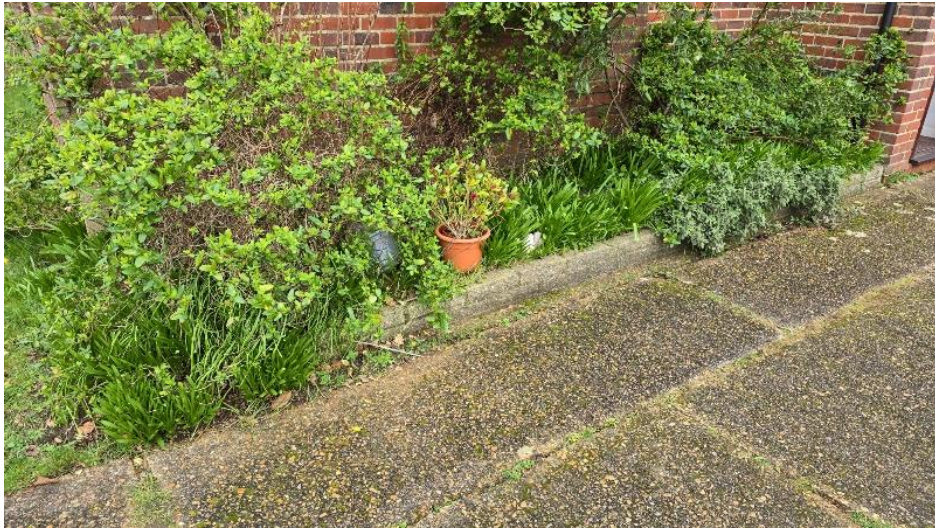
Raised plant beds close to DPC level

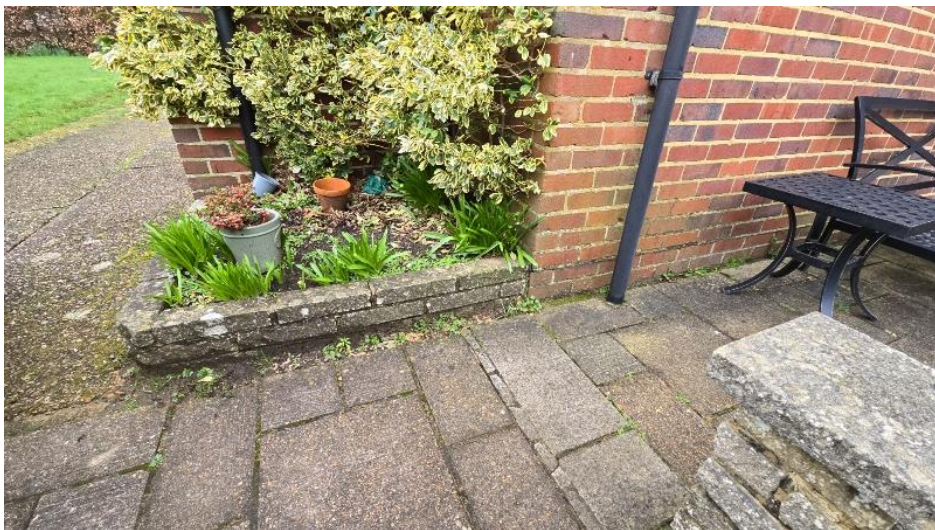
Raised plant beds close to DPC level

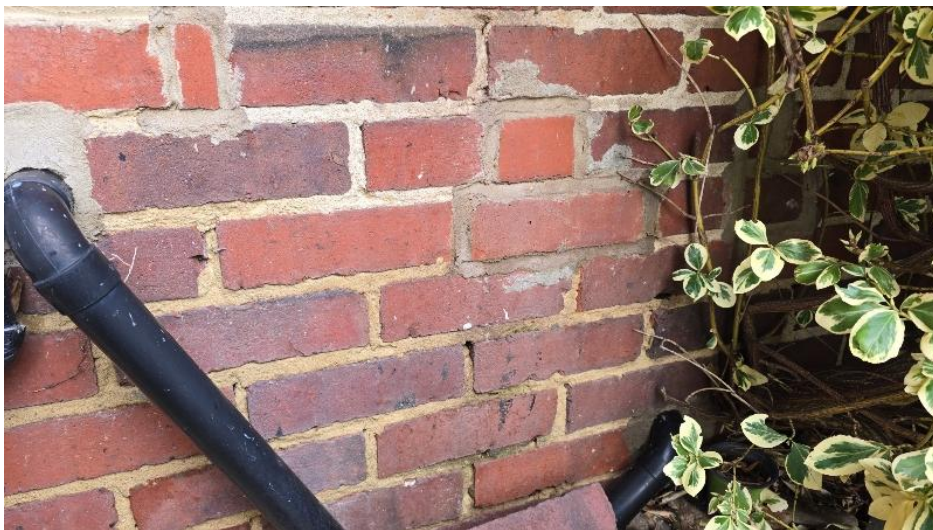
Repointing required

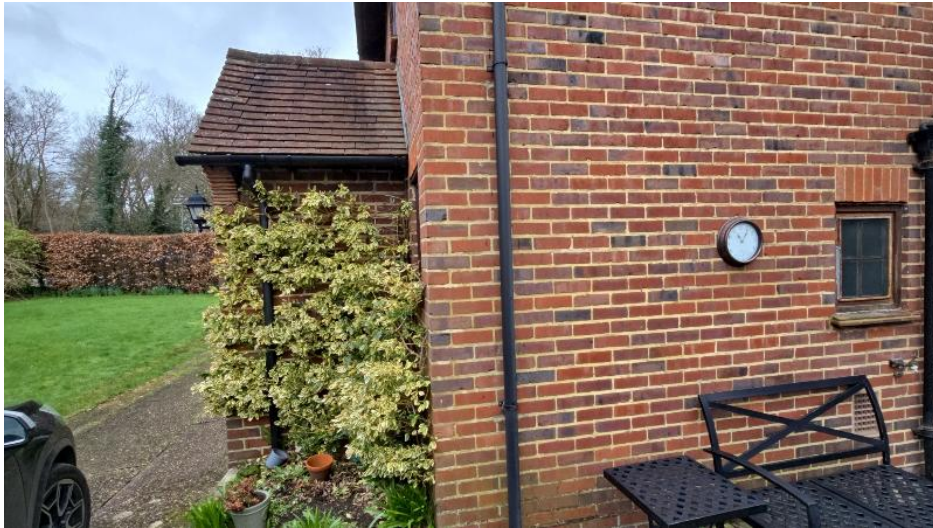
Undulation to roof

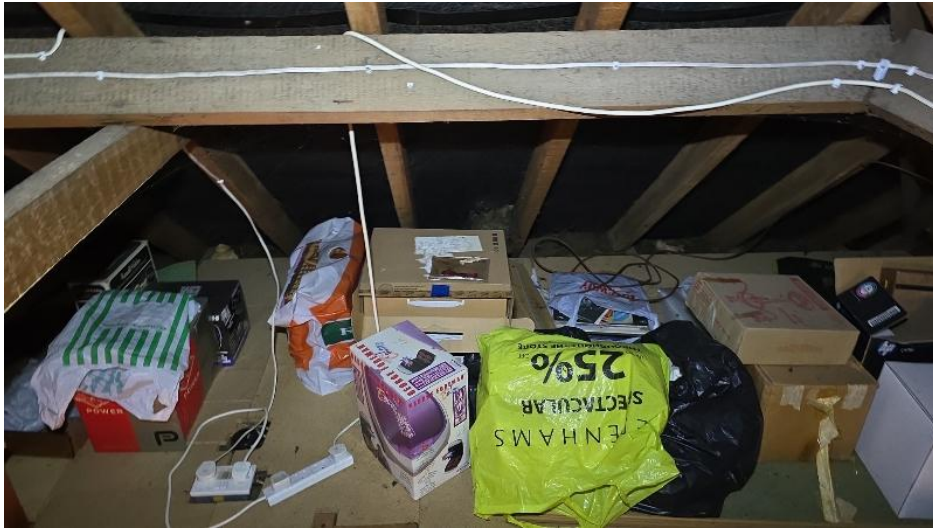
Daisy chain extension leads

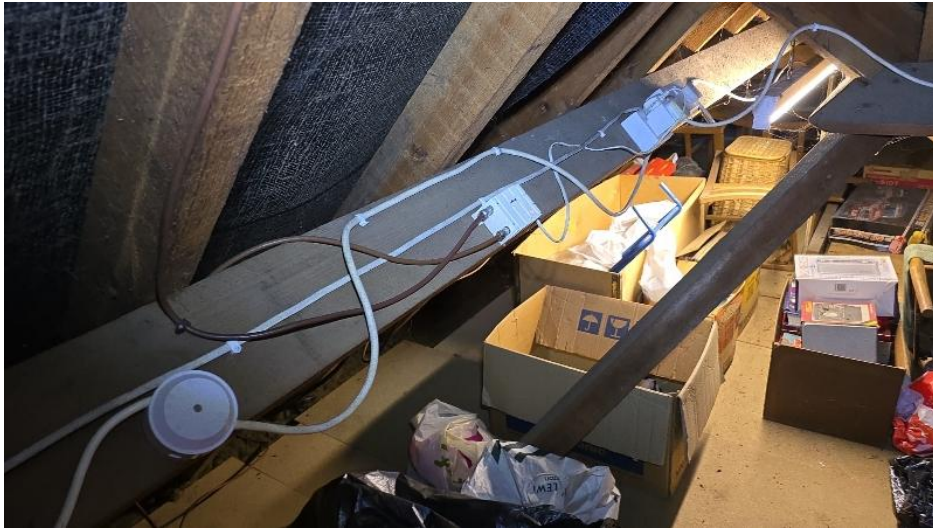
Daisy chain extension leads

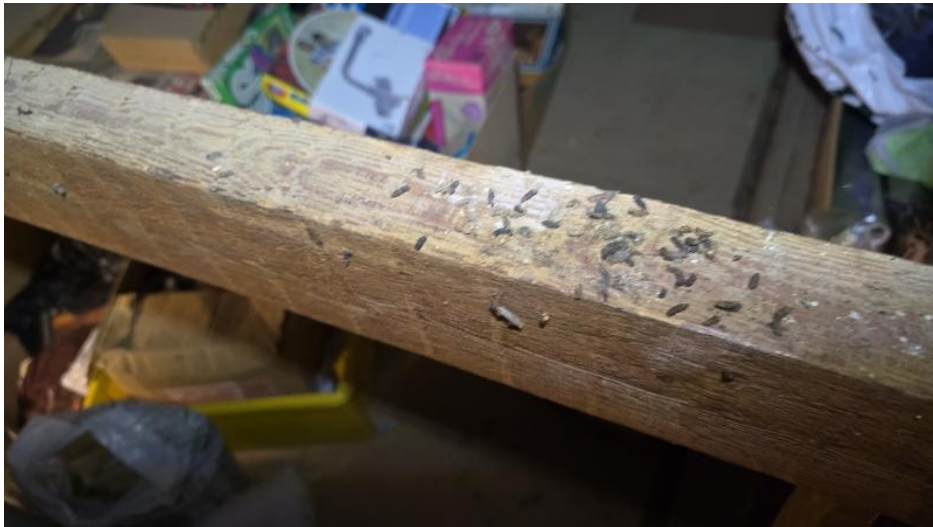
Vermin faeces

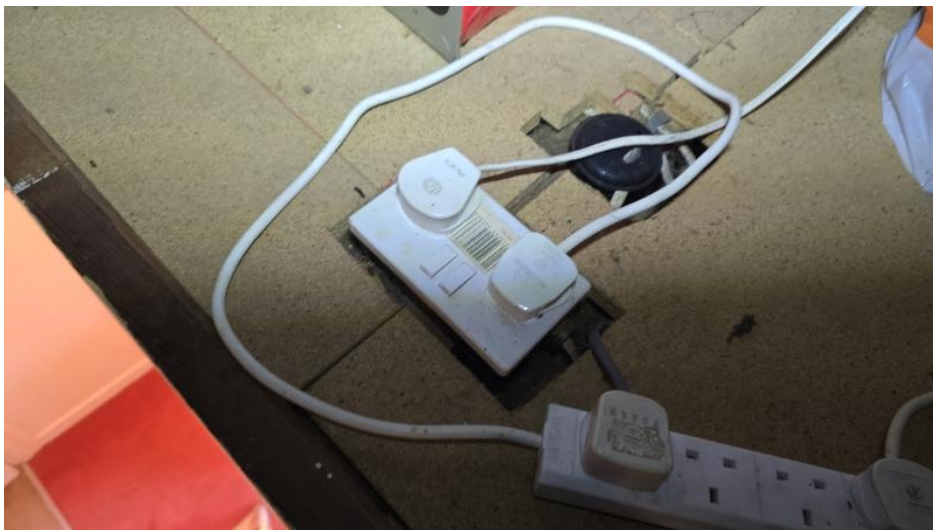
Daisy chain extension leads

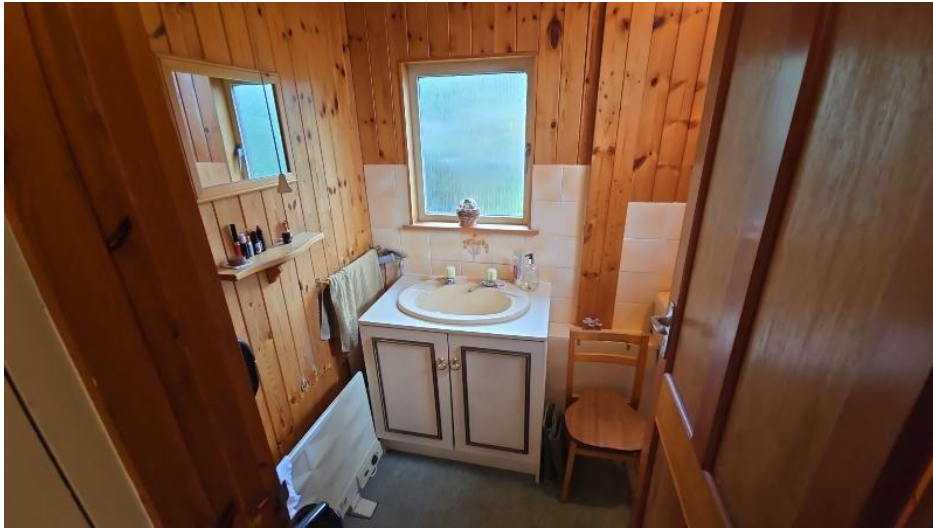
Dated WC suite

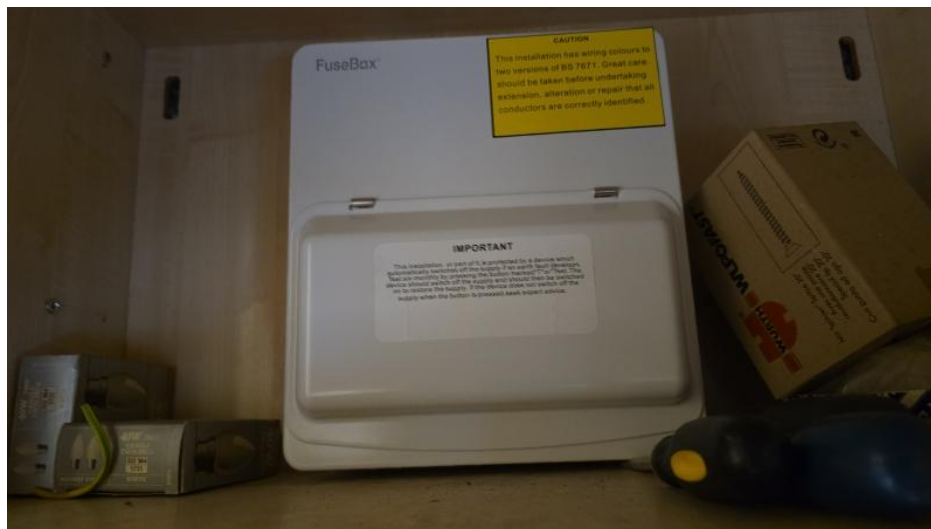
The consumer unit is located in the kitchen.

Consumer unit kitchen cupboard

Our visual inspection revealed no significant faults; however, we recommend that you have a NICEIC-registered contractor inspect the system to ensure your safety.

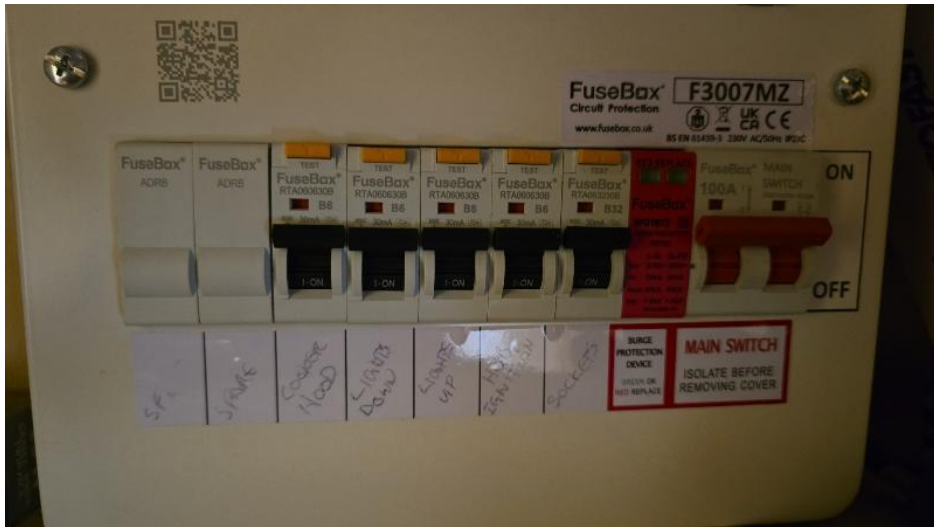
Consumer unit kitchen cupboard

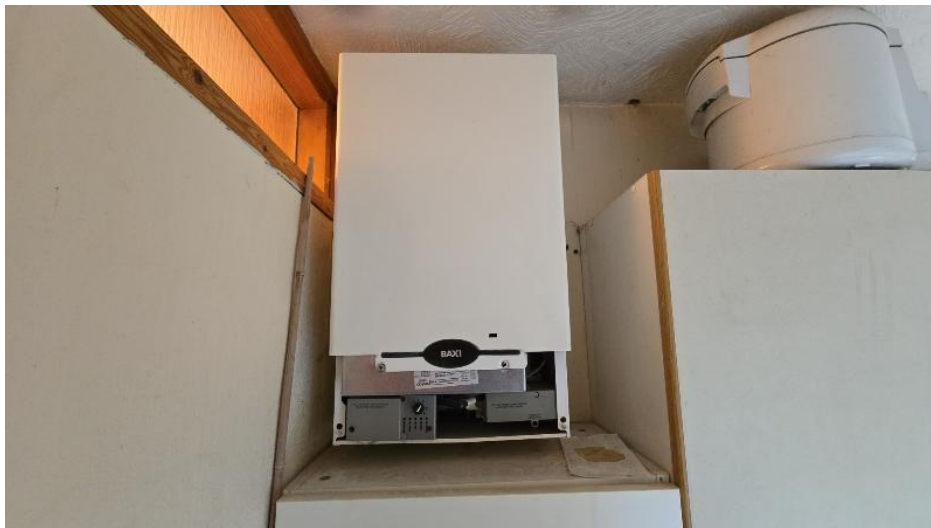
The system is outdated and has reached the end of its serviceable life. You should ask a Gas Safe Heating Engineer to provide a quotation for complete replacement and updating.

There is a Baxi Solo 3 PFL 50 non condensing boiler in the utility room. This type of boiler supplies hot water to traditional heating radiators, the domestic kitchen and bathroom, and other hot water taps throughout the property. The flue terminal is directly under eaves and gutters. Review of correct location should be considered on replacement of the boiler. The gas safe engineer should inspect the existing external flue and advise on any immediate remedial works.

Baxi Solo 3 PFL 50 non condensing boiler

You should have the entire system checked and tested by a Gas Safe Heating engineer prior to making any financial or legal commitment.

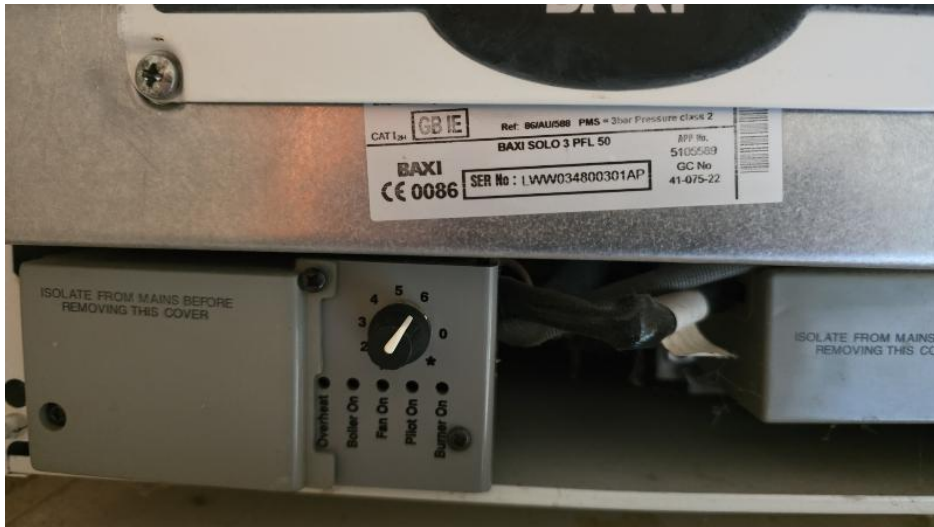
Baxi Solo 3 PFL 50 non condensing boiler

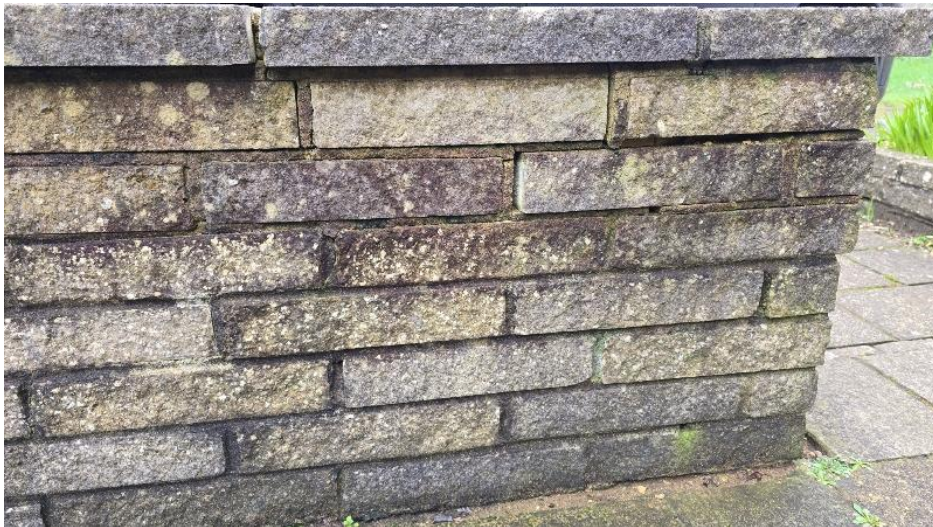
Structural movement/impact damage to low level wall off garage

It is strongly recommended that the wall be taken down and rebuilt in thicker brickwork, or replaced with a fence, as a matter of urgency. Until this is done, the wall should be screened by suitable temporary hoarding or fencing to provide protection to people. This is believed to be a party fence and your legal advisor should ascertain repairing liability.
